THE GUESTEN HALL ROOF, WORCESTER CATHEDRAL

A Survey by F. W. B. Charles

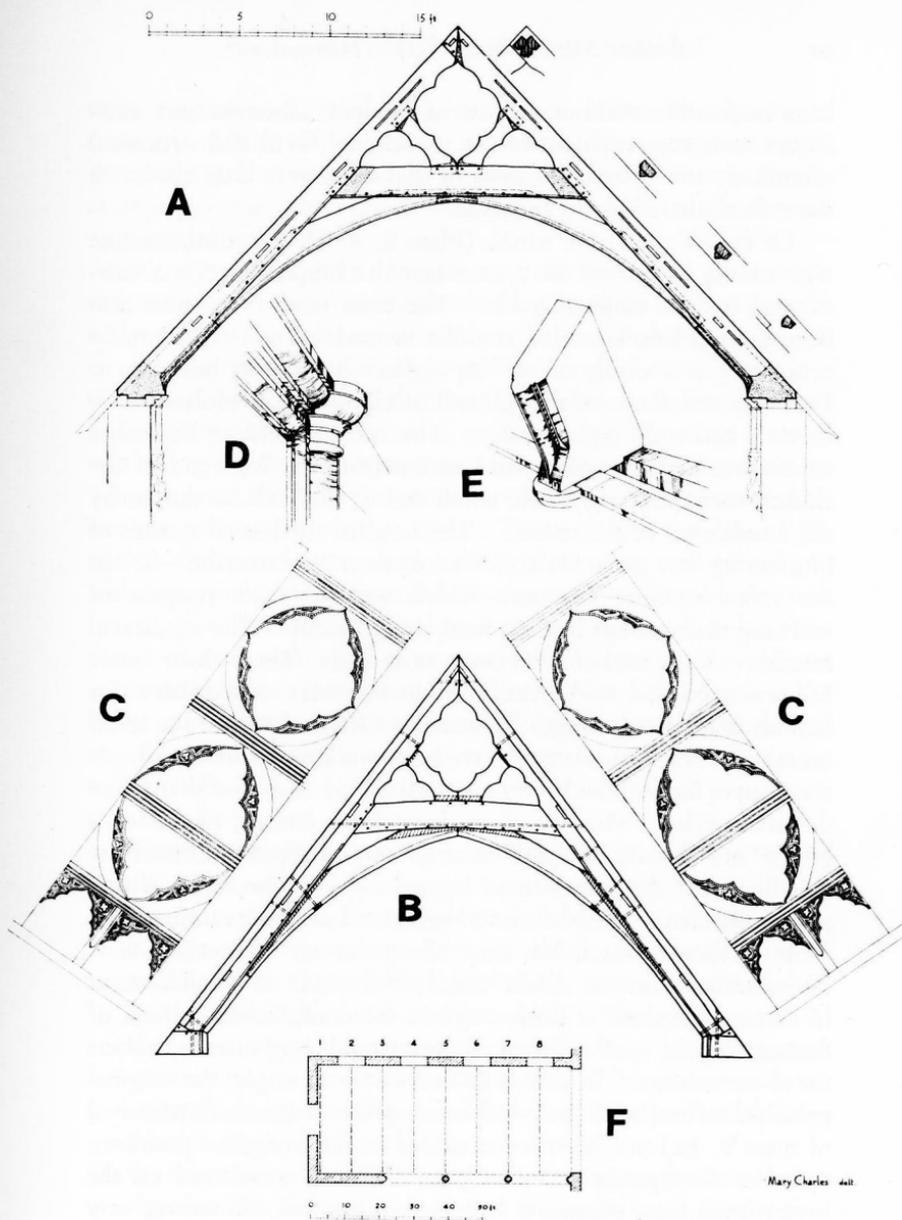
PLATE 11. Details of the Guesten Hall roof, Worcester.

A is a typical truss as it was at the Guesten Hall. The areas shaded were cut from the original members to raise the roof pitch as at B, which shows a typical truss at Holy Trinity Church. To the right of A is a section to show the ridge-piece and purlins. C, on either side of B, shows the wind braces within each bay, D has details of the wall-plate and corbel shaft, and E shows the probable design of the chamfer stop at the foot of the principal rafter. F is a key plan of the nave of Holy Trinity Church to show the numbers and positions of the trusses.

Of the original nine trusses (Plate II, A, F), the southernmost was wholly destroyed in 1741 when the hipped roof was substituted for the original gable. The truss next to it must also have been at least curtailed at collar beam level and considerably mutilated as a result of the hip rafters having to bear on it. Consequently the roof though still of eight bays at Holy Trinity Church had only eight trusses. The arrangement of the other trusses was the same as at the Guesten Hall, the west end of the church corresponding to the north end of the Hall, as shown by the numbering of the trusses. The original mediaeval system of numbering was generally followed in the reconstruction—not in the actual erection sequence, which was the main purpose of marking timbers, but in their final arrangement. The mediaeval numbers are chisel-cut Roman numerals. These have now become confused with similar style numbers added later for reasons that can no longer be traced. Originally only the main members of each truss would have been marked and those only on their upper face. The Victorian numbers are of no less than three different styles. Most of them have been cut by means of a gouge and consist of small lozenge-shaped digits. Others are chiselled, and the rest formed by an auger. The result is that practically every member now bears at least one number and most of them several, but they all appear on the correct face. Inconsistencies are no doubt mainly the result of misplacement of certain members at some stage in the complicated process of dismantling the roof and then repairing and laying out the timbers for re-assembly. In trusses IV and V, for example, the original principal rafters, with the possible exception of the south principal of truss V, had not been re-assembled in their original positions. Another discrepancy was that truss VIII was numbered on the lower (east) face, because it had been re-erected the wrong way round. On the other hand, such anomalies are occasionally found in mediaeval roofs that have never been altered, so that without further evidence of carelessness or disregard—and there is no

- (a) the foot of each principal rafter had been cut off and a new oak base substituted in order to obtain the same width of seating across the wall-plates and so the same load distribution on the wall itself as at the Guesten Hall. These bases deprived the principals of their original "chamfer stops", an important refinement of mediaeval carpentry. The most probable original design of this detail has been re-constructed from Street's drawing (Plate II, e).
- (b) the inner face-mould of each principal, leading from its foot to the shoulder from which sprang the arch brace, about four feet above the foot, no longer exists as an integral part of the principal. A new face-mould, following the original design, was nailed on, and this method was adopted not only in those

- (c) the arch braces, all of which were original members extending from the principal rafter to the collar beam, were altered in length. Moreover, owing to the more acute angle between the principals and collar the arch braces would no longer fit. So packing pieces of elongated wedge shape had to be inserted to close the gaps along the inner edge of the principals and soffit of the collars. The original tenons of the arch braces still partly engaged their mortices but it was a bolt inserted right through the arch brace and principal that secured them.

- (d) the collar beams were reduced in length by about twelve inches at each end and, as already mentioned, a deep trench was cut in their soffit to contain the tie-rod. Generally the soffit of each collar beam was also pared down, partly to compensate for the gap between it and the arch brace.

- (e) the cusped struts in the apex triangles had also to be drastically cut down, re-shaped and finally wedged top and bottom to fit the new angles. Victorian replacements had been used in trusses III and VIII—in the latter because the originals had obviously been destroyed to make way for the eighteenth-century hipped roof.

The church wall-plate (Plate II, D) was Victorian, but of oak and moulded exactly like the original. Instead of the mediaeval joints, however, each section was simply butted against the next and held in alignment by three metal bars or dowels. Longitudinally a dove-tailed wooden connector was let in on the top surface, and here shrinkage had permitted the butt-joints to open.
