The roofs of Beverley Minster

P. S. BARNWELL

The roofs of Beverley Minster are described and discussed with particular reference to the partial remains of a tower at the eastern crossing, the fourteenth-century nave roof, and the eighteenth-century work in all the other roofs. After some tentative suggestions are made concerning the development of the central tower it is concluded that the scale of the eighteenth-century work at the Minster has not been fully appreciated, and that it marks a significant phase in the construction of the present building.

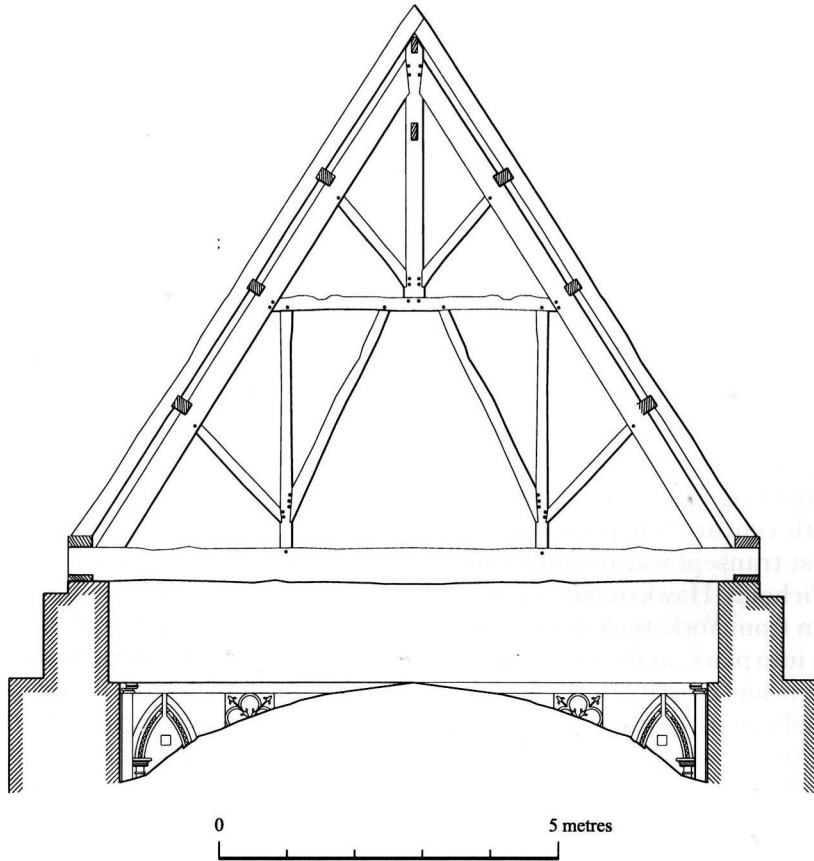
Fig. 2

The west cross wall (Fig. 2) is fully bonded into the north and south walls of the choir, indicating that it formed part of the same phase of both design and construction. Its upper surface is approximately level with the top of the vault which cuts across it. At each end of the wall is a plain attached shaft, beside which is a two-centred blind arch with dogtooth moulding; below the arches are single shafts which, although black, appear to be painted limestone rather than the Purbeck marble which was used extensively elsewhere in the eastern part of the building.⁴ Towards the centre of the wall are two quatrefoils, with slightly differently designed foliage cusps and spandrels. The centre of the cross wall is entirely obscured

Section through the choir roof at the eastern crossing, showing the form of the eighteenth-century roof above the west cross wall of the incomplete lantern tower.

It is not clear whether the tower was ever completed, or was abandoned during the course of construction. In favour of the former suggestion is the fact that the west cross wall has cracked approximately 75 cm (30 inches) in from each end, the central part of the wall having moved slightly forward (to the east). It is difficult to see how this could have happened once the area to the east of the wall was vaulted, as the vault should have prevented the movement. Further, the debris on top of the vault contains a number of fragments of black-painted limestone shafts similar to those used on the cross wall, suggesting that the decorative scheme was once more extensive. Against these facts are others of equal, if not greater, weight. In particular, at the ends of the west cross wall the upper surface of the cornice has circular marks for the siting of corner shafts which were to rise from it, but the surface is so clean that the shafts themselves can never have been fixed in place. Furthermore, as noted earlier, the east cross wall is altogether rougher than that at the west, and there is no evidence that it was ever decorated or capped by an extension of the coping or cornice. The balance of this evidence suggests that the tower was abandoned during the course of the construction of the east end of the church, perhaps because it showed the slight movement apparent in the west wall. Given that the thirteenth-century re-building of the Minster was occasioned

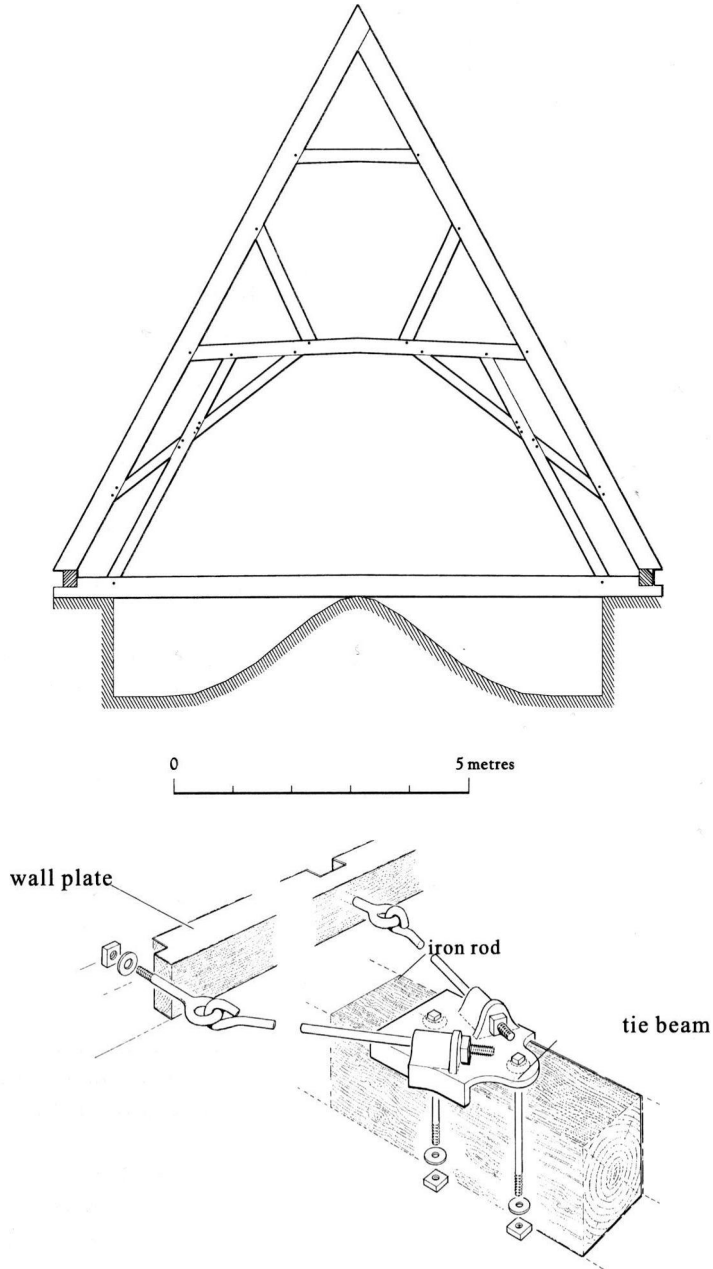
The construction of the bases of the trusses is unusual, and appears archaic for the fourteenth century, particularly since the form of the roof does not change towards the west end where it was completed near the end of the century. By the middle of the century, 'normal' assembly (in which the wall plate was below the tie beams in order to hold it against spread and rotation) was widespread. At Beverley, by contrast, the plate is above the tie beams, and does not appear to be fixed to them in any way; there is, therefore, almost no resistance to the twisting forces to which it was subject.⁸ The employment of this relatively inefficient mode of construction is surprising in a building of such high status as the Minster where one would expect the craftsmen involved to have been aware of the latest techniques. A further feature of the roof which is relatively unusual for its date is the apparent inclusion of some timbers which were re-used from an earlier structure, as witnessed by the presence of redundant mortices and matrices for lap joints. In other respects, though, the roof is less atypical of its age: the absence of longitudinal stiffening (in the form of purlins or a ridge) is not unusual, and most of the joints are tenoned.

Leaving aside minor patching repairs, there appear to have been two phases of significant alteration to the roof, one in each of the eighteenth and nineteenth centuries. As noted above, the form of the twelve trusses at the far east of the roof, against the central tower, differs slightly from that of the others. The variation is that there is no wall plate, the outer rafters instead resting directly on the sole plates or tie beams: this is a better form of construction than that in the rest of the roof, since there is no plate to be subjected to rotation. It is particularly striking that the better construction is found at the east, as that was almost certainly the first part to be constructed. The most likely explanation is that this area of the roof was taken down in the eighteenth century in order to facilitate the erection of the new crossing tower, and was re-assembled in slightly modified form, without the

Fig. 3
Section through the fourteenth-century nave roof, with detail of nineteenth-century tie rods.
© copyright English Heritage 1999

If this hypothesis is correct, it suggests that the potential for problems with the original structure was appreciated by the first half of the eighteenth century. By the nineteenth century, such difficulties must have manifested themselves more clearly, for measures were taken to counteract them. In the main part of the roof the wall plates were almost entirely renewed, and a set of iron tie rods was introduced to hold the new plates firmly in place (Fig. 3). Each truss has two collars (Figs 3 and 4), above the lower collar. One end of each rod was hooked through a large eye which was bolted through the wall plate; the other end was attached to an iron plate bolted to the upper surface of the tie beam. Between each main truss there are four sets of such rods, resulting in a chevron pattern on each side of the roof. At the east, where there was no wall plate, short lengthwise timbers were placed against the outer ends of the sole plates, and were similarly tied back into the centre by rods, so that there was no danger of the roof spreading outwards. Documentary research on this aspect of the fabric has not been undertaken, and so the date of this work is not certain, but its character suggests that it formed part of the restoration carried out by G.G. Scott between 1866 and 1878.

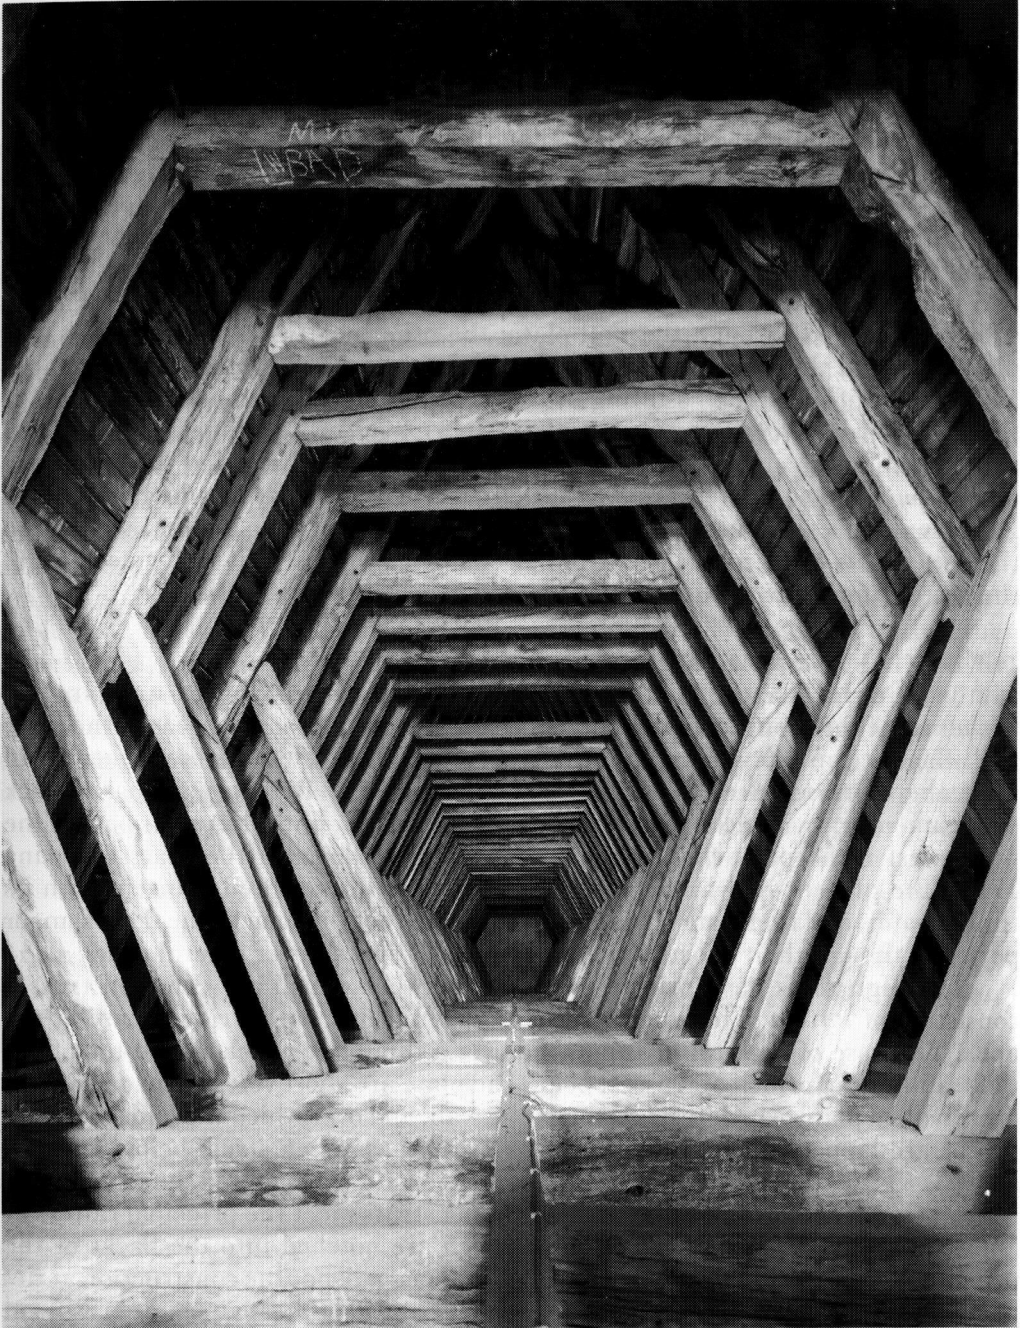
Fig. 4

View along the fourteenth-century nave roof between the collars

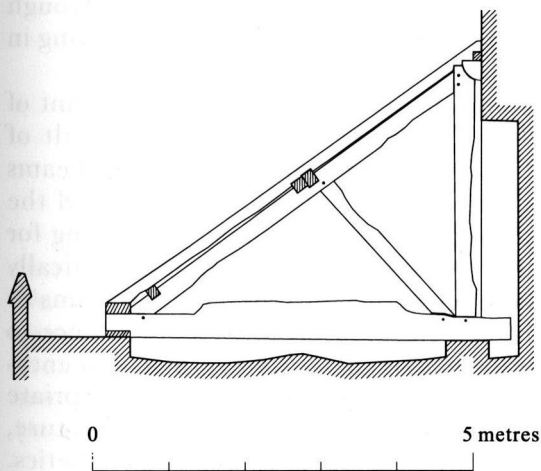
In the aisles, the principle trusses have tie beams from the inner ends of which rise posts supporting the tops of the principle rafters (Fig. 5). There is one raking strut between the principal rafter and the beam, and there are three purlins, the uppermost being supported on stone corbels which project from the buttresses at the back of the triforium and having the common rafters notched over it. The form of the ties is unusual: both ends are of reduced section, and each beam is only a half timber, those of adjacent trusses being the matching halves of timbers which have been split longitudinally. The combination of this and the fact that, like many of the tie beams in the high roofs, the timbers are not squared off, results in the mortices for the posts and principle rafters being set to one side of the tie beams – in the deepest part. The consequence is that there would be very little to prevent the tenons breaking through the sides of the tie beams if there was movement along the length of the roof. The fact that this has not occurred demonstrates the longitudinal stability of the roofs, each of which is contained between an external gable and the rear of the triforium. The same stability is also apparent in the other direction, across the width of the aisles, for the structure is not tied into the stonework at all. The outer end of each tie beam rests on the wall, as is normal, but the inner simply rests on a crude low brick pier constructed on top of the vaulting; the beam is neither halved over the pier nor attached to the triforium wall, so that it is only the weight of the lead-covered roof which prevents outward slippage.

Fig. 5
Specimen aisle truss.
© copyright English Heritage 1999

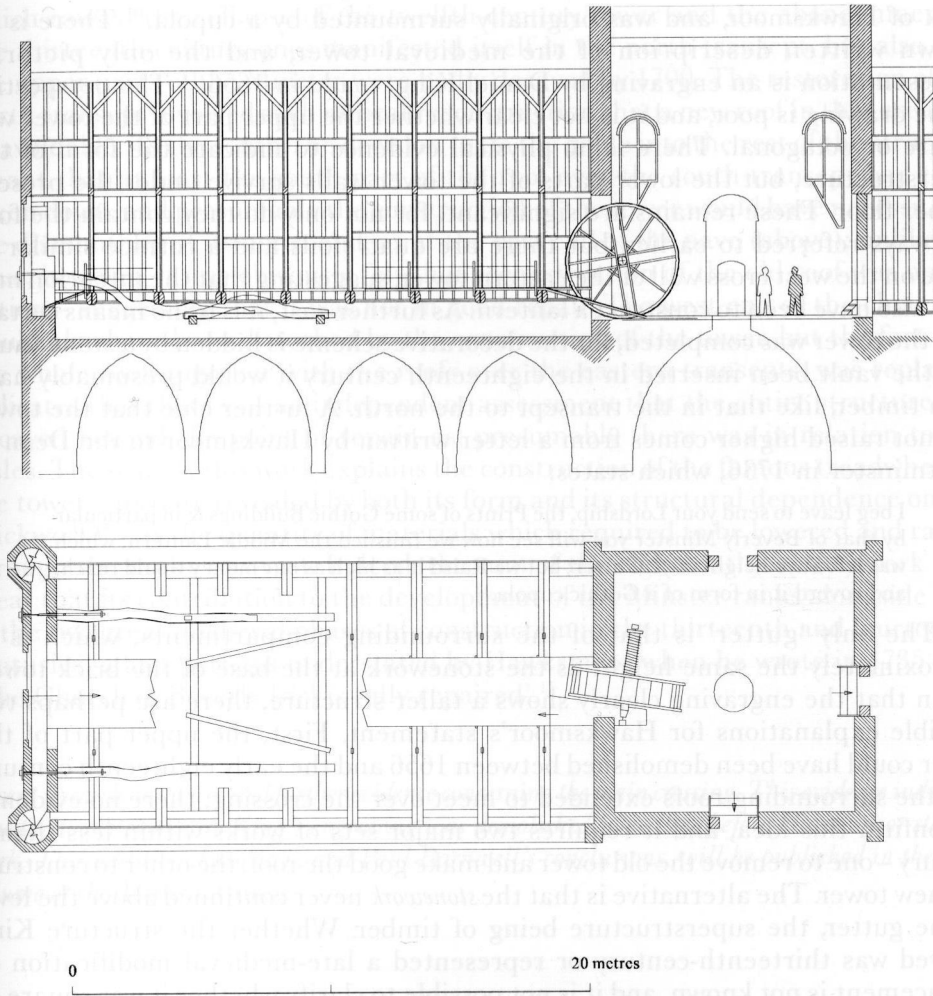
Fig. 6

This point is worth further consideration in the light of what at first appears to be a tangle of very oddly-shaped timbers below the tie beams in the south-west transept. Here, the eighteenth-century work involved more than replacement of the roof itself, as the south gable was tied back into the main structure of the Minster in order to forestall any repetition of the outward movement of the gable of the north transept (Fig. 6). The structure put in place consisted of two large square anchoring timbers placed across the transepts with their ends firmly embedded in the east and west walls of the third and fifth bays from the gable. They are approximately 50 cm (18 inches) below the tie beams, and are braced together by two timbers placed at an angle and bolted into their upper surfaces; these two braces are curved and were cut from a single timber, split lengthwise and selected so that each brace would rise from the cross beams to pass immediately under the third tie beam from the gable and thereby assist in the prevention of north-south movement. Beside each of the braces, a large square timber is notched over the cross beams; to the top of each is bolted a curved timber which extends to the gable, bending up under the second tie beam from the wall (around which it is notched) and over the first one. The end of each beam is embedded in the gable wall and has an iron strap bolted to its upper surface; the latter extends through the wall (including the passages to the stairs in the corners) before terminating in an iron plate against the external elevation.

Although this arrangement at first appears very crude, partly on account of the unusual and irregular shape of the timbers, it was clearly the result of considerable ingenuity, and was constructed with extreme care. The two cross beams are set at exactly the same height, and are absolutely level; both they and the outer linking timbers are of large section and are properly squared, allowing for precision in setting out and jointing. The remaining timbers were specifically selected for their shape, so that the structure could be linked to the tie beams as well as to the cross beams, thereby providing the greatest possible resistance to outward pull from the gable. Where it really mattered, therefore, the eighteenth-century workmen could obtain 'good' timber, and could choose material appropriate to their purpose, even if it looks odd to our eyes. As with the main roof structure, what mattered in this little-seen part of the building was function, not aesthetics.

Plan and long section of timbers tying the gable of the south-west transept into the main structure.
