# The Monument in the City of London: Repair and Discoveries

*The Monument to the Great Fire of London, constructed between 1671 and 1677, is located near Pudding Lane in the City of London where the Great Fire started in 1666. A contract to conserve and enhance the Monument was undertaken between 2007 and 2009 at a cost of £4,500,000, funded by the legal custodians, the City of London Corporation. This paper discusses why such a sum should be spent on the Monument and the philosophical questions raised during the conservation design process. An account of the preparation works prior to the contract is given together with the attitude taken to repair work and new interventions. The new design initiatives are described together with discoveries made during the works.*

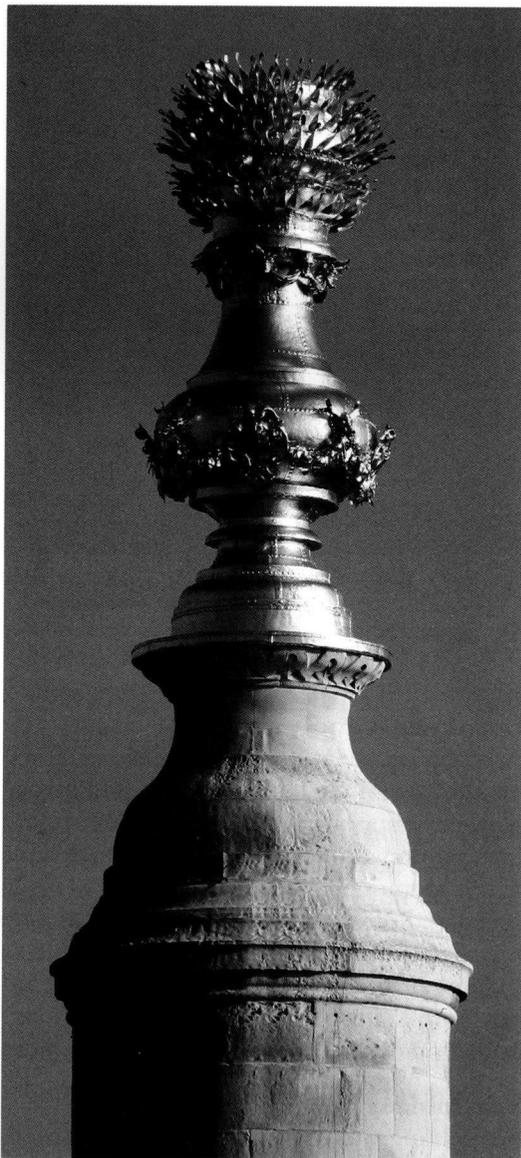
Fig 5

The re-gilded copper flaming orb at the top of the Monument, with riveted flames representing the Great Fire of London.

The difficulty and expense of scaffolding the column, 202ft (61.5m) high, governed the approach to designing the longevity of repairs. Historically scaffolded approximately every 80-100 years, external repairs to the Monument must be designed for a very long lifespan. Friable stone blocks at high level were repaired with well-secured natural stone repairs, and a larger proportion of a damaged stone was cut out and replaced at high level than at the relatively accessible base. No mortar repairs were specified above the plinth of the column due to their short lifespan in relation to natural stone repairs. The gilded copper flaming orb at the very top of the Monument, with its riveted flames, was repaired and regilded with two layers of 23.5 carat gold leaf, the highest quality available for the longest lifespan, applied over the thoroughly prepared existing finishes (Fig. 5).

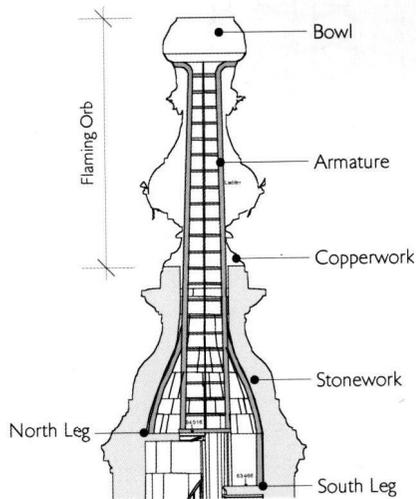
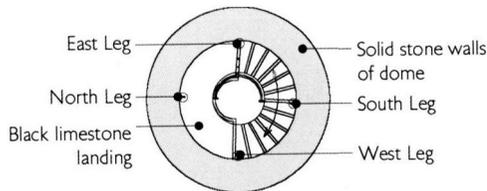
Fig. 6

The copper flaming orb is fastened down to the stone mass of the dome and drum below by a structural wrought iron armature, the form of which is a circular ladder. The ladder gives access from the black limestone landing at the top of the drum, up into the copper bowl at the very top of the flaming orb. The circular iron rungs are bolted to four iron vertical legs, with bolted flanges riveted to the copperwork. When viewed from the high level scaffolding it could be seen that the structure above the drum, together with the flaming orb, was leaning over.

Section through the top of the Monument and plan at the top of the spiral staircase, showing the four legs of the structural iron armature.

flanges let into the stonework. The foot of each ladder leg rests on a step of the spiral staircase, therefore the legs are of uneven length and the longest leg had buckled under the load, pulling the whole armature to the south, as illustrated in Figure 7.

Two options were considered to prevent the armature continuing to lean over. The first, quickly discounted, was to disengage the armature and flaming orb from the stonework and lift off the whole orb by crane. The crushed stonework on the south side of the dome would then be repaired and rusting iron cramps cut out and replaced with stainless steel. The armature and flaming orb would then be craned back into position and the armature securely fixed to the stonework. This option was ruled out due to extensive disturbance to the historic fabric and the excessive cost. Aesthetically there was no good reason to straighten the flaming orb. The second option was to restrain the leaning flaming orb in its current position, making no attempt to remove or reduce the distortion that had developed during the life of the structure. The proposed solution was to stiffen the bottom portion of the armature by tying it to the masonry. The restraint design consists of four circular iron bands fixed at equal intervals to the interior of the stone dome, each bolted into the stonework and welded to the 17th-century wrought iron armature legs. A welded connection was proposed to fix the new pure iron bands to the original wrought iron, in order to avoid drilling into the historic ironwork and to produce a good looking, clean connection.

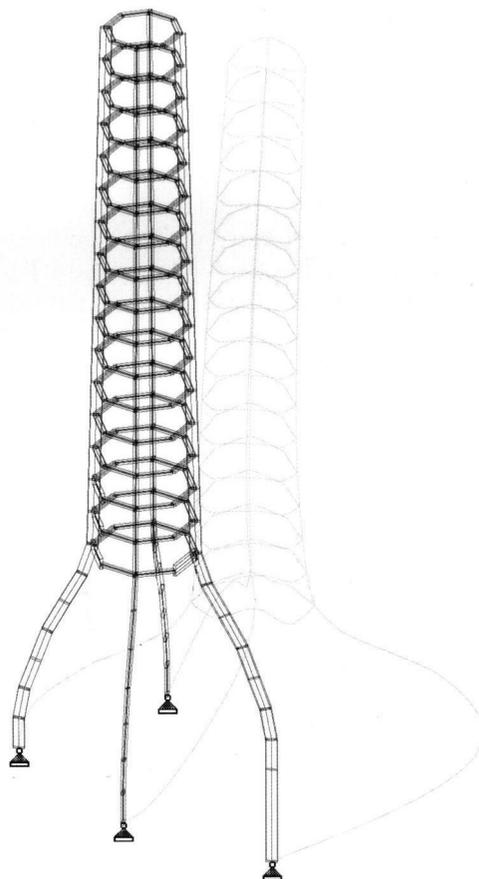
Fig. 7

Computer model of the iron armature of the Monument, illustrating distortion of the structure under load.

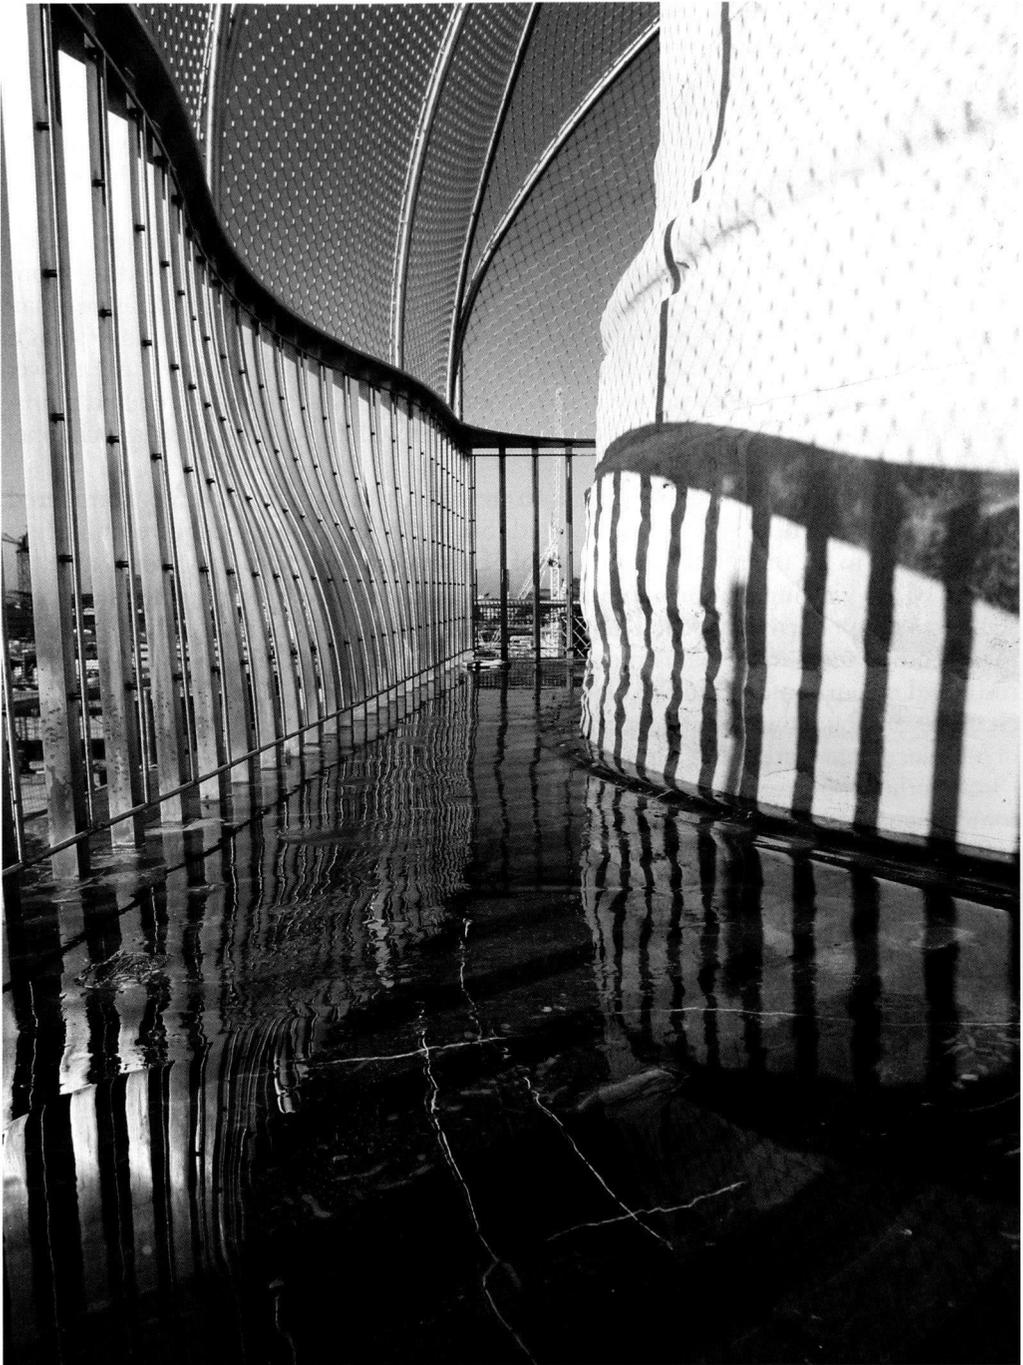
Fig 8

The newly revealed black limestone floor of the viewing platform of the Monument, with the new curved stainless steel balustrade and lightweight cage above.

The viewing platform had been covered with asphalt for many years, concealing the original black limestone slabs beneath, which had been partially revealed during pre-contract opening up works. The asphalt was judged to be unsightly and an inappropriate material for the repair of a 17th-century building, so it was removed. Six huge slabs of black limestone were revealed, with local cracks and damage that had previously allowed rainwater to soak into the structure below. Truncated sections of former iron and bronze balustrade fixings remained in the limestone together with the original drainage channel, drain pipe and spitter.

Overlaying the defective paving with new black limestone slabs was considered, to ensure a waterproof finish, but rejected. Slabs of the original size were unlikely to be available, to lift them into position would be very difficult, and they would alter the profile of the viewing platform and conceal the archaeology. So repairing the historic slabs was the preferred option. The bedded metal remains were retained and polished to indicate changes to the balustrade, whilst cracks in the slabs were injected with epoxy resin and colour-matched to the black limestone (Fig. 8). The poorly serving drainage channels and outlet were cut deeper and wider into the stonework, to discharge by way of a replacement lead spitter pipe.

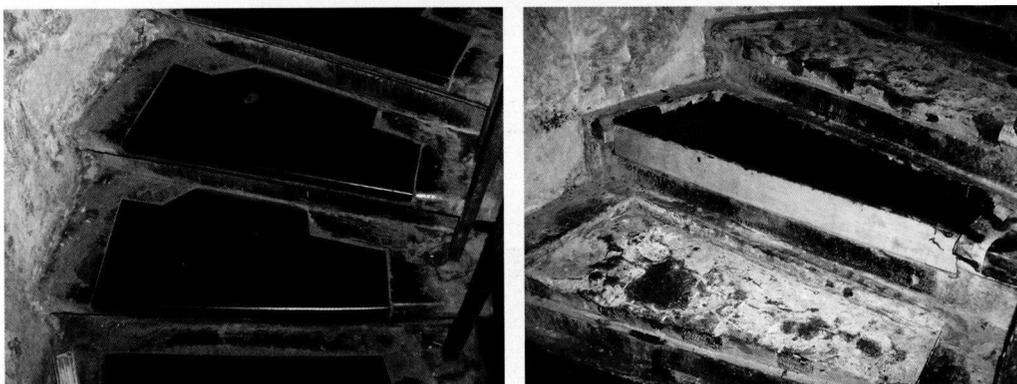
Fig. 9 A-B  
The Monument.

Another opportunity to replace inappropriate former repairs to the building revealed some alarming structural damage to the spiral staircase. The stone treads, worn down by centuries of use, had been pieced in with Belgian black marble inserts (Fig. 9,A). The opportunity was taken to replace these with inserts of black limestone, matching the original material, and to improve on the appearance of the previous angular-shaped

- A. Previous repairs to the black limestone steps used angular-shaped inserts in Belgian black marble.  
B. The previous deep excavation of the stair treads was revealed beneath the Belgian black inserts.  
Fischer epoxy resin was poured over reinforcing rods before new black limestone inserts were laid.

insets with gently curved inserts reflecting the wear pattern on the treads. When lifting the Belgian black inserts, bedded on mortar dabs, the extent of former wear of the historic treads below was apparent. Hockley & Dawson, structural engineers, designed reinforcement for the treads using stainless steel rods, bedded in Fischer epoxy resin well bonded to the keyed surface (Figs 9,B). Black limestone inserts from the Pooil Vaaish quarry on the Isle of Man, believed to be the original source, were laid on top of the reinforced substrate. The new inserts were hand dressed to a lightly dished surface to soften their impact in the historic interior, an approach contrary to the philosophy of the Society for the Preservation of Ancient Buildings of ensuring that new repairs look new.

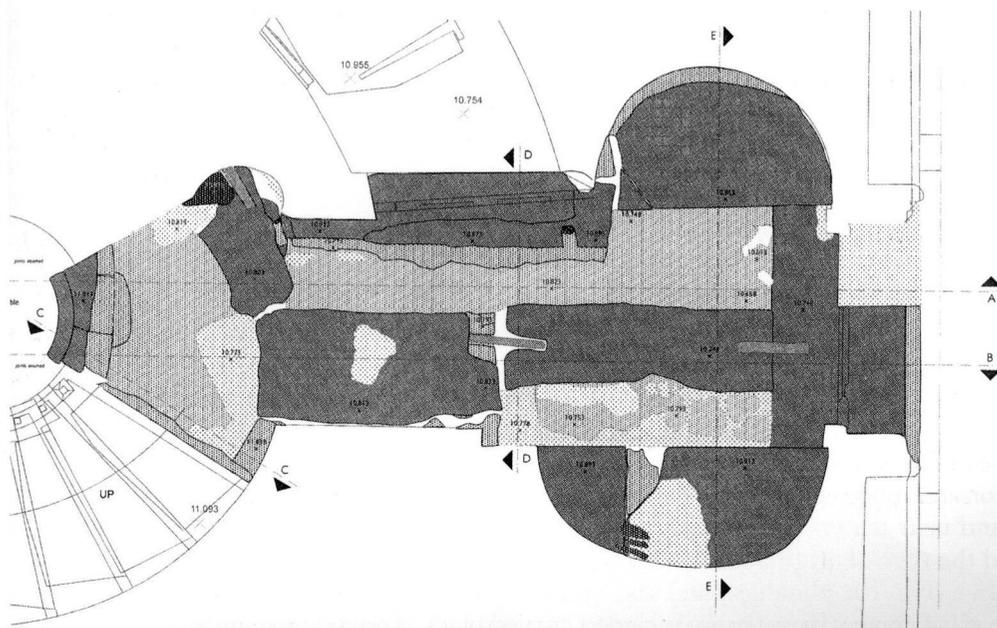
Fig. 10

Plan of the ground-floor entrance to the Monument recording the archaeology revealed following the lifting of the concrete floor slab. The dark grey represents stone slabs; the light grey represents sand and soil mixed with pebbles.

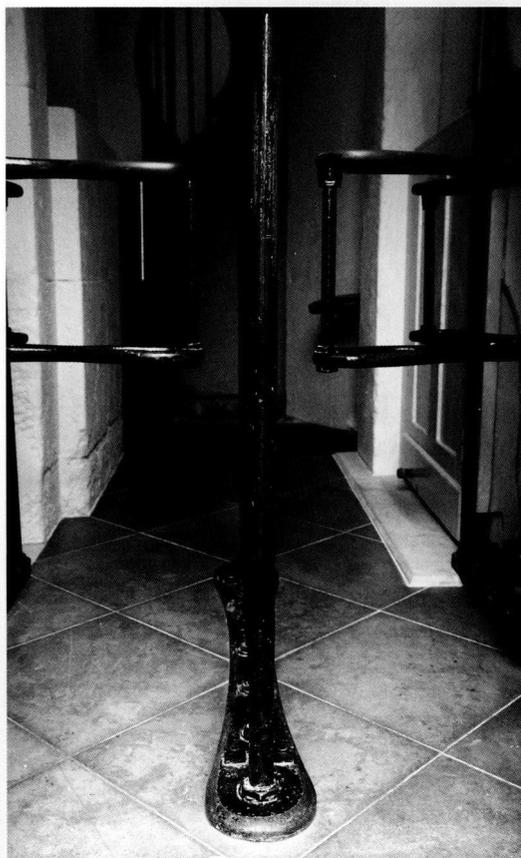
Fig. 11

View into the entrance of the Monument, showing the Victorian turnstiles on the new Purbeck freestone diamond patterned floor finish.

For the ground floor of the entrance lobby, the decision was again taken to restore (together with a little new design, where historic evidence was unclear), rather than retain the functional but inappropriate carpeted concrete floor slab. A thick concrete slab had been laid over the original stone floor raising the floor level, reducing the height of the first spiral step and increasing the height of the entrance step. Lifting the concrete revealed the archaeology of floor finishes beneath, the remains of which were beyond a conservation repair robust enough to receive thousands of visitors. Purbeck stone was found near the entrance door, but damage was extensive at the base of the spiral step and the type of original stone finish unclear. The archaeology revealed was measured, drawn (Fig. 10), photographed and overlaid with a thinner finish of stone slab on lime screed. The new floor design included curved black limestone paving at the base of the

black staircase to complete the circle and Purbeck freestone, now only available in fairly small slabs, set out in a diamond pattern in the entrance hall (Fig. 11).

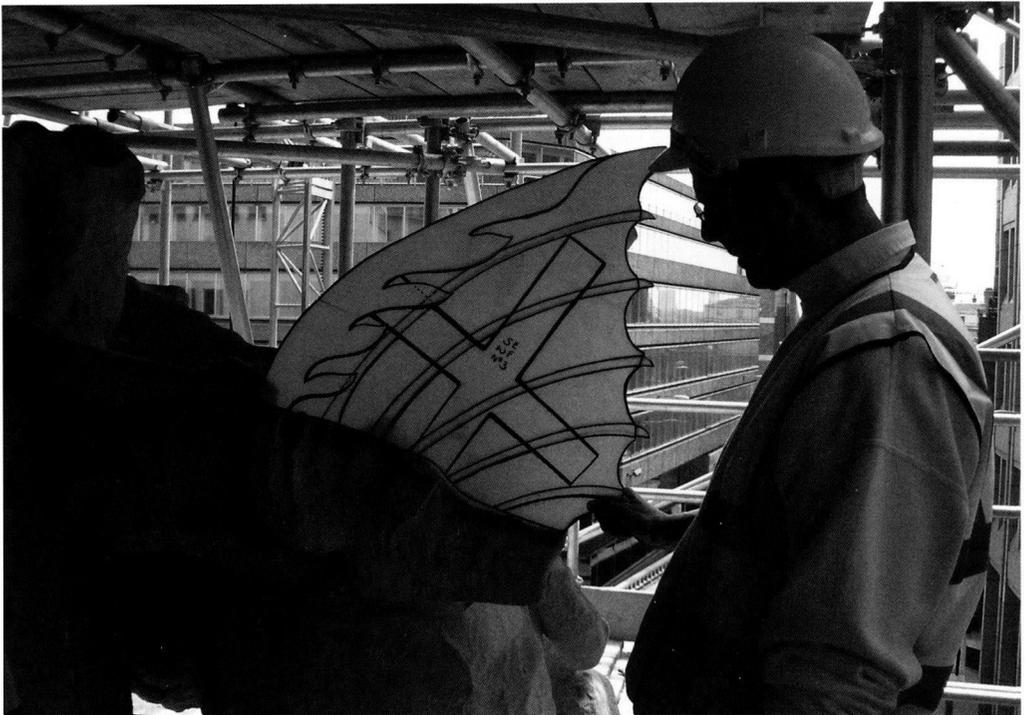
Fig. 12

The Monument: The site agent holds in position a template of a missing part of a sculpted dragon's wing.

Four carved dragons representing the City of London sit at each corner of the base of the column, clearly silhouetted against the sky. Their profiles are dramatic but much damaged, as stonework less than 1 inch (25mm) thick had eroded or been damaged by the erection of timber scaffolding in the past. A decision was taken to re-carve and reinstate missing dragons' wings, ears, tails and tongues to re-establish the silhouette originally intended (Fig. 12).

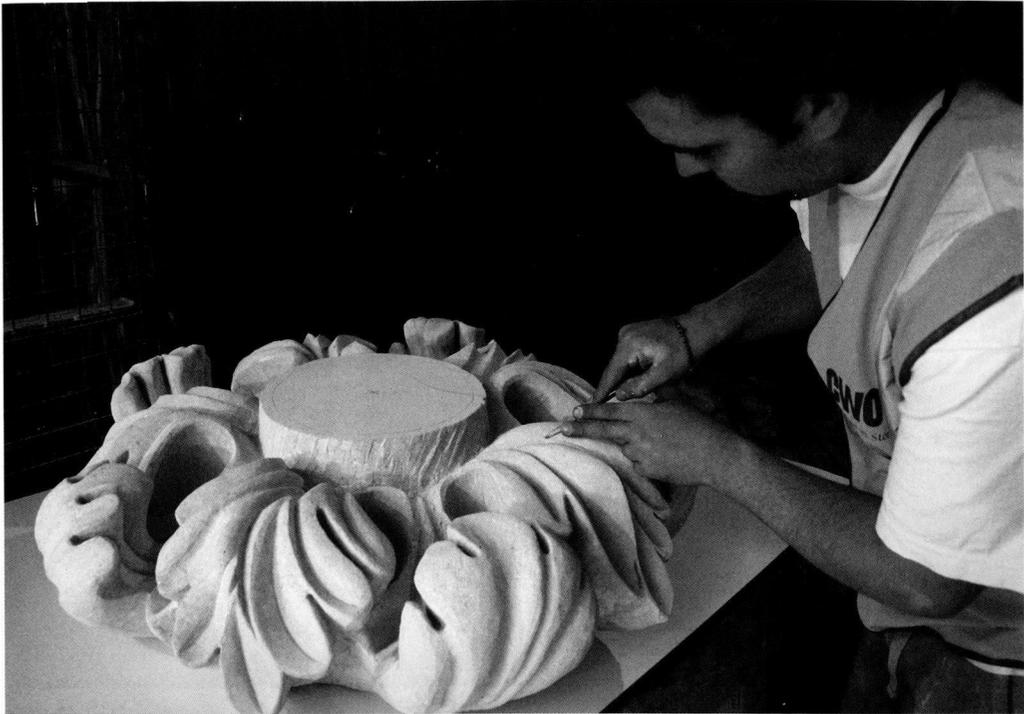
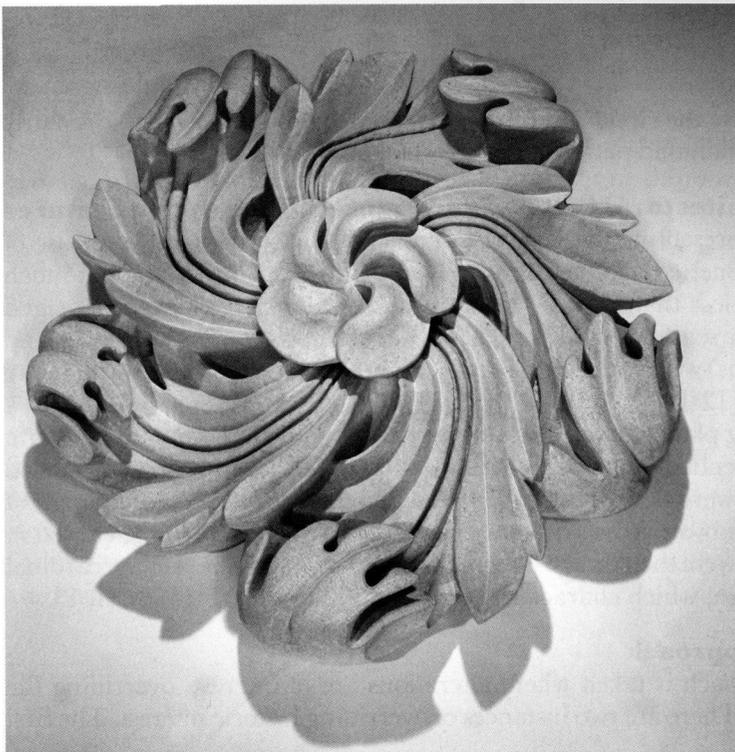
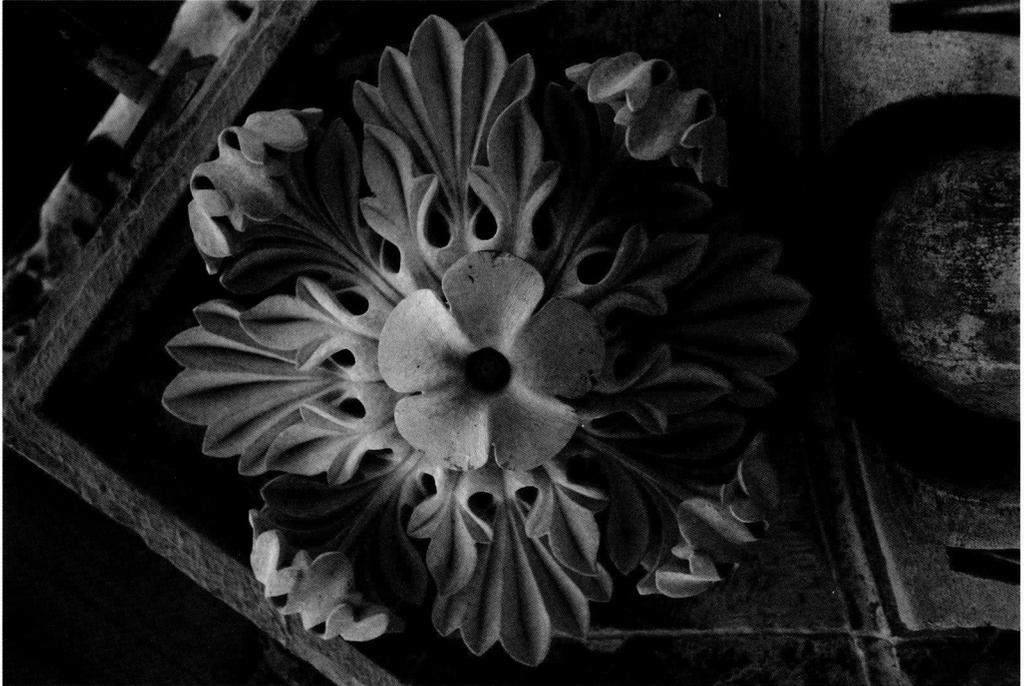
The Monument: A sculptor completes the carving of one of the four new Portland stone paterae; the carvings are deeply undercut in order to be effectively viewed from a great distance.

The new carved stone patera with a swirling design for the south-west corner of the Monument, where the winds are strongest; the centre is removable to allow fixing.

The Monument: One of the new stone paterae fixed in the original location on the underside of a corner of the viewing platform.

Beneath the viewing platform are four new, re-carved stone paterae some 900mm (36 in.) in diameter suspended by stainless steel bolts. Wren's carved paterae detached themselves in 1882 and were never replaced, so the architect researched the design of similar decorative elements on Wren's St Paul's Cathedral, which were being carved in the late 1660s. Proposals were then drawn up for individual designs related to the cardinal winds expected in a storm, which characterise the English weather (Figs 13, 14, 15).
