RESTORATION WORK AT BLENHEIM PALACE

By Thomas Rayson

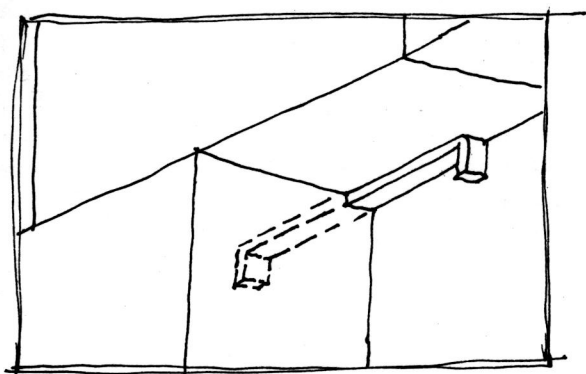
FIG. 1.

There are three types of these iron features: the simple cramp, the flat tie of stone to stone and the linked chain which is built in to counteract thrust to the exterior. The metal is wrought iron. Despite its impurities, the continual presence of damp causes oxidisation which increases a half-inch bar to three times its original thickness.

The force of this rusting is enormous. It will lift almost any weight above it if the stone on which it bears will stand it. If not the stone itself will fracture. This is seen all over the building where a cramp of 8 or 9 inches by 2 inches by half an inch bent down at the ends and placed across the vertical joint between two stones and set in from the face of the stone 5 to 7 inches, has burst off a triangular piece of stone. When the fractured piece is removed the offending cramp is seen solidly embedded in the joint. (Fig. 1)

The method of dealing with such a matter is to remove the stone, cut out the iron and make good the masonry. Sometimes it is possible to insert a small stone while at other times a large stone has to be used.
