PLAS-UCHA, LLANGAR, CORWEN

By Peter Smith and Ffrangcon Lloyd

SUMMARY

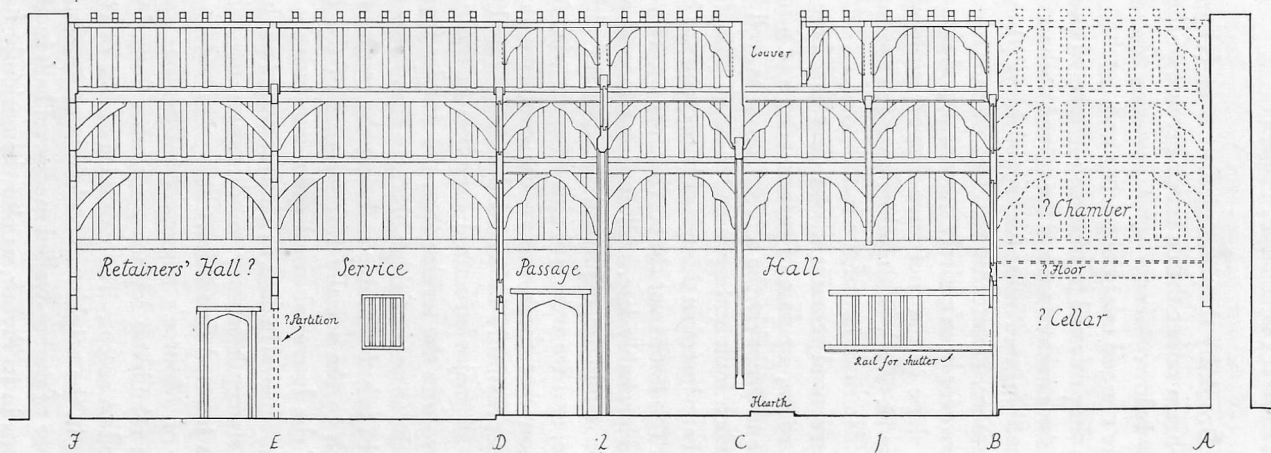
Long Section

We begin our study with a detailed account of the roof structure as most of our interpretation of the building depends on it. The main framework seems to have consisted of five cruck trusses labelled A B C D E and F on the drawing, A, B, and F no longer surviving, B and F easily, and A somewhat more problematically inferred. These cruck couples were set out in bays 13 feet—15 feet wide and about 19 feet 6 inches across. Interposed between them, in the hall only, are two intermediate trusses of differing design labelled (1) and (2) on the drawing, and one louver truss, the latter a very rare survival.

Note: Bay E-F partly restored; B-A conjectural; ~ see text.

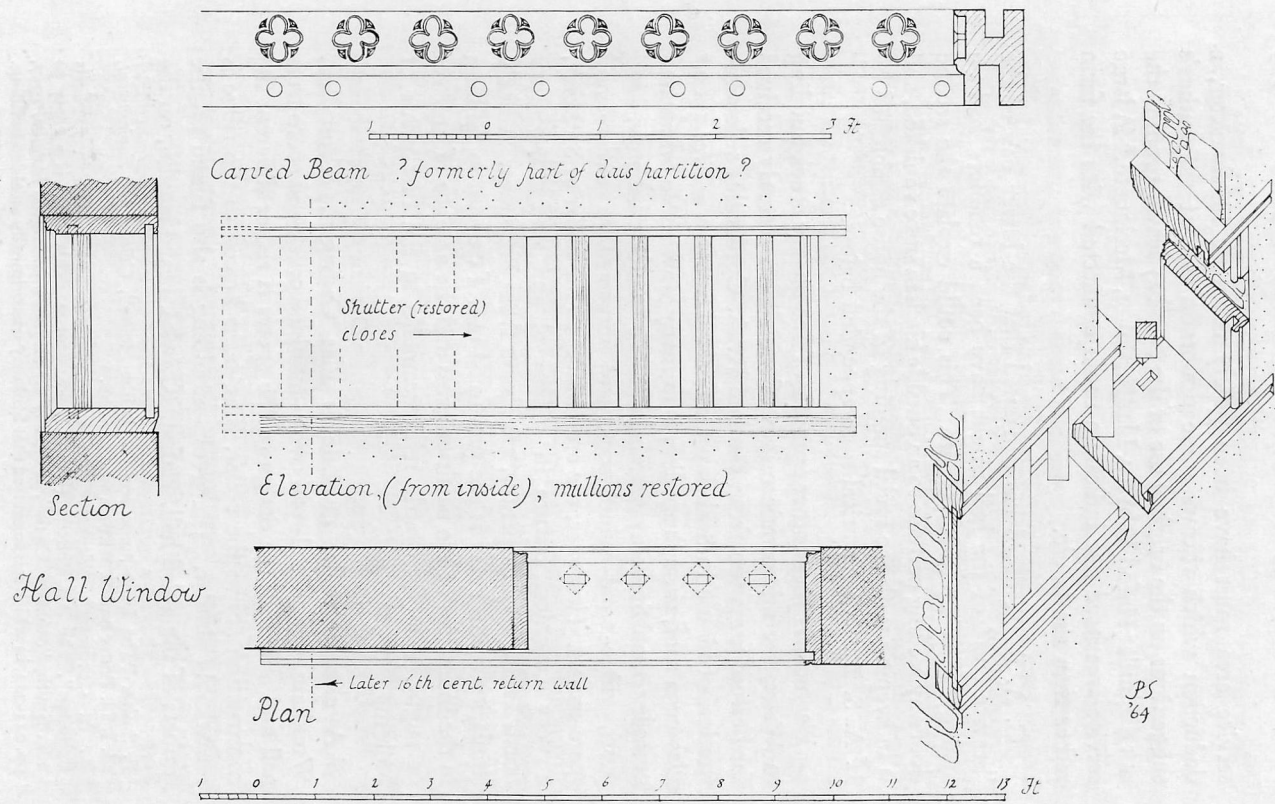
Hall Window

It was just possible to imagine that the exceptionally stout wall-plate had been shored up while the walls were rebuilt beneath it. However a final indication that the side walls were substantially original came from an examination of the two hall windows nearest the present end wall, an examination which incidentally threw much light on the original layout of the upper part of the building. Cutting away the plaster round both windows showed that the original box framework for a pre-glazing wooden-mullioned window. Such a window could as far as we knew be sixteenth century in date, and in fact a box-framed window was built into a Flintshire hall as late as 1589. However an integral part of the frame were grooves for sliding shutters and these grooves, embedded in wall ran well beyond the face of the present end wall. The windows therefore clearly antedated the chimney, and they and the walls were part of the original structure. A further original window was found in the south wall of the service area next to the doorway.

Carved Beam ? formerly part of dais partition ?

Elevation (from inside), mullions restored

← Later 16th cent. return wall
