CAPEL FFYNNON FAIR

THE CHAPEL OF ST. MARY'S WELL, NEAR CEFN,
DENBIGHSHIRE

By Cecil F. Wright, Dipl. Arch., A.R.I.B.A.

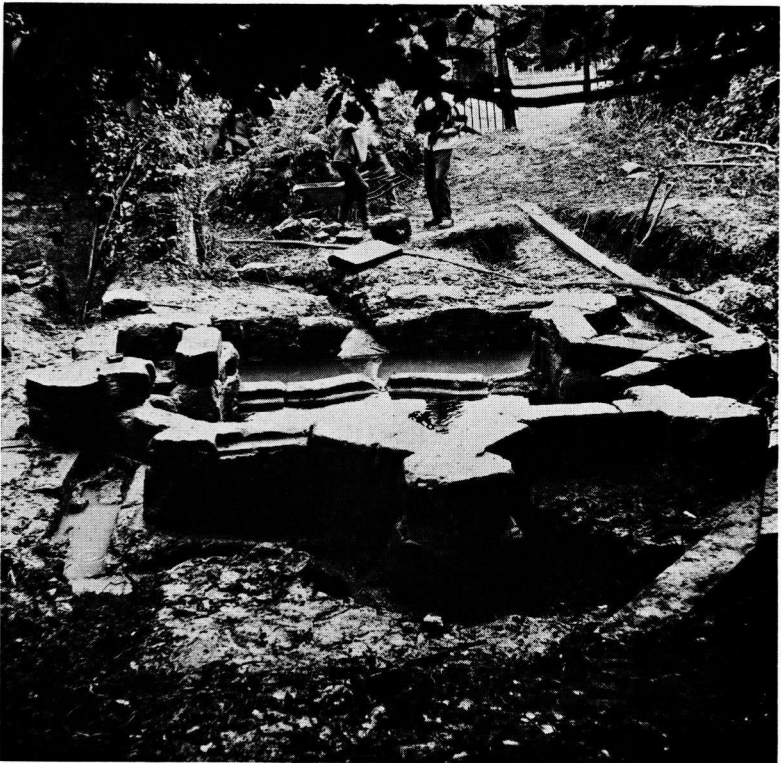
The Well from the north east. Note the absence of one pier on the well surround (middle left). The top stone at this point was part of a moulded transom.

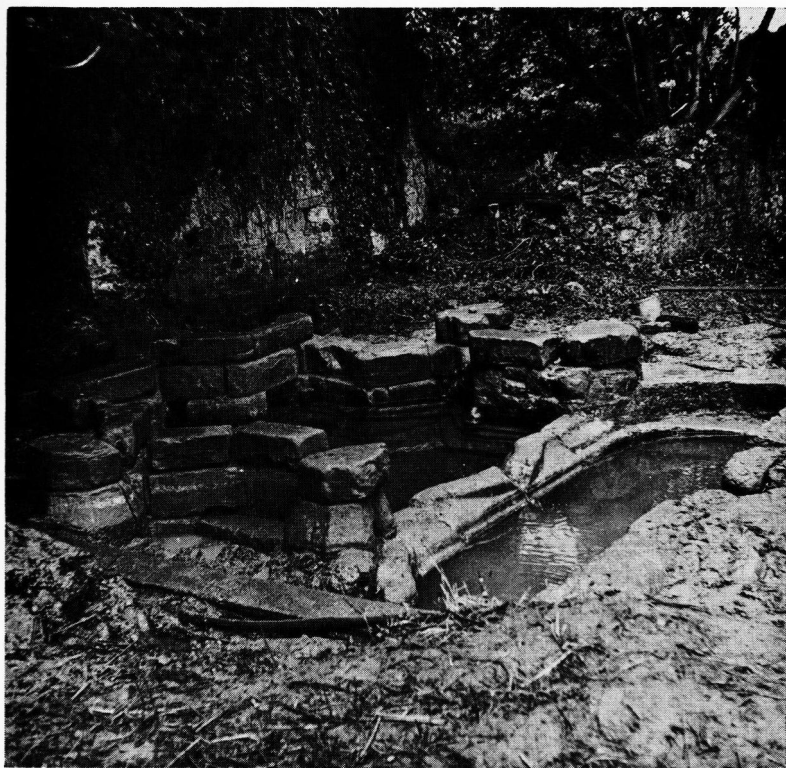
The Well and Bath from the west, with the eastern gable of the original chapel at the rear.

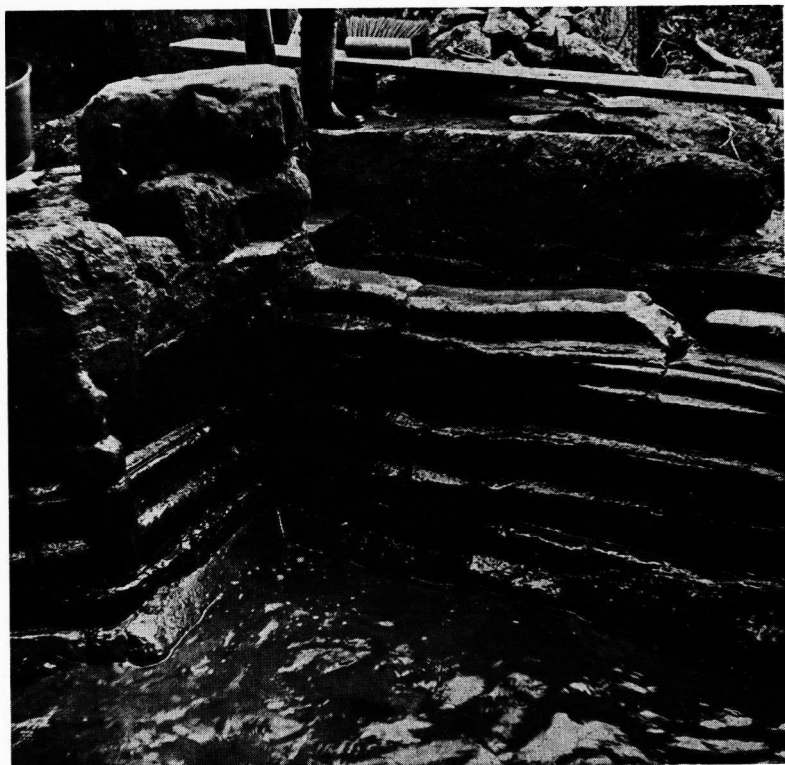
Moulding details inside the well basin, and the back of the wall with bowed sill (water pumped out).

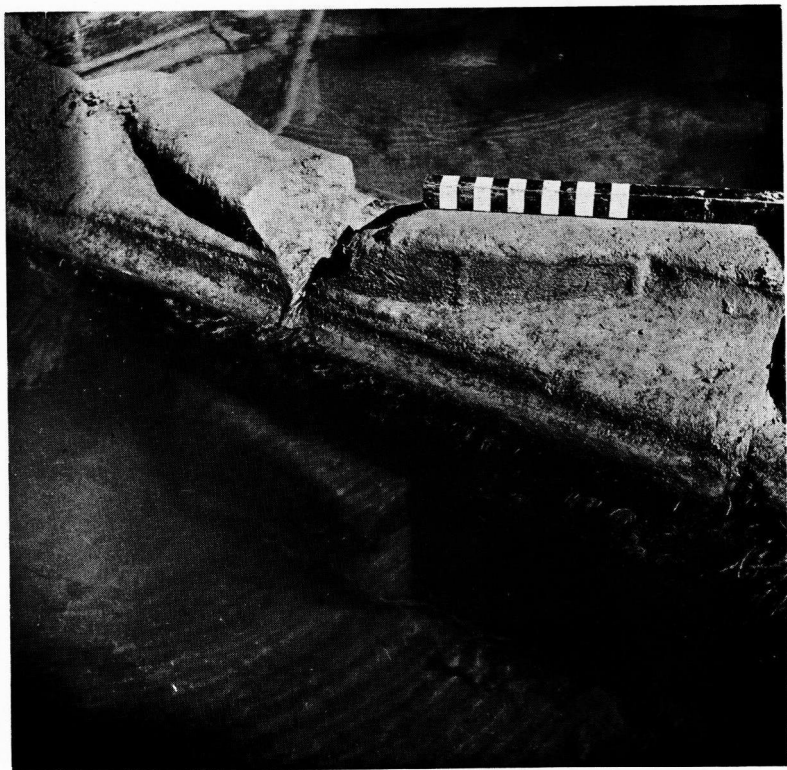
The Wall between the well basin and the bath showing the stopped mouldings on the bowed sill and the rectangular plaque below the modern water level.

Some two feet below the present water-level of the bath, on the outer surface of the masonry wall, is a rectangular projection chamfered on the top and both sides. The face of this panel is very badly weathered and there is consequently no trace of any inscription there may have been. Immediately below this panel, in the face of the wall, is an opening which was found to be blocked by bricks and mud. On the other side of the wall, in the well basin, clay had accumulated against this spot below the lowest water level that the pumps could achieve. Some of this clay was finally removed and the outlet of the water from the basin discovered. The outlet had been almost entirely blocked with bricks set and rendered in hard mortar, so that only a small orifice remained near the bottom. The true floor of the bath, as yet unlocated, must therefore be below the level of the orifice.

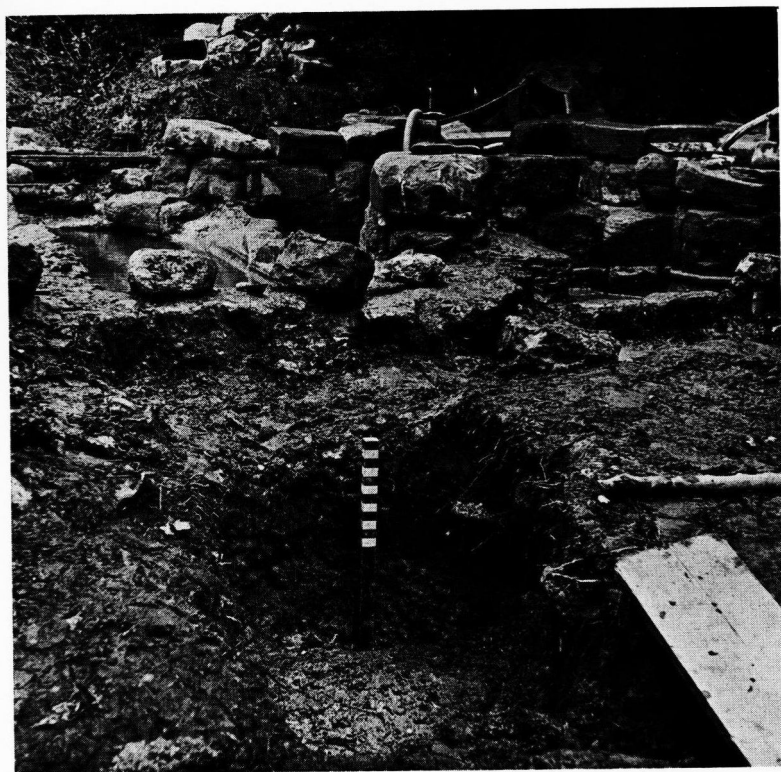
This clay was probably placed there in an attempt to keep the chancel dry but it has deteriorated and the well water again seeps through into the chapel to form the morass already mentioned.

The clay lining (shown by the scale) against the inside of the north wall of the original chapel. The bath and well encroach upon the north wall at this point.

It is known that the soil has risen against the east and north walls of the chapel. In consequence the north side of the chapel became very wet from water soaking into the accumulating soil instead of running away. The wall was therefore damaged and the clay wall was presumably placed on its inner side to reduce the unwanted flow of water onto the chapel floor. Probably the chapel was abandoned in the mid-17th century as much because of its permanently sodden state as through lack of worshippers. The seepage of water may also explain why it was seemingly never used for farm purposes. During the next two centuries the north wall

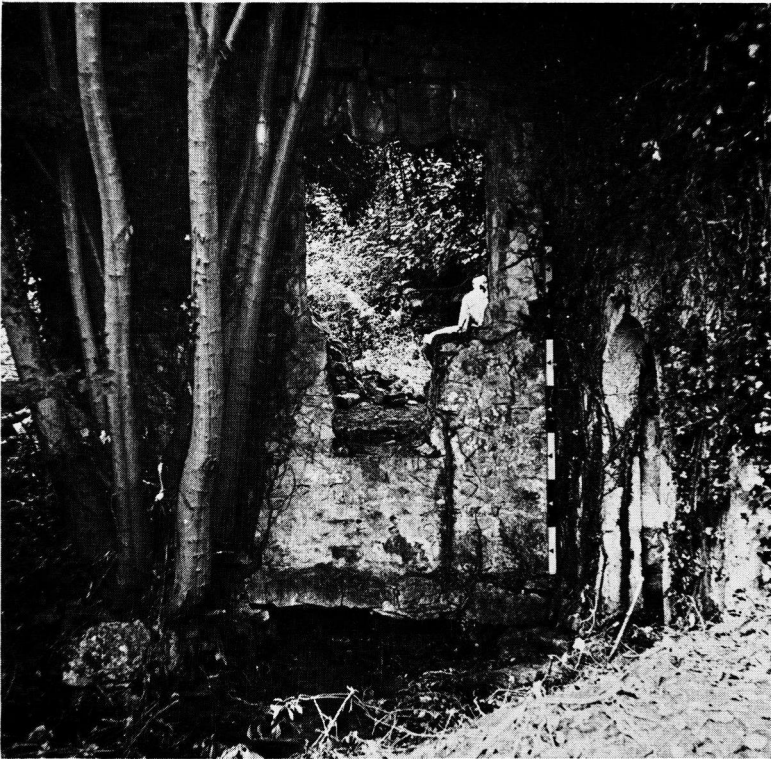
On the outer face of the wall above the exit culvert to the south, roughly over the centre of the lintel and about a foot below the bottom of the rectangular window opening, are two holes. These appear to have formed part of a support for some object, perhaps a small shelf for a statue. They are of insufficient size and depth to have supported a weight of more than a few pounds for any length of time. On the interior of this wall, just above the exit culvert, was found a roughly-chiselled shallow groove running vertically upwards to slightly below the sill of the later 15th-century window opening. Over the exit culvert is a crude uncut lintel some five or six feet long on the outer face. It was not possible to establish whether there was any sill to the culvert, apart from a few large stones set in the shale, and it would be necessary to divert the water to examine this area further.

The chapel window over the exit culvert. The arched doorway on the right came from the original chapel in the fifteenth century.
