## Zacs, Oxford:

### The Restoration of 26, 27 Cornmarket Street and 26 Ship Street

F.W.B. CHARLES

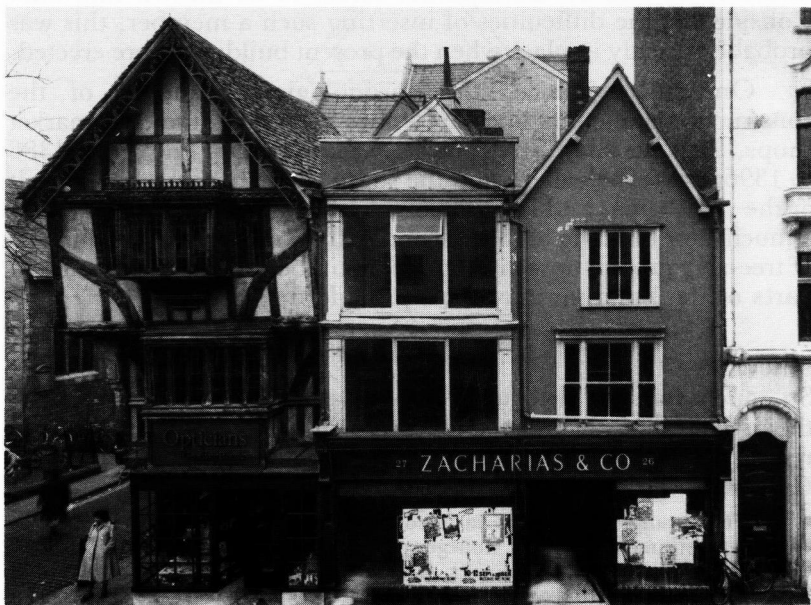
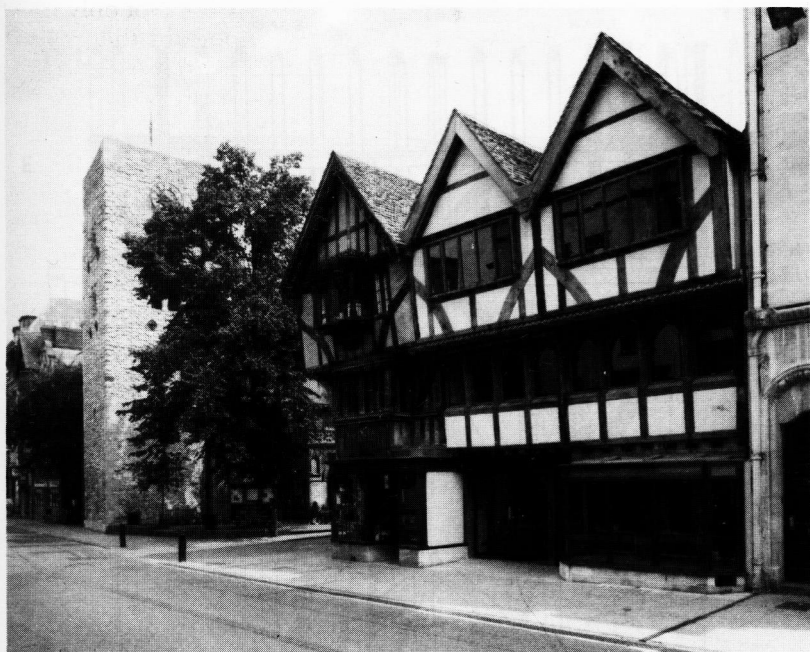
Lastly, it was Julian Munby's report that generated the support and enthusiasm that led to its restoration. Figs 5a and b show how radical was the reconstruction of the Cornmarket elevation. It was no less radical throughout, revealing everything that remained of the original, but always within the evidence of the surviving timbers. Where the evidence was lacking, as in the attic windows, there was no conjectural restoration of what they might have been. And it is astonishing within our experience of other similar projects approached in exactly the same way, that all our proposals went through without resistance even from the Historic Buildings and Monuments Commission. Perhaps also the restoration of the corner building, by Thomas Rayson in 1951, with rather more historical conviction than we would attempt, also helped.

Fig. 5(a)  
Cornmarket Street frontage  
(a) As before; (b) As restored  
*Photos: B. J. Harris Photographers, Oxford*

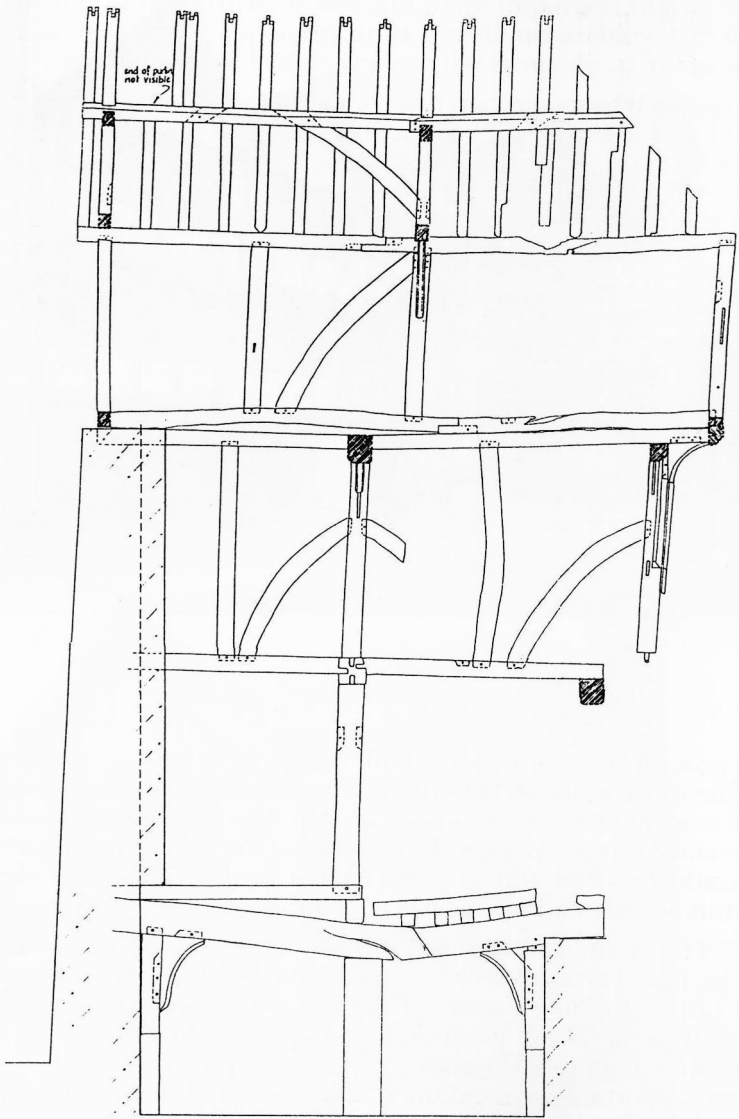
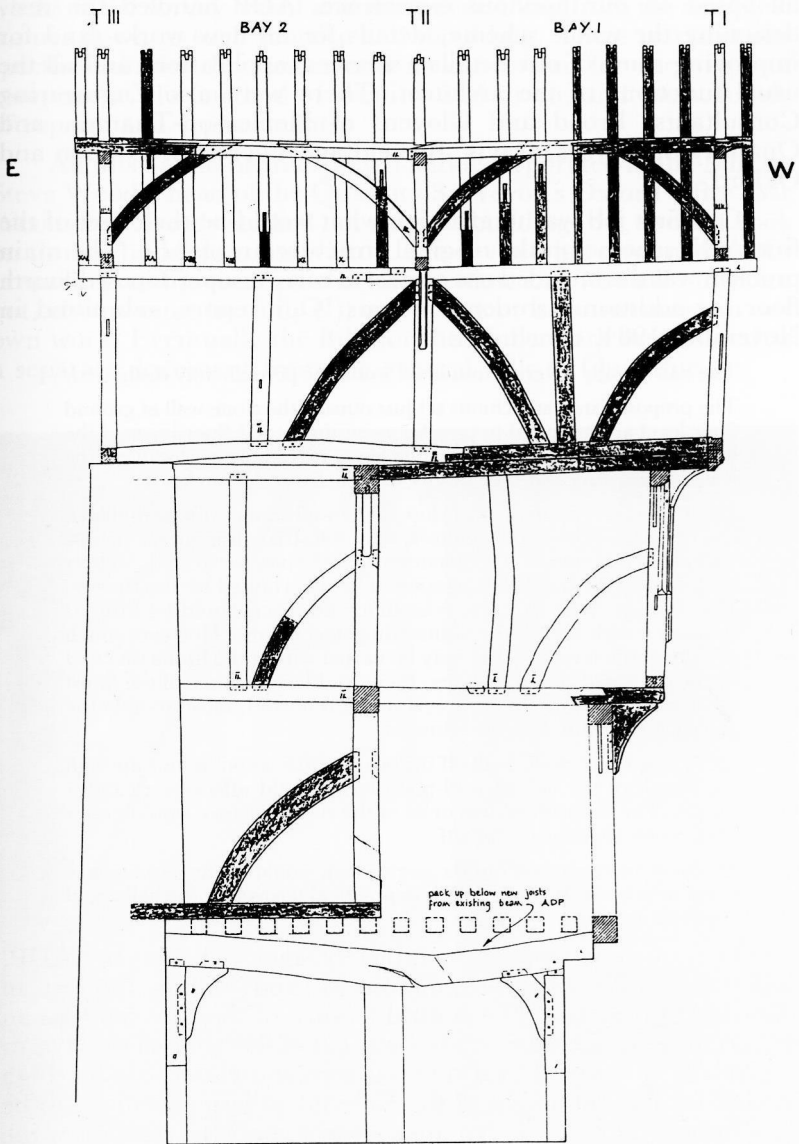
Long section of number 26 Cornmarket Street

(a) 'S' drawing showing surviving framework; (b) The same frame as reconstructed

We had produced half-inch scale details of every frame as it stood, our 'S' or Survey drawings, and the corresponding 'R' or Repair drawings (Figs 6a and b). These were done by Nick Joyce of our office, who by practically living on the job for the first few

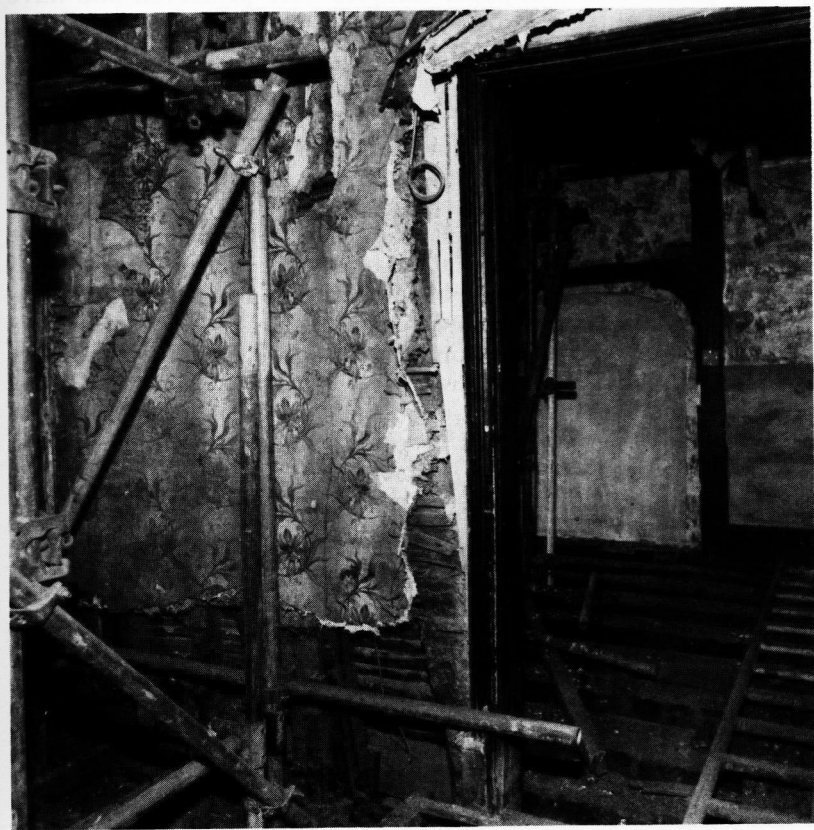
Fig. 7

Wall-papered panels

The panels and finishes in ancient buildings may be hardly less important than its structure. In this respect the Cornmarket shops were exceptionally rich. Some of their inserted attic ceilings were painted uniformly in characteristic orange-red (ruddle), an earth ochre often found externally as well as internally over timbers and panels alike; wall-papers were innumerable (Fig. 7), differing from room to room and in successive layers. A rare stencilled pattern and even rarer panel of sixteenth-century mural painting were found beneath the wall-paper.

None of this could have survived the building's reconstruction. Fortunately, members of the Oxford Archaeological Unit, the Oxfordshire Museum Service and of H.B.M.C. were able either to preserve or record photographically everything of note. Complete plaster panels and wall-paper samples were preserved and have already been publicly exhibited.

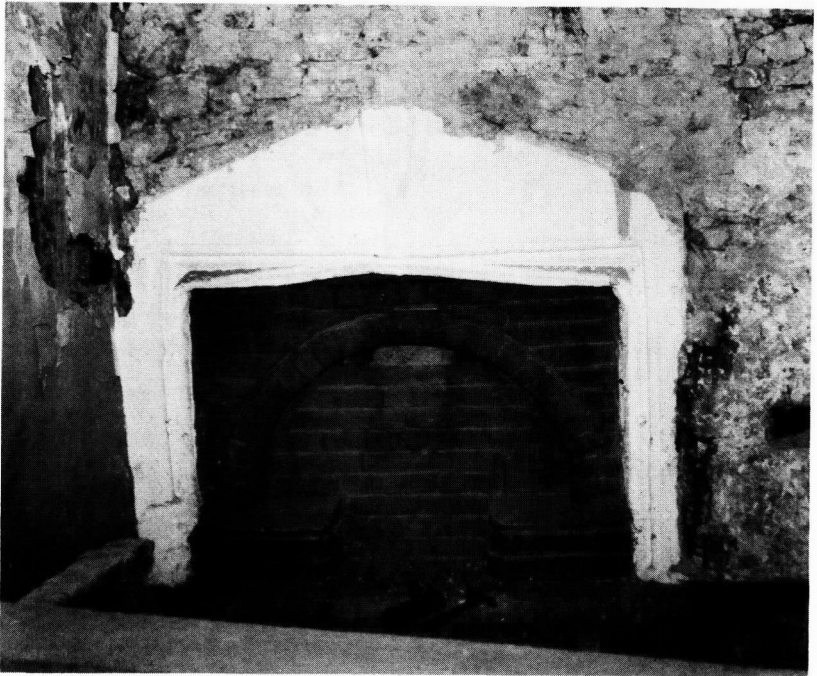
Fig. 9

For a time it seemed that two separate contracts would be preferable, as our preparatory work had to be done ahead of ADP's, and the timber structure practically completed before the other trades could start. In the event, it was the foundations, exceptionally deep because of earlier building not even suspected until the excavations began, and work in the cellars that had to come first. Nor was it possible to dismantle any of the framing until the pre-contract scaffolding could be re-organized (Fig. 8). A sheeted scaffold roof over the whole site also had to be erected for the duration before the roofs could be stripped. And lastly, the stone wall, altered through the ages to incorporate doorways, fireplaces and flues, had to be made safe (Fig. 9).

Inserted sixteenth-century fireplace in number 27 Cornmarket Street

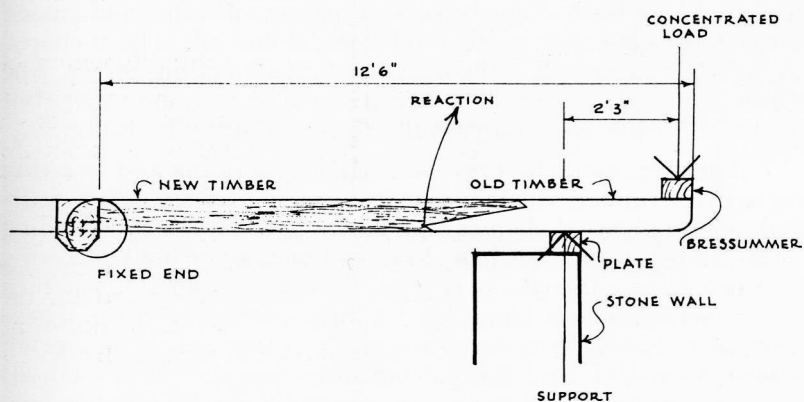
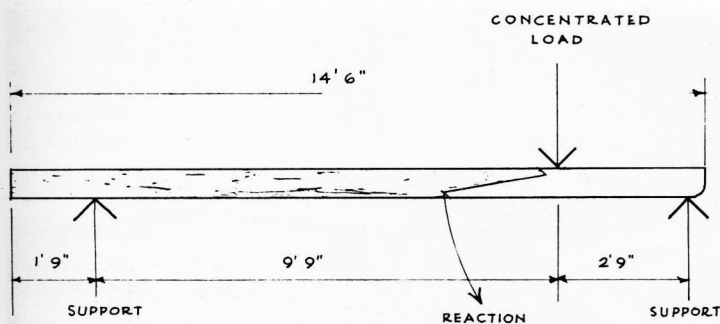
Fig. 10  
Diagram of scarf joint  
(a) Condition of repaired joist in building; (b) The joist as set up for testing

the courtyard wall for the insertion of a nineteenth-century fireplace and stair. Our normal repair joint for this not uncommon improvement is a long splayed scarf with under-squinted ends. The weight of the timber-framing on the outer edge of the jetty counteracts the floor load so that the tendency of the joint is to spring upwards (Figs 10a and 10b). The joist was tested in Groves' yard (Figs 11a and 11b). It will be seen that the actual loading and resistance points were reversed, so that the scarf was deprived of the reinforcement in the form of 2" x 2" battens and floorboards nailed to its top surface which it would have in the building, and also the anticipated 80 lbs per square foot of live load, also resisting upward spring, was eliminated. Nevertheless, the joist was found to be capable of taking three times the engineer's estimated load on each joist, with a maximum deflection throughout its length of barely three-quarters of an inch. The engineers remained sceptical, but only those very few joists that would not be exposed when the building had been completed were additionally strapped. The rest may still be strapped if they should look like failing at any time in the next few centuries.

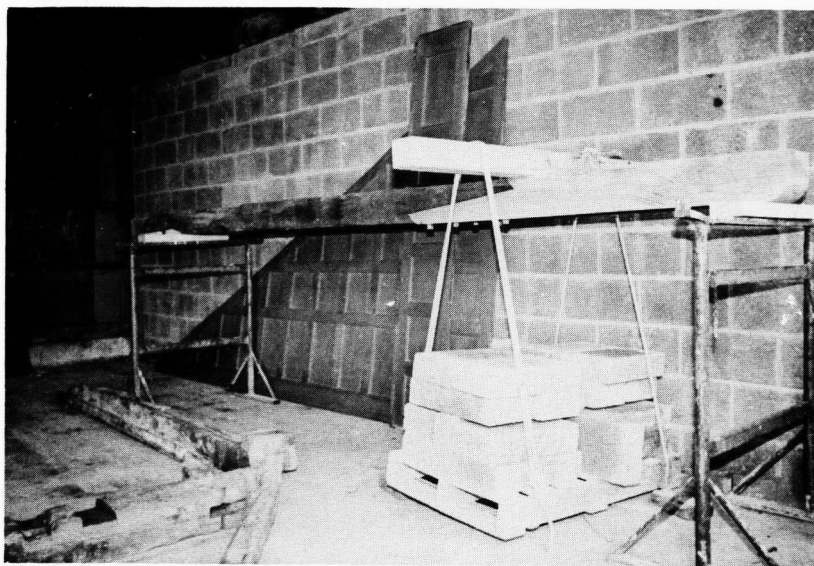
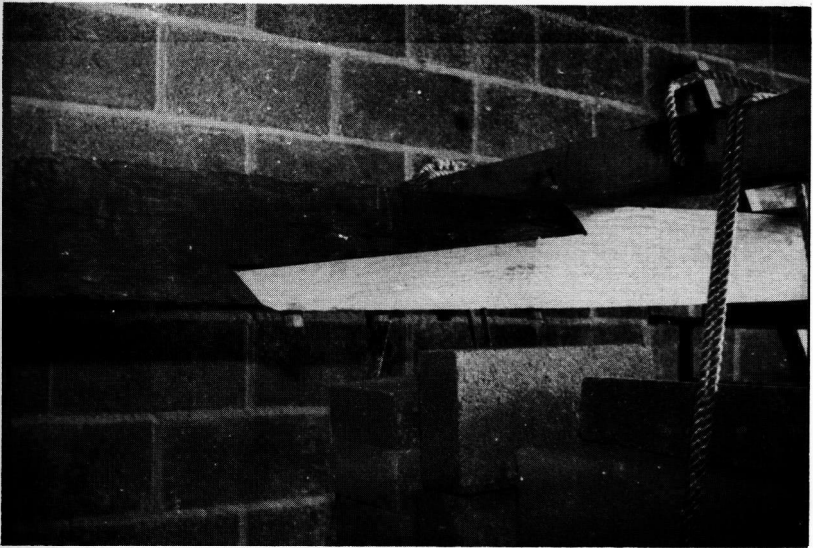
Testing of joist required to take load of 350 lbs per square foot  
(a) The joist loaded to 840 lbs per square foot; (b) The same loaded to 1232 lbs per square foot

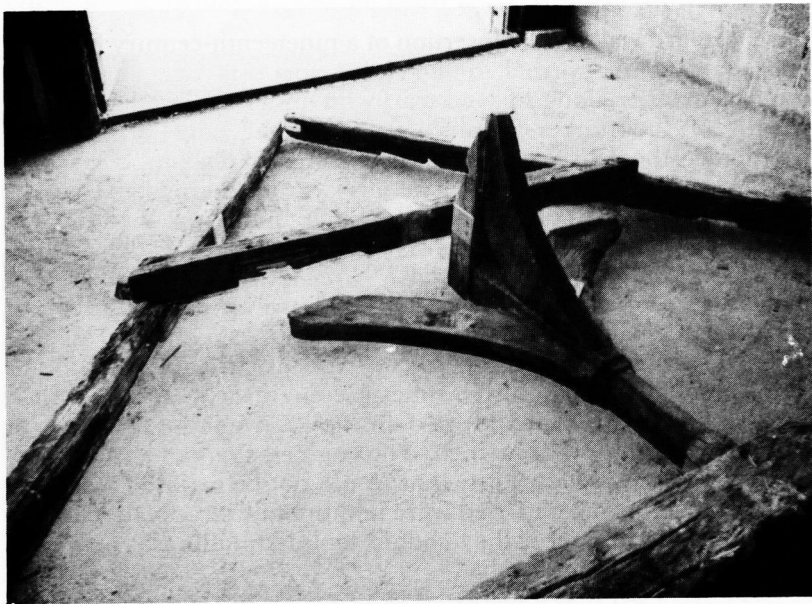
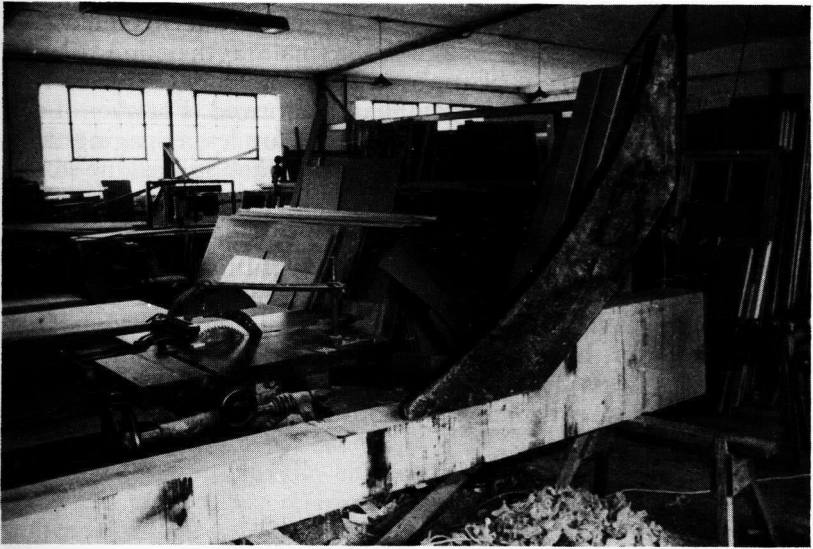
(a) Gallery—TII laid out for repair;

(b) Ship Street Range, new corner-post and existing knee-brace

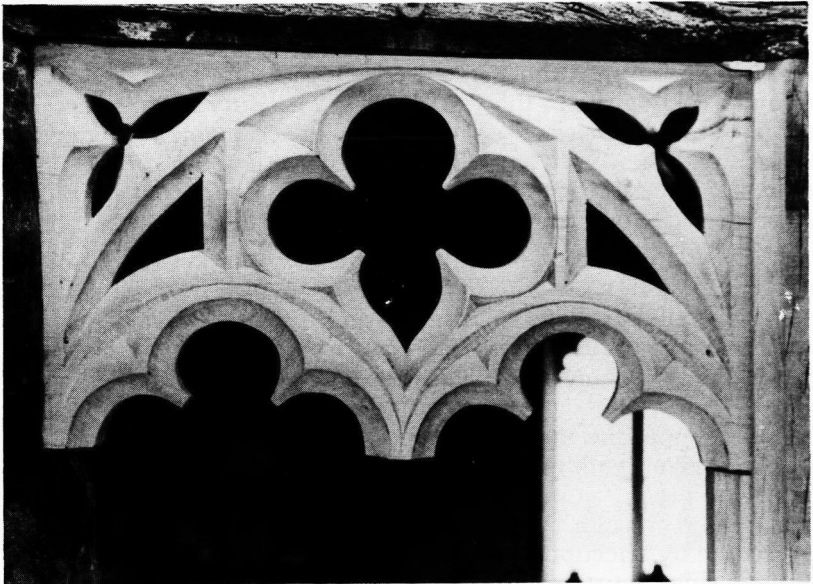
There was a hitch in May 1986 when H.B.M.C. had doubts about the authenticity of the tracery of the second window of the hall. According to their officer there was insufficient evidence in the surviving timbers to be sure that it was of the same design as the one that was still complete. Moreover, Buckler, though he had drawn the latter, had only indicated the one in question, so that his evidence was also lacking. Against that, Buckler was an architectural draughtsman and recorder *par excellence* and had the windows differed in any detail he would surely have drawn both of them. The other objection was the old one of 'don't restore anything'. Eventually the architectural *lacuna* that would have resulted from its omission was realized and agreement given for its restoration (Fig. 13).

Fig. 13  
Restored tracery for the second hall window

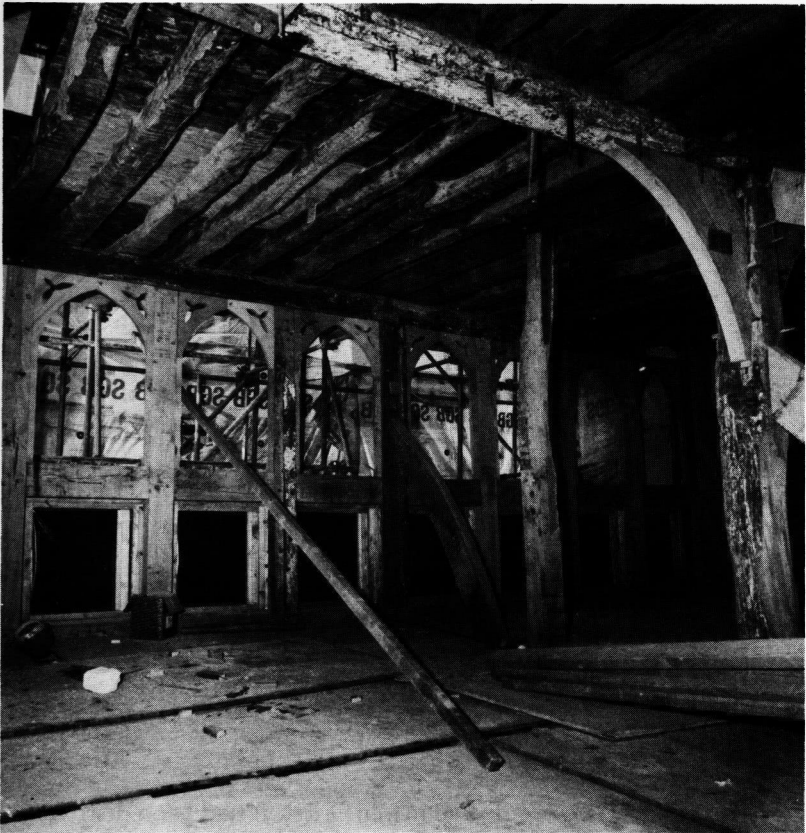
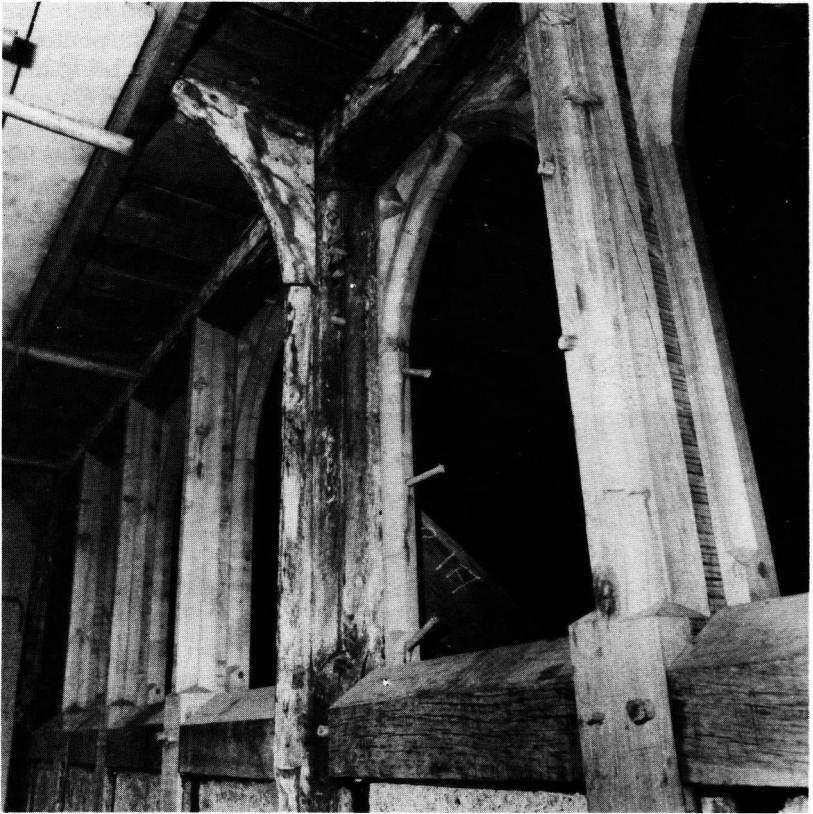
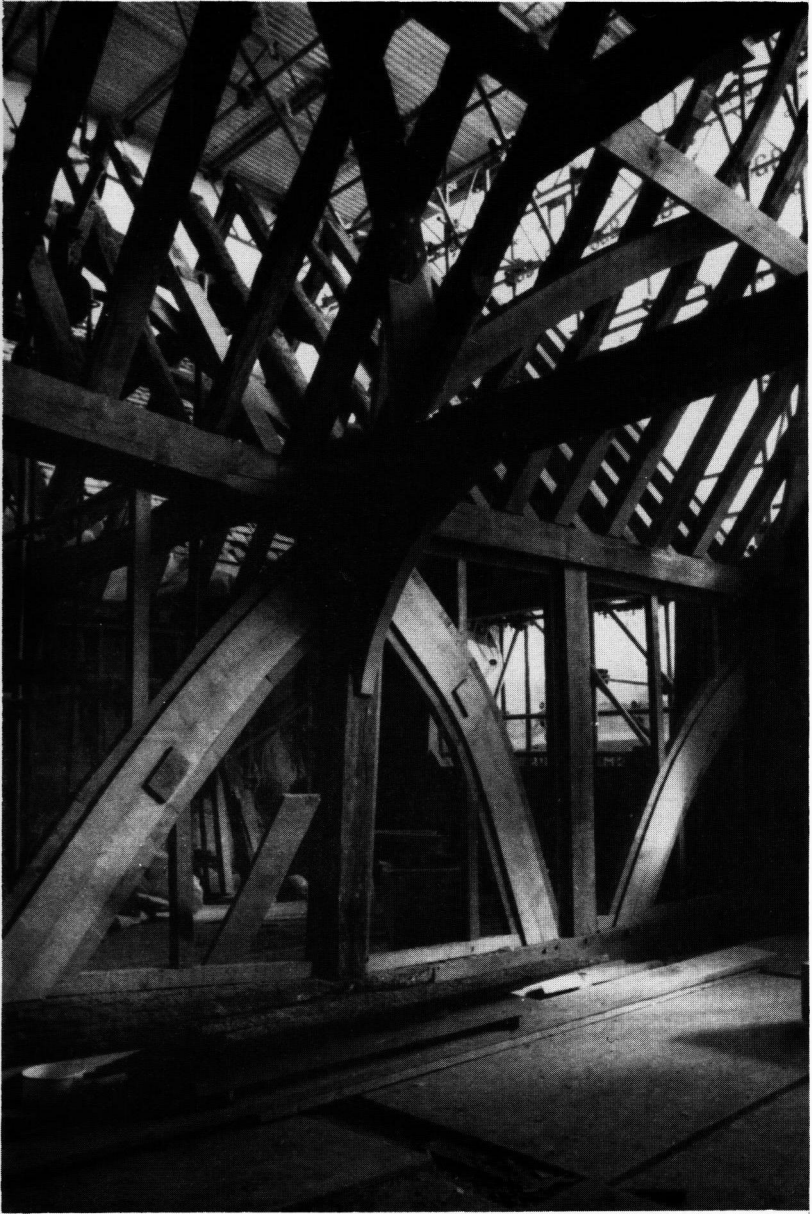
(a) Cornmarket Street shops first floor re-framed; (b) Details of windows;  
(c) Attic floor and roof

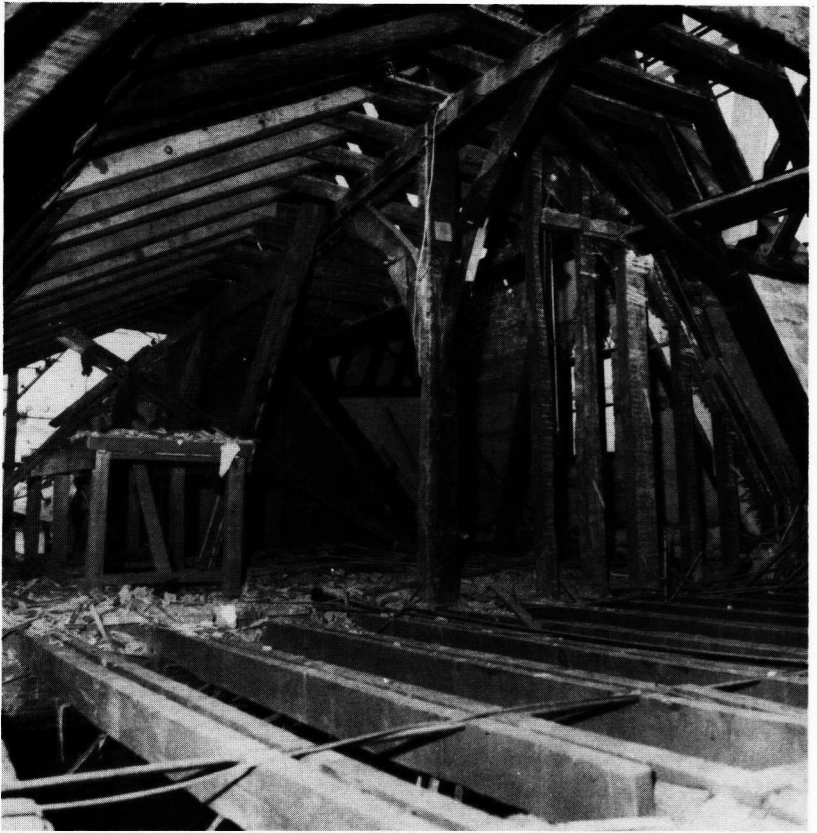
Fig. 15  
Hall roof repaired *in situ*  
*Photo: B.J. Harris Photographers, Oxford*

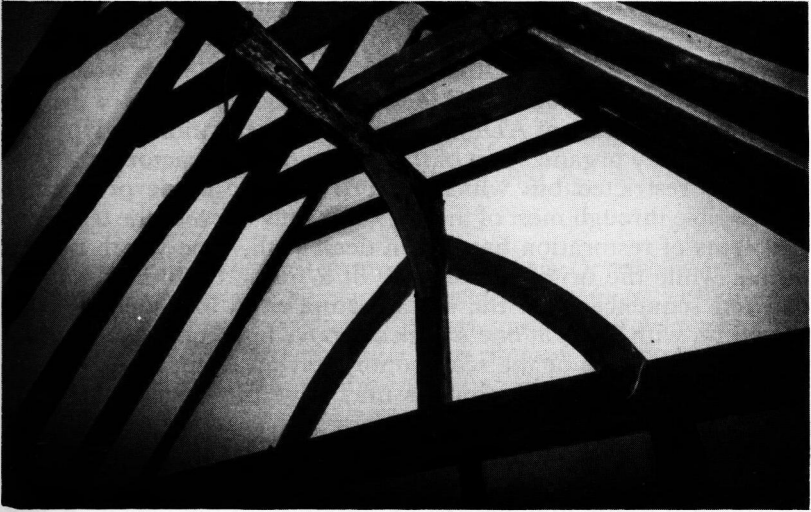
in the Bodleian Library proved that the original had been a closed truss of quite different design (Fig. 16). The correct truss had to be made after Groves had already carved the new crownpost. Secondly, the length of the collar-plate had to be reduced as the re-facing of the party wall terminating its south end prevented the surviving crown-post and tie-beam from being placed exactly in their original position. And thirdly, the stanchion to support the concrete roof over the yard had obliged us to move the north-east corner-post of the gallery a matter of six inches away from the hall wall-frame. Altogether the collar-plate is now about a foot too short.

Fig. 16  
Restored Truss I of the gallery
