Contrasts and Parallels

Two Conservation Case Studies: Greenhill and Thorpe Hall

ANTHONY P. ROSSI

This article describes the conservation approach to the rehabilitation of two important and virtually ruinous buildings, one at Wirksworth in Derbyshire and the other just outside Norwich. For the first the architects were Derek Latham and Associates of Derby; the author acted as project architect for this and as architect for the second. The work at Greenhill, completed in 1983, received a craftsmanship award from the local society of architects and the building is part of a group which received a Civic Trust award in 1986. The work at Thorpe Hall was completed in the summer of 1987.

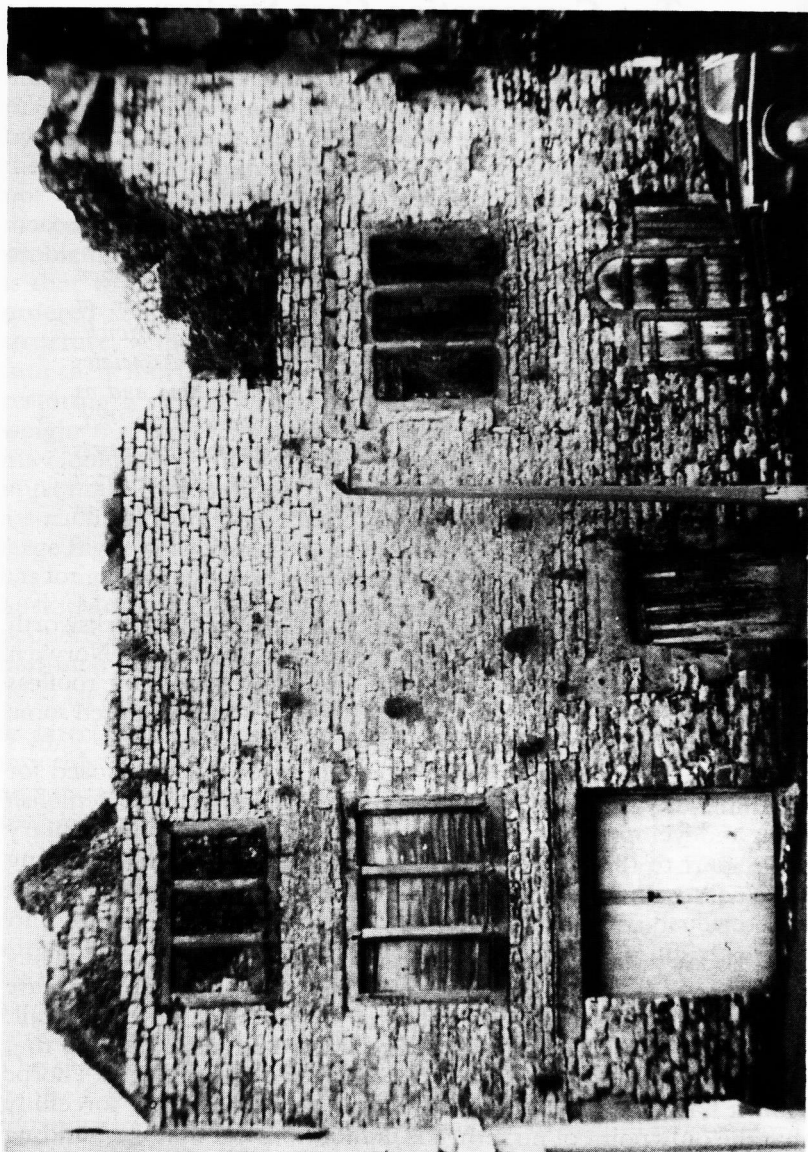
Fig. 1

- a) 1-3 Greenhill, Wirksworth in 1980 when the building had been a ruin for more than twenty five years.
- b) 1-3 Greenhill, Wirksworth in 1984 following rehabilitation by the Derbyshire Historic Buildings Trust. Minimum repair and reconstruction was undertaken and the variation in the treatment of openings arises from a deliberate acceptance of the alterations that the building has undergone during its 450-year history.

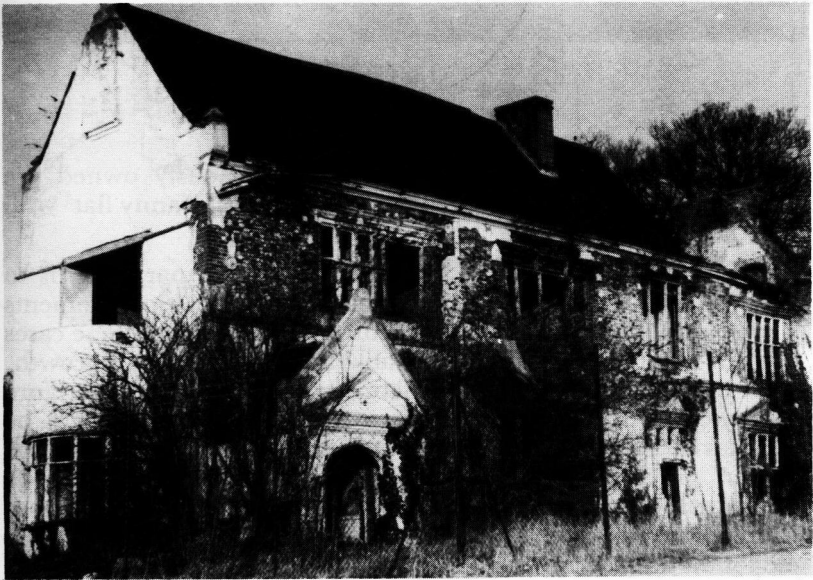
Fig. 2

- a) Thorpe Hall, Norwich from the south east in 1983, as a vandalized and partly collapsed shell;
- b) Norfolk County Council, Thorpe Hall, Norwich in October 1987, nearing completion as a rehabilitated dwelling. Originally there was a lower service wing running south from the gable but the surviving building had only two large late openings with insufficient evidence to allow an accurate re-construction; the enclosing two storey bay, clearly unhistorical but designed to blend with building, is a solution to this problem. Generally the late sixteenth-century pattern of the east front has been restored but a later cornice has cut the first-floor pediments; the south first floor window head has a Victorian stone repair and the steep roof and gable of the porch is also a nineteenth-century alteration.

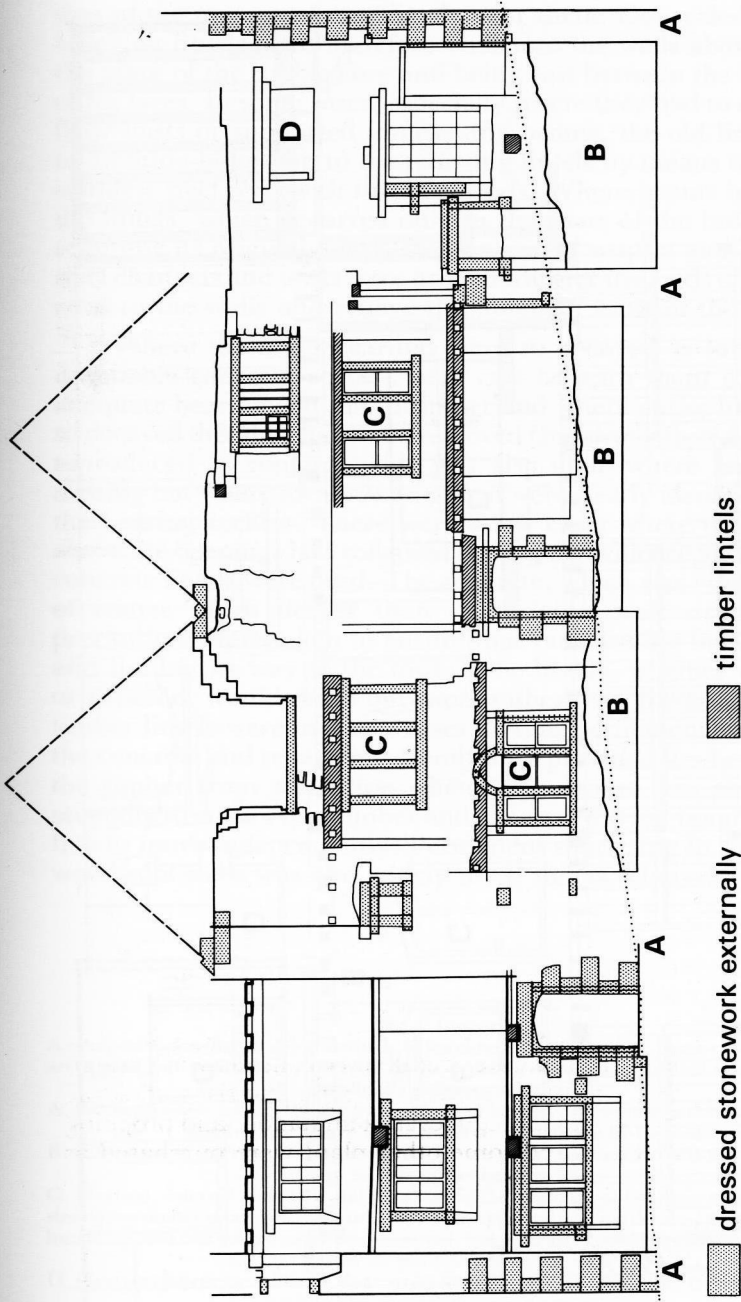
Fig. 3

Survey drawing of the inner face of the front wall of Greenhill before repair. The cross hatching shows timber lintels and the tone of dressed stonework on the exterior face; the letter (A) indicates abutting gable and cross walls still not fully investigated when the drawing was made. Except at the south (left hand) end/floors have collapsed but their levels and form can be deduced from the joist holes many of which are in the lintels above the openings. The gables, indicated by the broken lines, have collapsed but two kneelers remain. The dotted line denotes the exterior ground level and when the drawing was done the ground floor areas were still partially filled with rubble (B) and some openings blocked or inaccessible. The letter (C) indicated three large original openings reduced in size in the late eighteenth century; others have been further altered in the nineteenth and twentieth centuries and most have later joinery. At (D) is a surviving fragment of an unglazed timber window frame, subsequently reinstated.

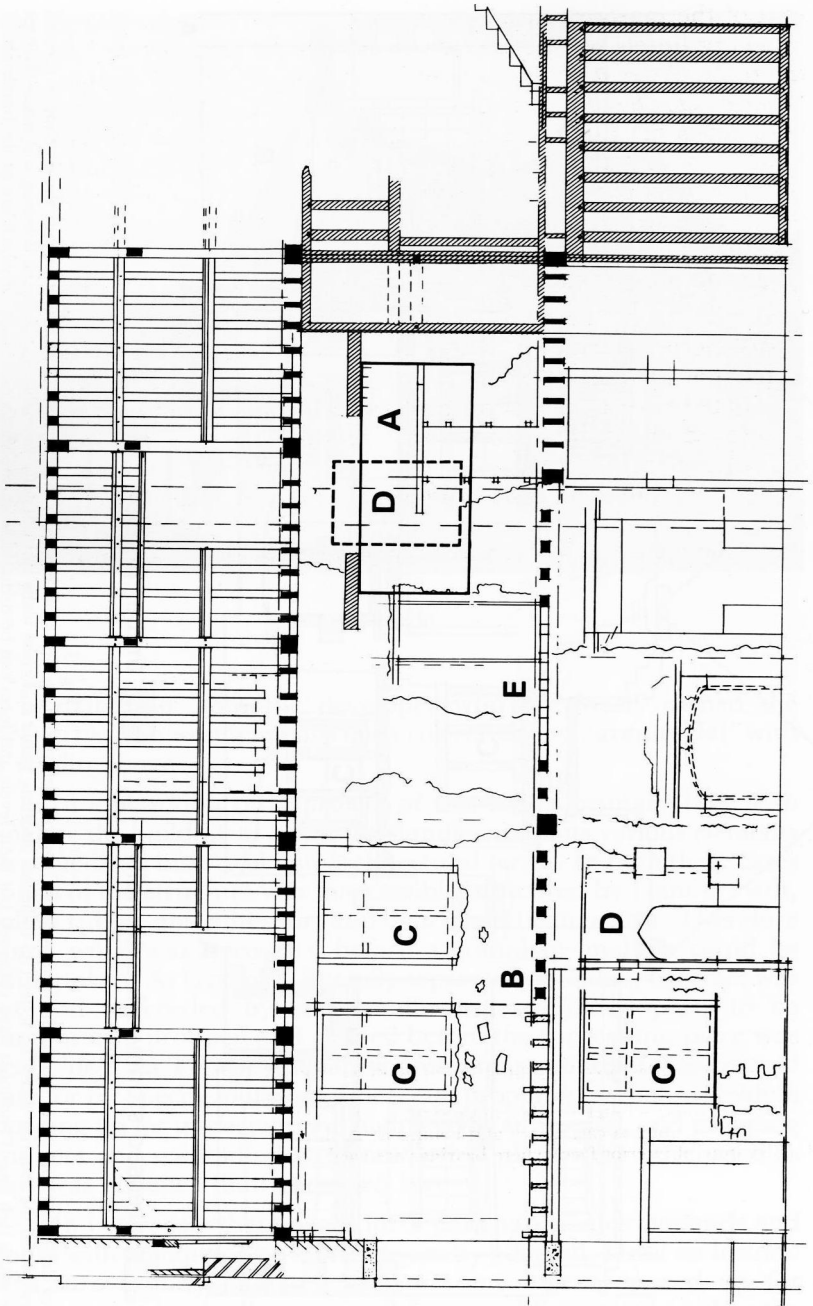
Fig. 4 (opposite)

This elevation of the inside face of the west wall of the south wing of Thorpe Hall shows a whole series of alterations extending over some four centuries; as a result there is multiple cracking and local overloading. The value of an internal elevation in showing sections through floors and roofs, and the way they bear on the walls, is well illustrated.

The solid outline rectangle at (A) indicates a late sixteenth-century opening of which the lintel ends and one reveal survive; moulded bricks from a similar opening are built into the wall at (B). The rectangular openings at (C) and (D) date from a remodelling of the elevation probably carried out about 1700; those at (D) have been further overlaid by nineteenth-century alterations. The interruption of the first floor structure at (E) is due to the floor being trimmed across the face of the chimney stack.

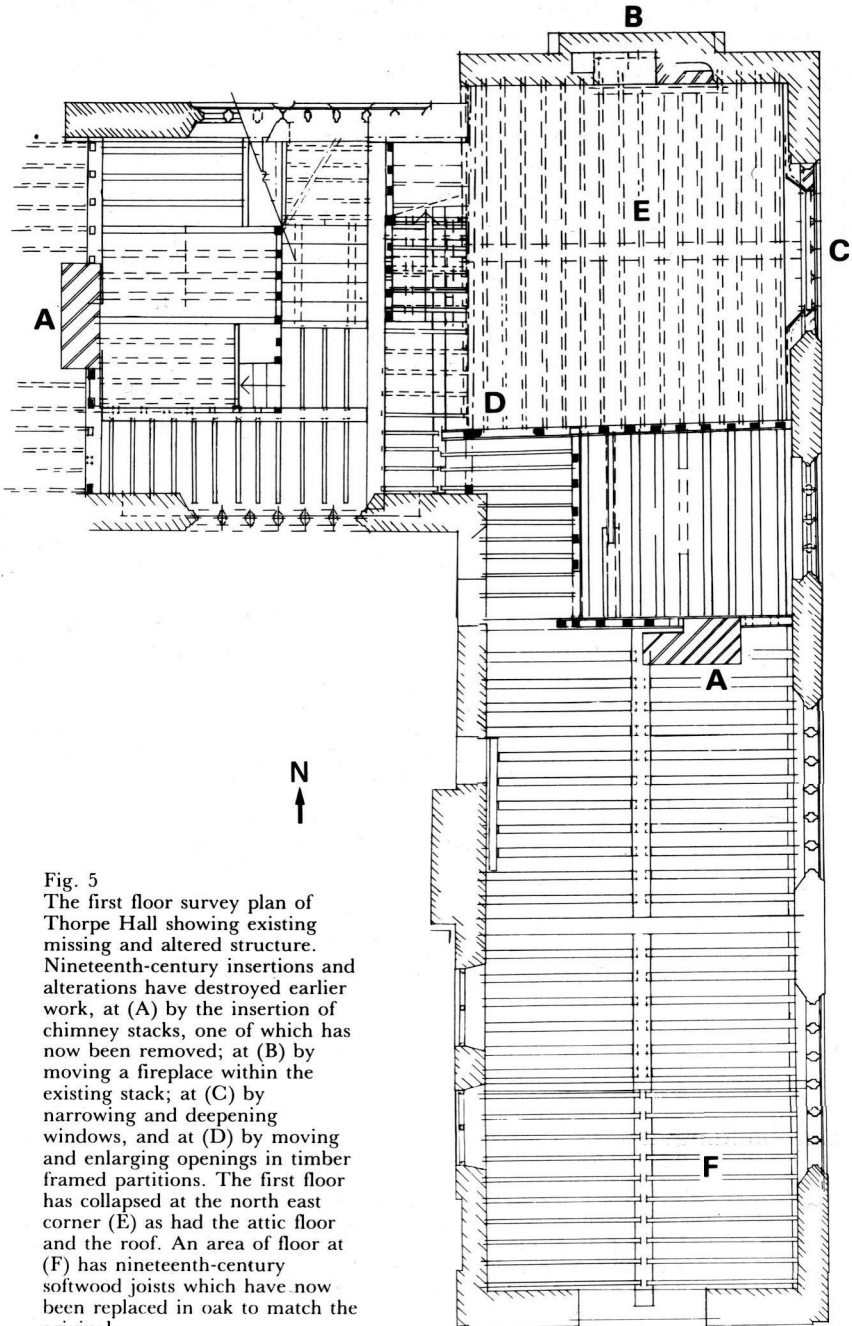
Fig. 5

The first floor survey plan of Thorpe Hall showing existing missing and altered structure. Nineteenth-century insertions and alterations have destroyed earlier work, at (A) by the insertion of chimney stacks, one of which has now been removed; at (B) by moving a fireplace within the existing stack; at (C) by narrowing and deepening windows, and at (D) by moving and enlarging openings in timber framed partitions. The first floor has collapsed at the north east corner (E) as had the attic floor and the roof. An area of floor at (F) has nineteenth-century softwood joists which have now been replaced in oak to match the originals.

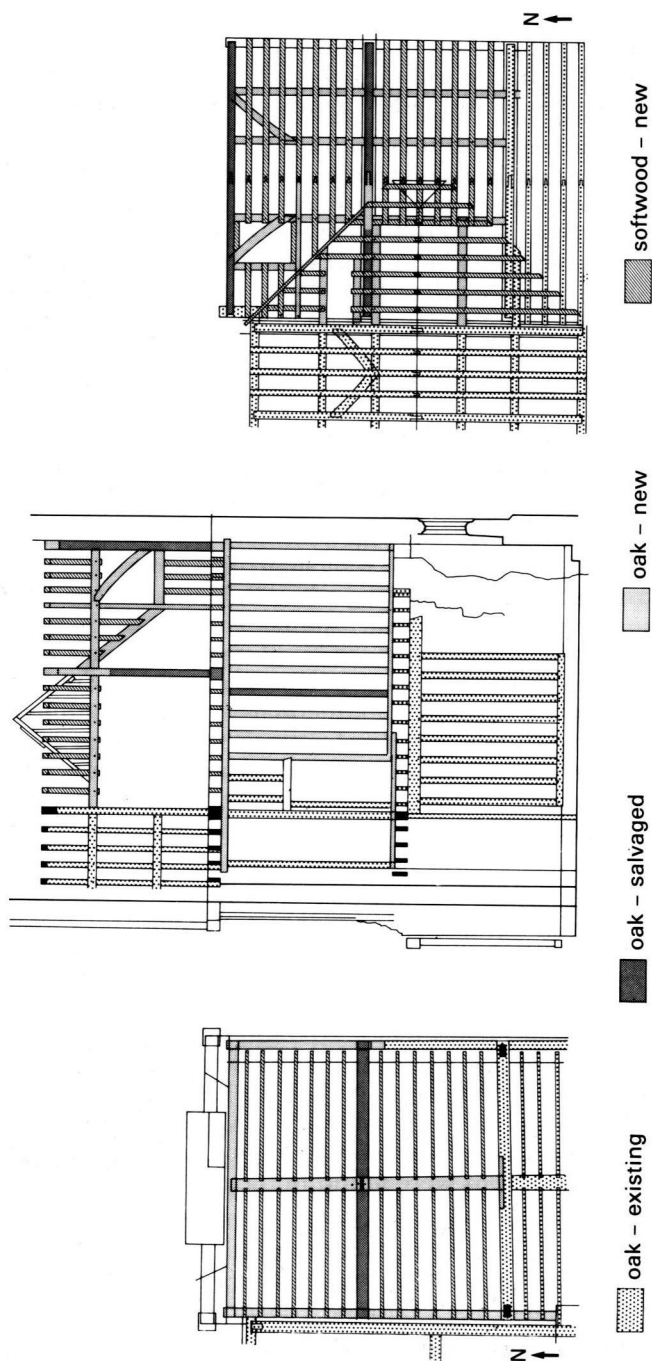
Fig. 6

Plans and sections showing the reconstruction of part of the roof (right), attic floor (left) and a first floor partition at Thorpe Hall. Some of the timbers are shown *in situ* and some salvaged from heaps of collapsed material; others are new oak, where architecturally significant, of softwood where not seen. English oak was used throughout for repairing the old structure but softwood was considered acceptable for re-construction of collapsed areas where it would be invisible in the finished building.

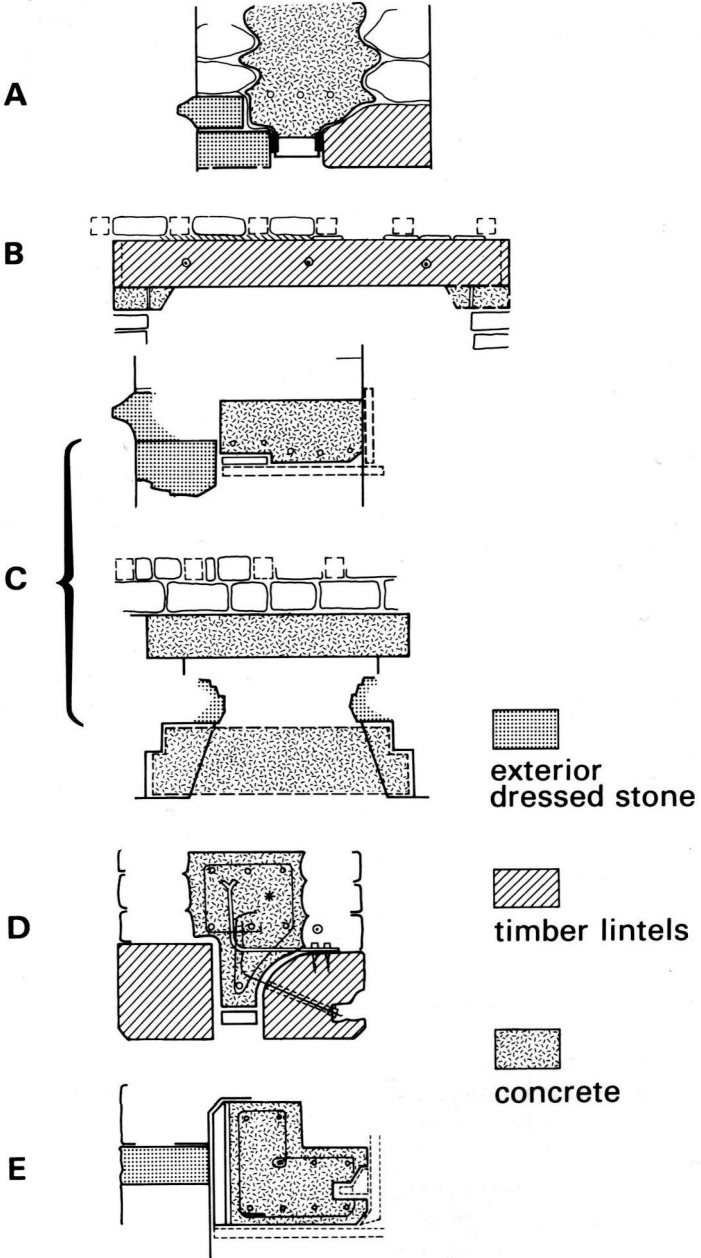
Fig. 7 (opposite)

At Greenhill most of the problems with the old unroofed structure were related to openings, mainly because of decayed timber lintels (Fig. 7). It is normal for timber to decay where it is least ventilated; consequently the parts of lintels at risk are the bearings and the concealed rear faces. In many cases the bearings had decayed while the remaining parts remained relatively sound but the rear faces were also generally suspect, aggravated by the fact that, as is normal practice, the timbers had originally been built in with their heart side exposed to the internal face, leaving the sap and wane concealed in the wall. Generally the lower face edges were stop chamfered and in a number of cases window lintels doubled as floor beams, with shouldered mortices for the missing joists.

that of the masonry immediately over them. Concealed concrete relieving lintels were therefore built into the walls above, taking the place of the rubble core and being cast between the inner and outer faces. In some cases, especially where they had to carry new floor joists or supported intersecting beams, the old lintels were in addition bolted up to the relieving lintels by means of cranked stainless steel rods with threaded ends. Where beams intersected the lintels, which occurred only in that part of the building still retaining its original floors, the joints were suspect and concealed steel channels and joists were used to transfer the loads of the beam ends to the walls and relieve the lintels of most of the weight.

Where the lintel bearings were so decayed as to be totally unreliable concrete corbels were cast beneath them to produce adequate bearings on sound timber and where entire lintels were so decayed that they had to be removed completely their forms were reproduced in concrete; this was also done where lintels were missing but where their size and form were clearly identifiable from the bearing sockets. There were a few cases where the masonry above the openings had collapsed leaving no evidence and here new concrete lintels were used. The concrete, which was vibrated, was of course much denser than the original wall structure and precautions were taken to ensure that rain driving into the walls and finding its way to the tops of the lintels, whether concealed or exposed, would drain outwards rather than inwards. Existing timber lintels were in many cases used as permanent shutters for the concrete and separating membranes provided firstly to protect the timber from saturation when the concrete was poured and secondly to ensure that timber and concrete did not bond and were free to move independently. Permanent shuttering in the form of woodwool slabs was also widely used; this is relatively easily cut

A composite drawing to show methods of lintel repair at Greenhill, using concrete. These are typical but in fact every opening in the building required individual assessment and a slightly different solution.

- A. (Section) where a lintel is sufficiently strong to bear its own weight, a concealed concrete lintel is cast above and behind it, in the core of the wall.
- B. (Elevation of interior face) where bearings are weak, concrete corbels are cast beneath them to extend the bearing area.
- C. (Section, internal elevation and plan) using the evidence of bearings a concrete lintel simulating timber is cast where the original has disappeared or is too decayed to save. Concrete lintels are also cast where no evidence existed, but with an exposed aggregate face to show that there was no historical basis for their form.
- D. (Section) where an old lintel also carries floor joists it is additionally bolted or strapped back to the concealed concrete member.
- E. (Section) a simulated concrete lintel cast complete with joist holes into which new joist ends were later fitted.

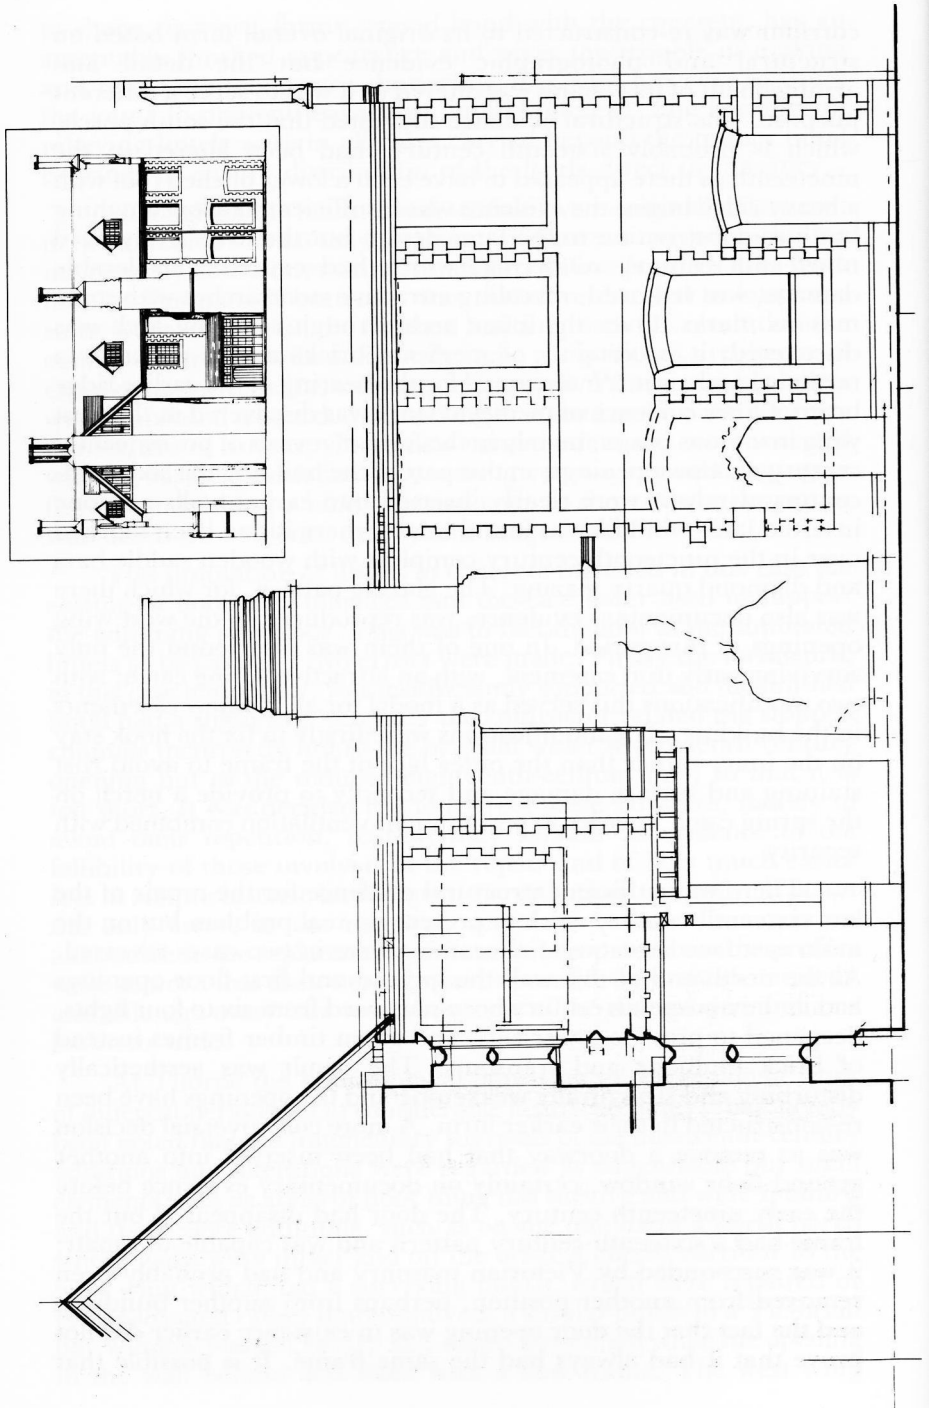
Fig. 8 (opposite)

Once the Victorian additions were removed the scars that remained were simply disfiguring and the inserted openings had also weakened the wall. There was insufficient evidence to allow anything other than a very conjectural restoration of the sixteenth-century window pattern and it was decided to re-construct to the pattern of the intermediate period. In one place however even this was missing and there was just a pair of large nineteenth-century openings separated by a rather weak pier of sixteenth-century (or possibly earlier?) masonry (Fig. 8).

The west elevation of the south wing at Thorpe Hall (see also Fig. 4). The work is a mixture of periods with a possibly medieval chimney stack and evidence of large sixteenth-century window openings. This elevation was heavily remodelled about 1700 but there are also later alterations overlaying the remodelling. It was decided to repair the elevation by reconstructing the pattern of the *c.* 1700 remodelling as there was insufficient evidence of earlier work and the later insertions made no architectural sense, having been related to additions that have now been removed.

At the left-hand end of the ground floor however there was no surviving evidence at all; the late openings were therefore accepted and a totally new structure in the form of an oak-framed half-glazed bay was added externally. The inset shows the finished pattern, including reconstruction of the top of the chimney to a form related to but not matching the missing chimneys shown in old photographs, and new dormer windows placed where they would not interfere with early roof structure.
