## STRUCTURAL PROBLEMS OF THE REFECTORY OF S. MARIA DELLE GRAZIE IN MILAN

*Marginal Notes on the 'Last Supper' of Leonardo da Vinci*

By *Gisberto Martelli*

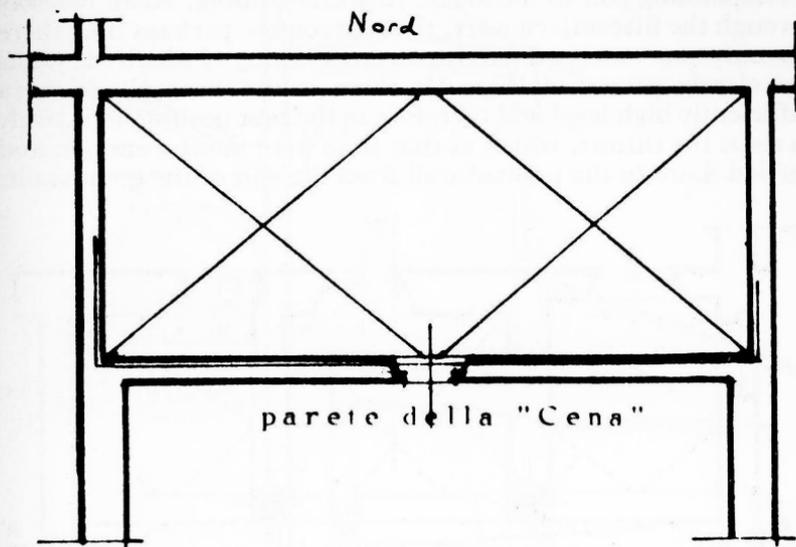
Fig. 1: Room behind the "Last Supper" showing original vaulting. (15th century)

The painted wall has suffered the effects of a series of grave tamperings increasingly affecting the two small rooms to the north superimposed one on the other and analogous to the corresponding pair to the south. At the beginning, about halfway through the fifteenth century, the rear room – perhaps then there was only one – was covered by two cross vaults, of which the joints are clearly preserved (Fig. 1); these vaults were placed at a sufficiently high level and therefore in the best position effectively to resist the thrusts, which at that time were modest enough and carried down to the painted wall from the end of the great vault.

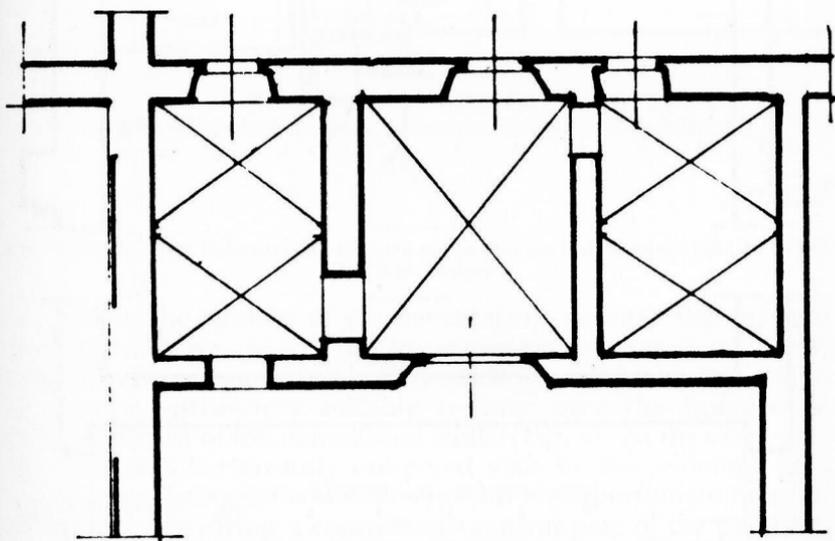
Fig. 2: Room behind the "Last Supper" showing vaulting as altered in the 17th century.

About the middle of the seventeenth century this original arrangement was upset: the two cross vaults were demolished, and there were constructed other vaults placed lower, but still in a position sufficiently suitable to take over the function of counter-thrust of the demolished vaults (Fig. 2). At the same time the wall was barbarously tampered with by the widening of a small pre-existing central doorway with a proportionate increase in height, destroying a conspicuous central part of the painting; another doorway towards the west was made near by, perhaps in the same years. The new vaults underwent ruinous treatment in

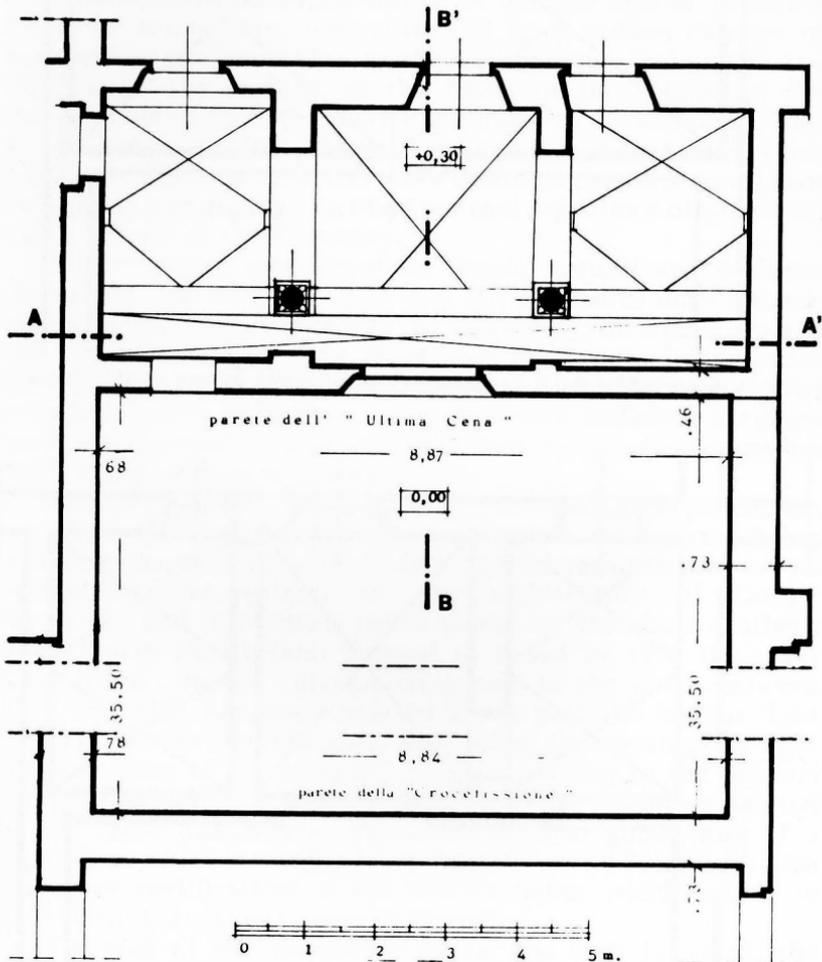
Fig. 3: Refectory plan showing partial destruction of vaulting behind the "Last Supper". (1924–25)

times nearer to our own, with the partial demolition of the walls which divided the space into three parts; then, in the years 1924—25, with the aim of making uniform the air in the two superimposed rooms to the effects of temperature and humidity, a section of the vaulting along the whole support on to the wall was demolished, creating thus a gap about 70 centimetres broad (Fig. 3); with the result that the wall was left without valid counter thrust throughout the whole of its considerable height (Fig. 4). In these conditions it was miraculous that the structure succeeded in surviving the tremendous test of the effects of a big aerial bomb that exploded on 16th August 1943. The long eastern wall, the great vault, the roof and the body of the adjacent building—made out of the beautiful fifteenth century library with three aisles—collapsed completely. Even before the war ended provision was made for the reconstruction of the wall and the roof; the latter was put together as could best be done with the timbers of the old roof gathered from among the ruins and hastily adapted. The vaulting was reconstructed later in a manner identical with the original: but the body of the fabric of the adjoining monastery reconstructed some years later did not reproduce exactly the reciprocal links peculiar to the early structure, on which the structural equilibrium of the whole relied.

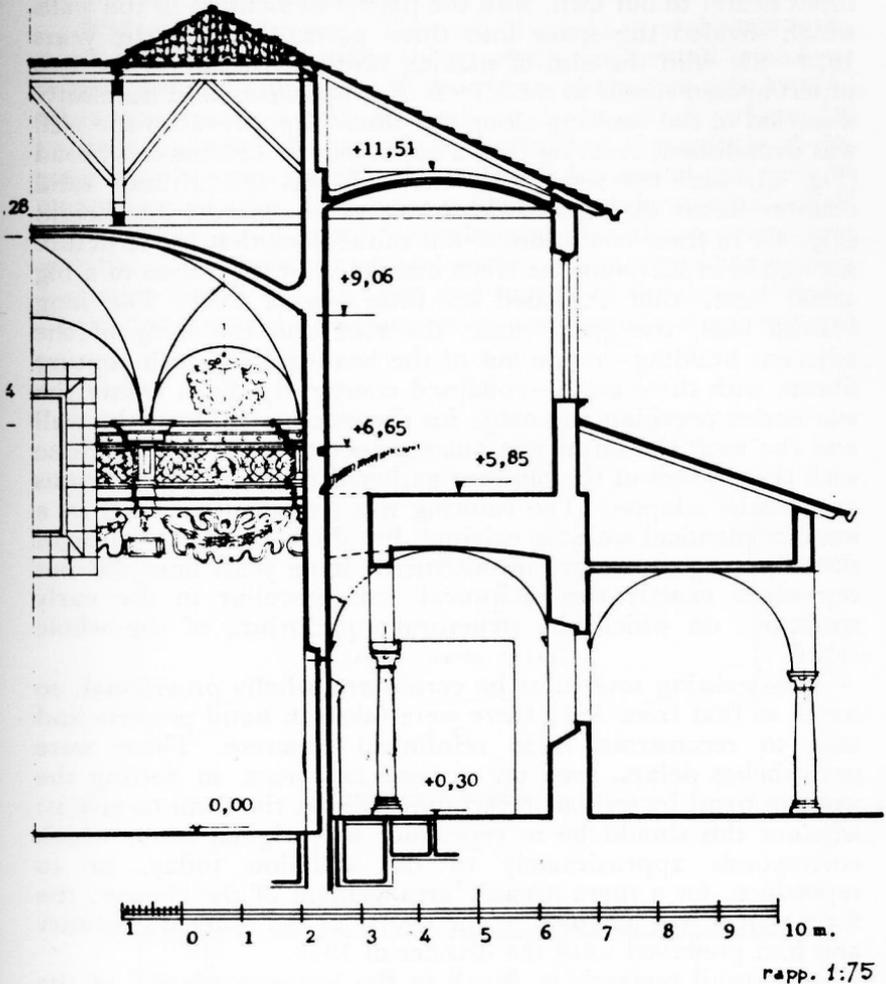
Fig. 4: North end of Refectory and adjacent rooms showing lack of support for the wall of the "Last Supper".

When in June 1980 it came about that one of the small glass 'tell-tales' placed astride a crack broke, it appeared very clearly that we were confronted by a warning of progressive deformations; it was then decided to put in hand with all urgency a special metallic structure designed by the Chief Architect of the Fabric of Milan Cathedral, Engineer Carlo Ferrari da Passano.<sup>4</sup>

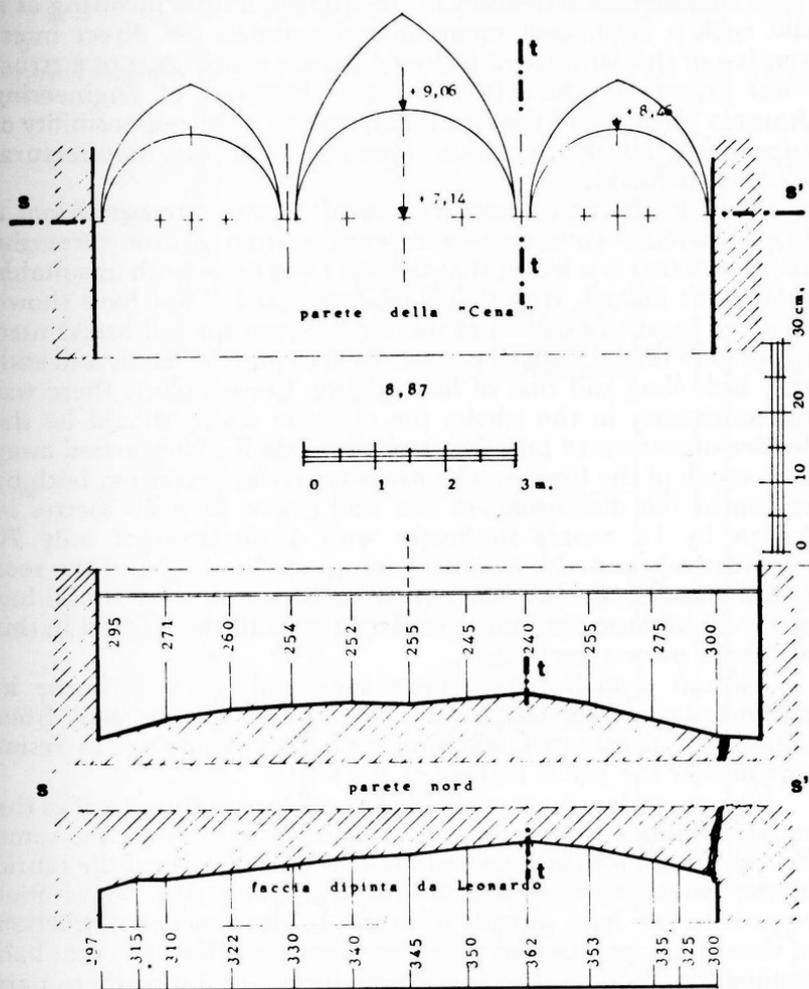
**Wall of the 'Supper':** The web of cracks very obvious in its north face shows, alongside things which can remind one of an adjustment now completed to the effects of the war-time attack, other phenomena which are without doubt still in process. A horizontal section of the wall at the level of the corbels of the great vault—with two different scales for horizontal and vertical measurements (Fig. 5)—shows evidence of deformations which are of the order of about 7 centimetres, exactly corresponding with the two corbels: the vertical section agrees, signifying equally and more clearly the direction and sources of the thrust (Fig. 6). The curvatures of the two faces of the wall fortunately correspond

Fig. 5: Horizontal section of the wall of the "Last Supper" showing deformations.

sufficiently, excluding the possibility that empty spaces between the bricks were produced internally; but it is beyond doubt that to the tensions of the north face which cause the cracks there correspond in the south face compressions which could also compromise the stability of the painted plaster, leading to bulging and local collapse.

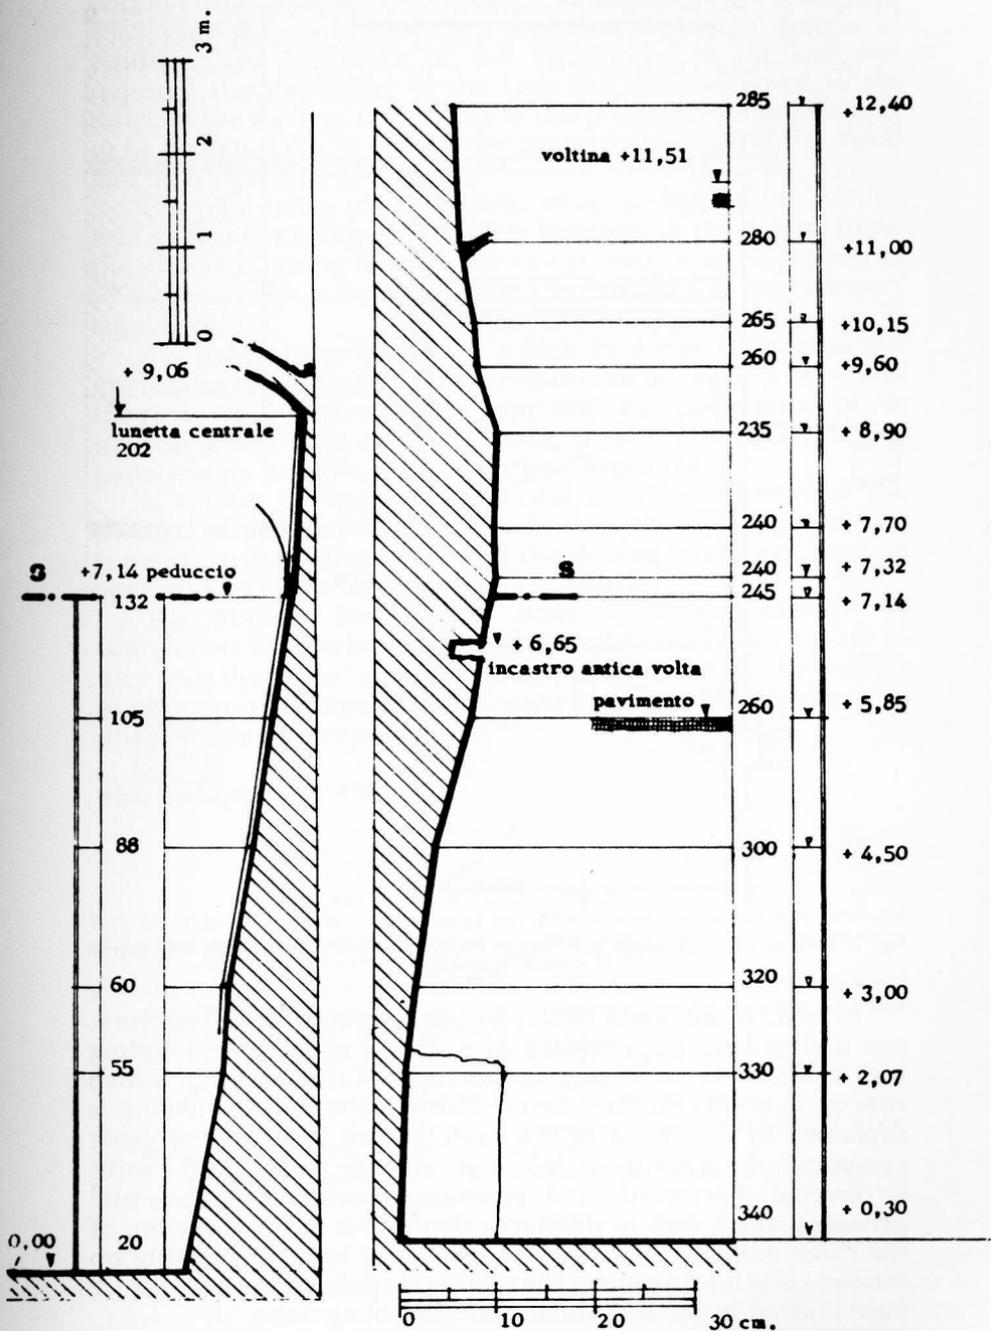
Fig. 6: Vertical section of the wall of the "Last Supper" showing deformations.

Indeed, if one looks closely at the interior of the Refectory, one notices here the evidence of a serious crack corresponding with the north-east corner, to the right of the painting, which rises up to border on the lunette. This impairment, so obvious, is explained by the thrust of the vault, at this point not properly countered; the consequent deformation of the surface of the soffit is directed downwards and generates considerable abnormal pressures which seek to discharge themselves in the direction of the three lunettes above the 'Supper', and by concentrating on the two corbels bring about the noticeable deformations which we have noticed in the horizontal and vertical sections.

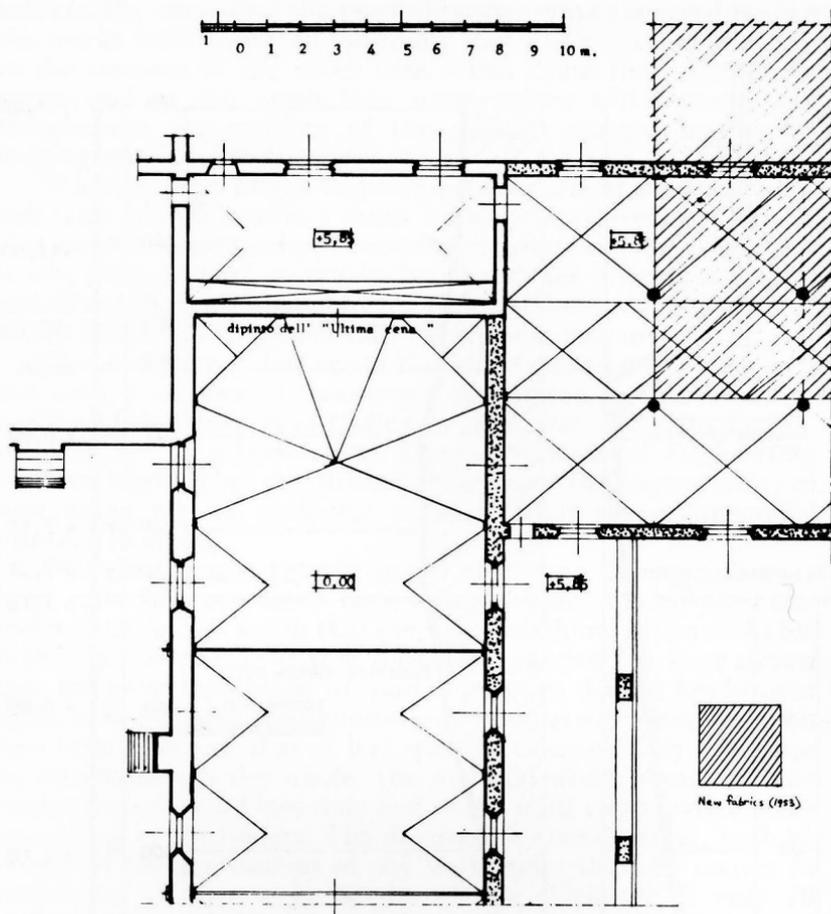
The exceptional nature of the circumstances fully justifies the reconstruction carried out in a hasty manner in 1943; the same cannot be said for the reconstruction of several parts of the fabric of the monastery executed several years later (Fig. 7) without regard—as we have already noticed—to the exact reproduction of those reciprocal ties between the structures; those ties that had assured for centuries the general equilibrium of the northern part of the Refectory.

Fig. 7: Refectory and monastic buildings to the east (ancient library) with new fabrics (1953) hatched.

Various remedies have been suggested, from a frame in reinforced concrete lodged in the thickness of the wall from outside to an extensive stitching with steel clamps set in resins spread over the whole surface of the wall.
