Some Clay Dabbins in Cumberland: their Construction and Form Part II

J.R. HARRISON

This paper, of which Part I was published in Transactions, 33 (1989), summarizes the results of field studies of a number of cruck-framed and clay-walled houses on the Solway Plain in Cumbria, undertaken between 1979 and 1982. Part II presents a number of individual case-studies of building plan and section and considers the way these changed with time. It concludes with a brief survey of the wider structural, material and plan-form context of the tradition.

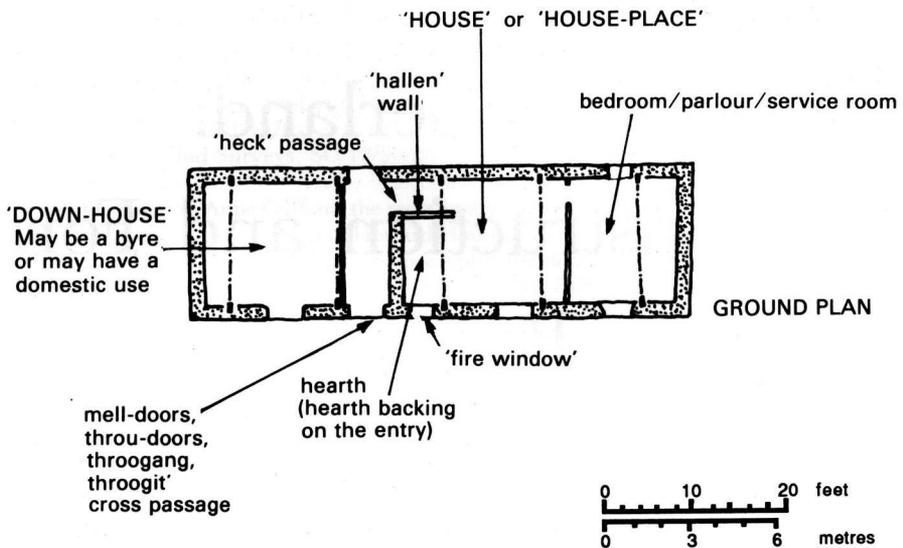
'Statesman' type plan based on Lamonby Farm, Burgh-by-Sands. The room names shown are those discussed by Bouch in 1954 (Hodgson, K.S., Bouch, C.M.L., and Bulman, C.G., 'Lamonby Farm: a clay house at Burgh-by-Sands', *Trans. Cumberland and Westmorland Antiq. Archaeol. Soc.*, N.S., 53 (1954), 149-59)

of the earliest recognizable type-plans in the region—the ‘hearth backing on to the cross-passage’ plan which was referred to in Part I when the role of the ridge was being considered. Fig. 1 shows a typical plan of this sort. The arrangement is found quite widely in the north of England and it is generally thought that it replaced plans that were less fully ‘compartmented’ in their layout and which were sometimes long-houses. Turner and Parker, writing of mid-nineteenth-century Northumberland, confirm that the long-house shared by man and beast still existed there at that time:

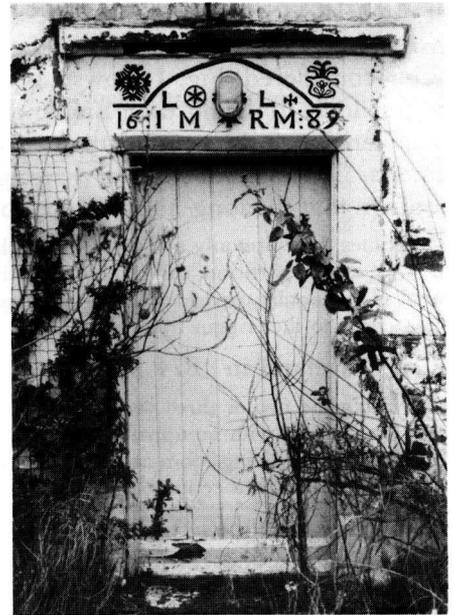
Fig. 2
Date-stone lintel, Ratten Row, Durdar, 1988

It is from James Jackson's period and later that date-stones are found over the doors of one or two mud houses on the Plain (Fig. 2) and, coupled with these, one

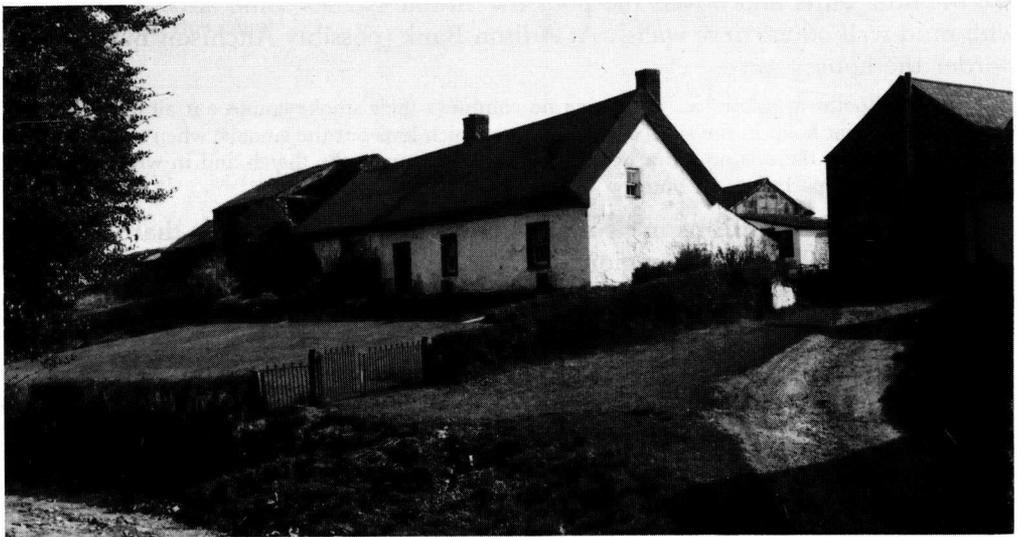
Fig. 3
House at Kirkandrews on Eden. The attached barn, later in date than the house, is of masonry, with wall-head roof-trusses. It was in a derelict condition when the photograph was taken in 1979. The position of the chimney stacks shows that the elevation seen across the garden was originally the (probably windowless) rear of the house. Note the small gable window lighting the chamber over the parlour and the galvanized iron sheeting covering thatch. The building has subsequently been preserved and modernized and with the removal of the galvanized iron sheeting the original roof-raftering and thatch structure will have disappeared, as at Lamonby Farm

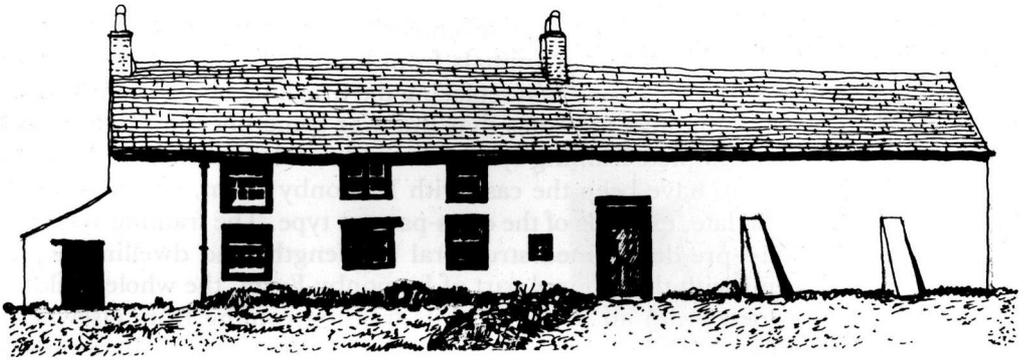
Fig. 4

Fingland Farm, Fingland, Grade II*. Close inspection of the walls and roof of this house would probably confirm raising of the wall heads from an original height similar to that shown in figure 3. The barn has been rebuilt, only the house being of clay. Note the very small fire-window and variety of other windows

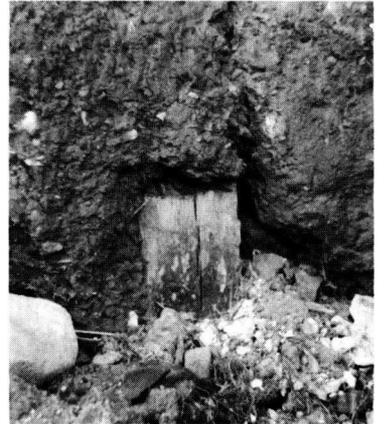
Fig. 5

Close-up view of a cruck foot exposed externally in the clay wall of a small house at Green Lanes, Dalston

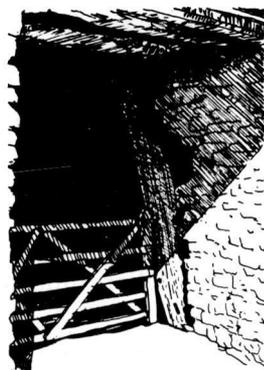
Fig. 7
Wagon entry, Drebley Barn, Wharfedale, 1982.
Cruck foot rests on the ground

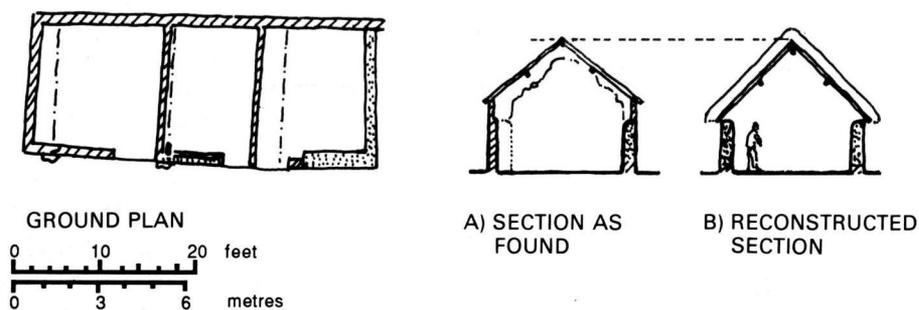
Fig. 8
Combined stables and wash house, Lamonby Farm, containing evidence of an earlier clay structure, with cross section of latter, reconstructed. Collapsed in late 1980s. This building was integrated into a brick nineteenth-century range, possibly of about 1840, at right-angles to the farmhouse, which also included a substantial open-sided wagon lodge with granary above. A single surviving cruck foot and, elsewhere, a substantial boulder protruding from the wall face (at a construction joint) confirmed the earlier structure as having been at least three bays long. The surviving mud-work was raised in brick at side wall and gable

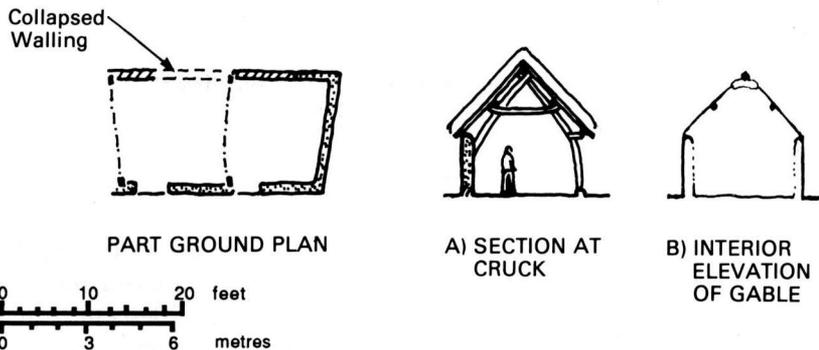
Fig. 9
Plan and section of the clay-built part of a house at Green Lanes, Dalston. Note the timber spreader plate at the top of the mud gable-wall, supporting the end of the ridge. A slender eaves-purlin, resting at one point on a cruck spur, supports the rafters over a section of collapsed walling

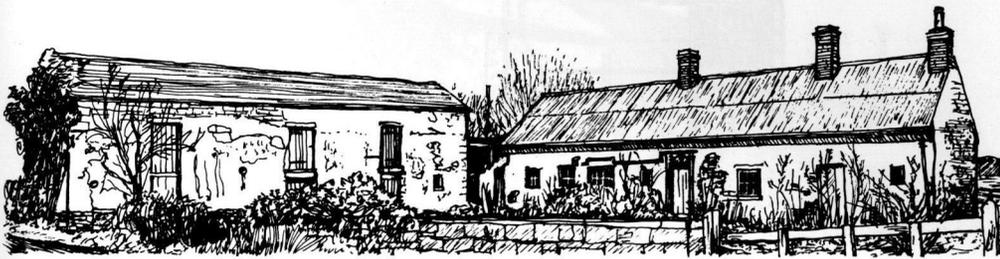
Fig. 10 (*Above*)

Ratten Row, Durdar, clay house section to left, and stone section to right, of cross-passage. Chimney-stack positions confirm the use of crucks in both parts of the house. On the left is a two-storey barn, clay walled below, but raised in stone

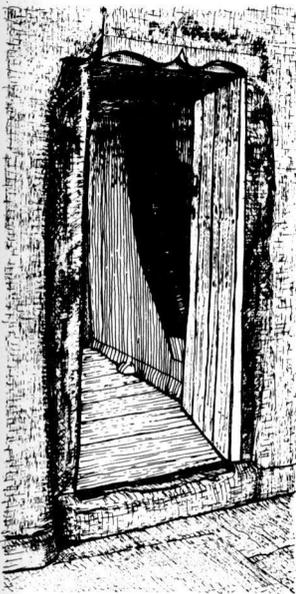
Fig. 11 (*Left*)

View from house place into parlour, Ratten Row, 1988. Note the heavy timber ground-sill to the partition wall, the ogee door-head with the ceiling trap to the loft immediately behind it and behind that the lower part of the heavy cruck blade. The downstand at the junction between wall and ceiling in the parlour, almost certainly formed part of the timber support system for the loft floor.

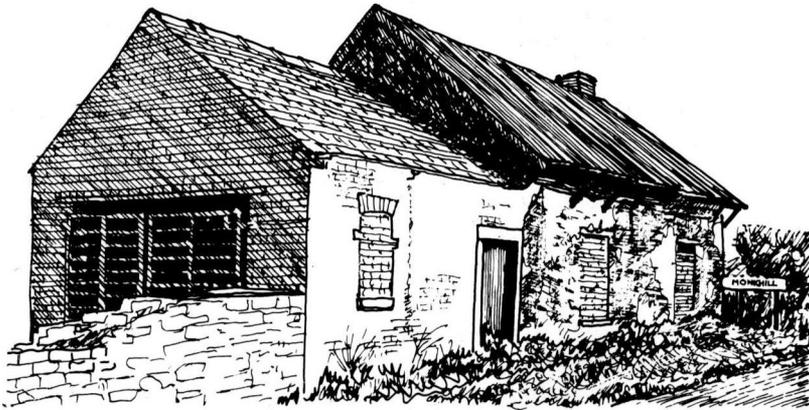
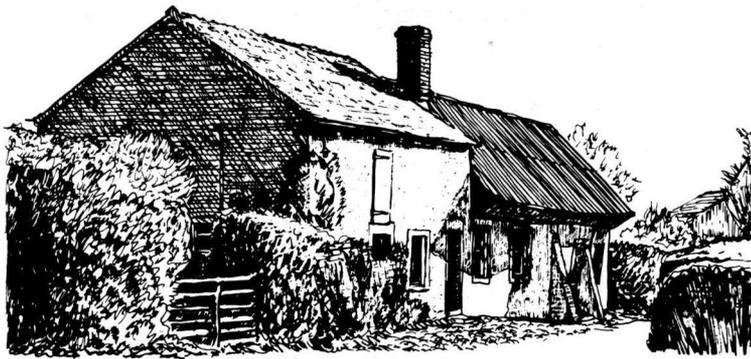
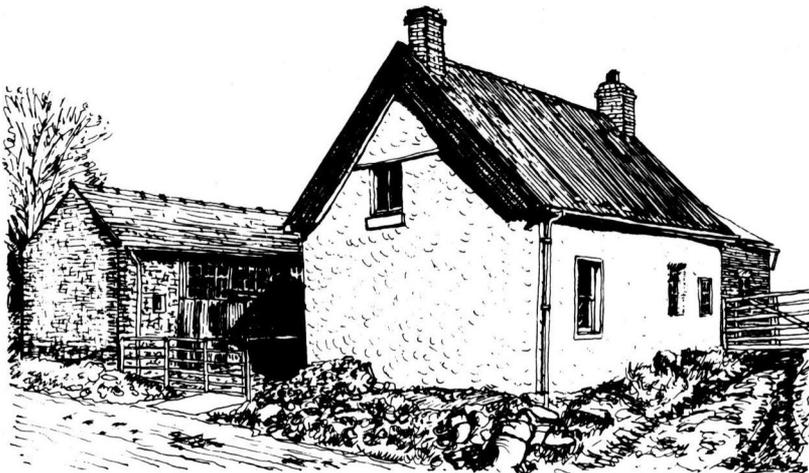
Three small houses all with apparently 'external' cross-passages and either built of, or probably formerly built of, clay. Internal inspection at Monkhill confirmed that the earlier building formerly extended over the cross-passage. The house is cruck-framed and carries an eighteenth-century date-stone. It will be lost within a few years. The upper of the two houses at Burgh-by-Sands is largely now of cobble and stone construction and possesses one very rustic, central, cruck frame. The other Burgh-by-Sands house was not inspected internally but must be, or have been, cruck-framed, as the chimneys lie in the usual position in relation to the ridge. Note the panel in the gable peak above the window: the horizontal line at window-head here must represent the top of the original gable structure, which has been infilled above. The ridge may have been supported by the type of gable crutch described in Part I, or it may have been set back and the end of the roof half-hipped. (The render finish to the walls of the last example is in no way traditional and is greatly to the detriment of the character of the building)

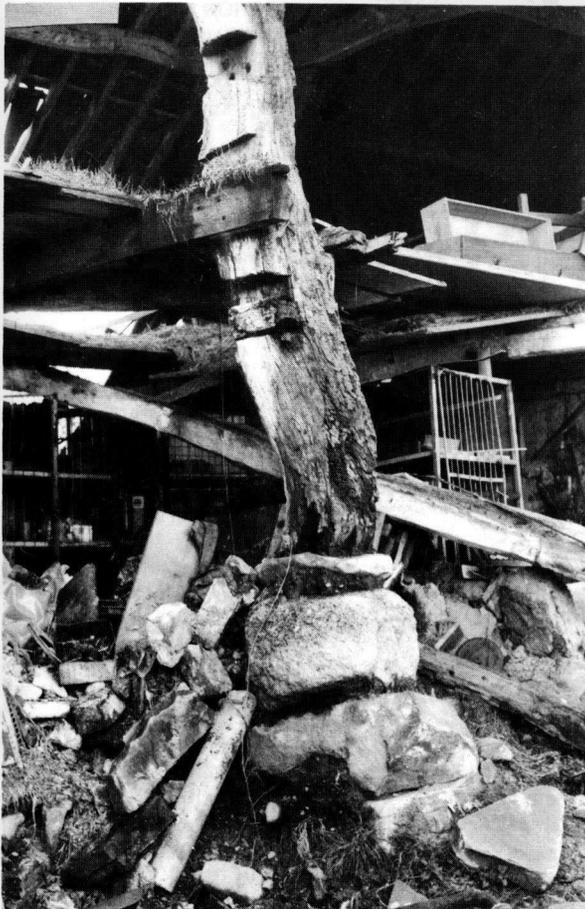
Fig. 16

Moorhouse Barn, 1988, (Grade II*). High plinth beneath cruck foot, exposed when the mud side-wall was allowed to collapse. The remainder of the plinth, between crucks, would have been built up to a similar height

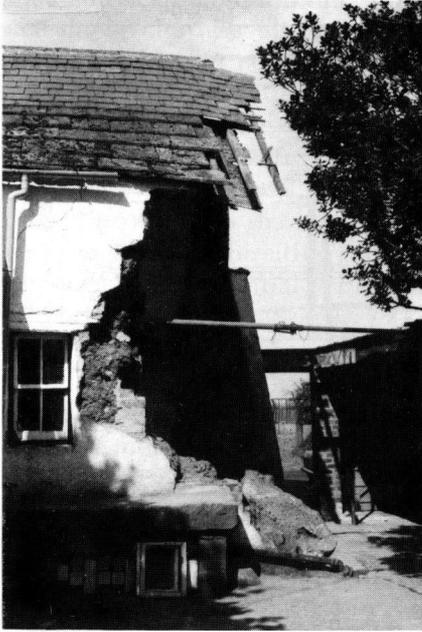
Fig. 20

Vicarage house, Burgh-by-Sands, following the earthquake of the early 1980s. The short bay to the gable is clearly visible, the cruck being between the sash window and the edge of the failed clay. The building has been raised to a slack pitch carrying slate and stone-slab, a very common practice. The *Carlisle Journal* of 14 January 1804 reported a similar, and fatal occurrence, 'On Tuesday evening last, a very shocking accident happened at Caldewcots, or Caldcots, one of the suburbs of this city.—The wife of one David Sinclair, a rope-maker, being unwell, retired to bed rather earlier than usual. The house . . . is built of clay, and divided in the middle by a thin partition wall. About nine o'clock that evening a dreadful noise was heard in the farther part of the dwelling . . . and . . . some of the inhabitants . . . found that the gable end of the cottage had given way, and the whole of that end of the roof had fallen in. Some of the heavy timbers falling upon the woman in bed, bruised her in a most shocking manner, so as to occasion her immediate death. It is supposed that the foundation of the wall had been much decayed, and probably being loosened by the breaking of the frost, the whole had given way . . . The suburb where this cottage is situated is a straggling street of great length, and leads

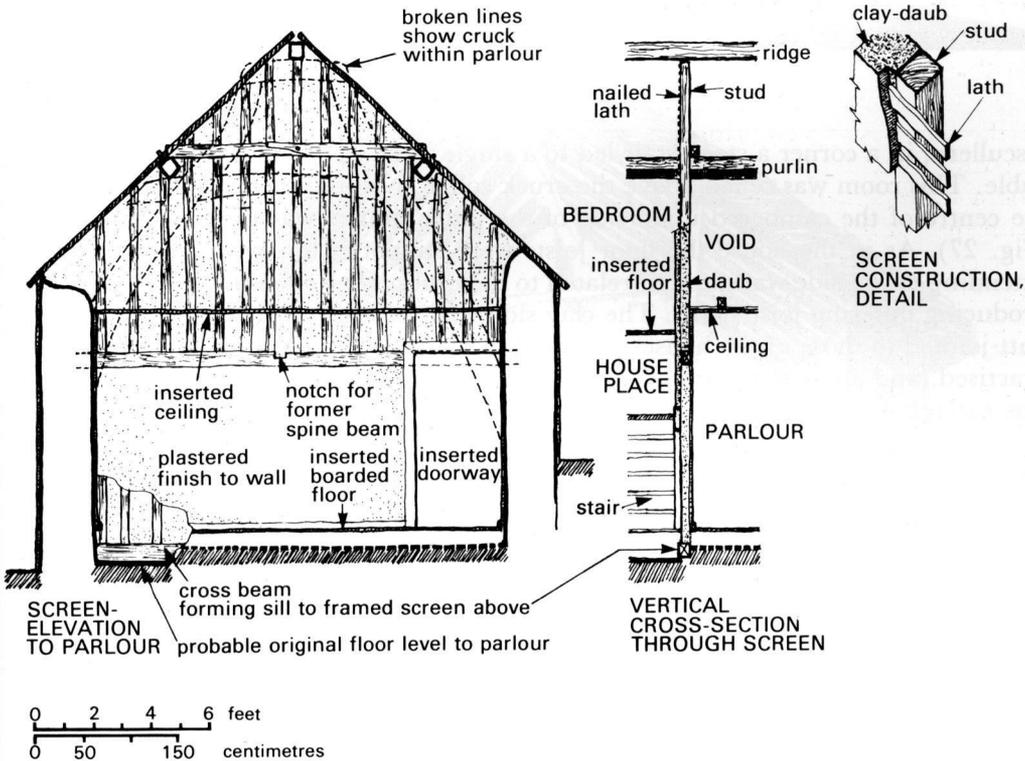
Fig. 24

Details of screen wall between living room and parlour/loft, Lamonby Farm. The use of lathing for the daub might be taken to suggest a relatively late date for the screen.

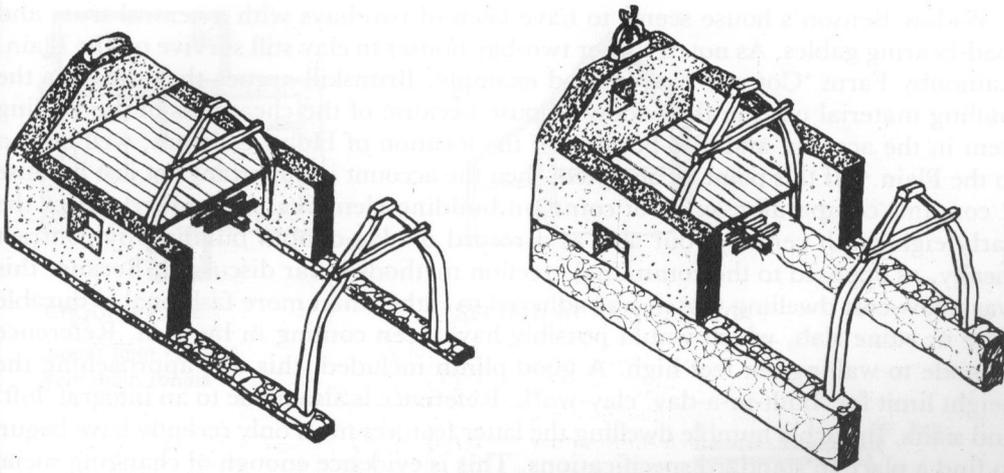
Fig. 28

Structural progression from crucks on low bases to crucks on higher bases, walls above comprising similar amounts of clay-work. Floor joists were supported on spine-beams spanning from gable walls to intermediate partitions. Floor structures were not structurally related to crucks. (Key examples: Ratten Row and White Cottage, Longburgh)

In their original state Lamonby Farm and White Cottage seem to represent the limit to which the local cruck-frame and clay-wall system could be pushed without resorting to larger scale, and therefore unavailable, timber-work, or the taller, and therefore more tricky to construct, clay side-walling (Fig. 28). Constrained as they

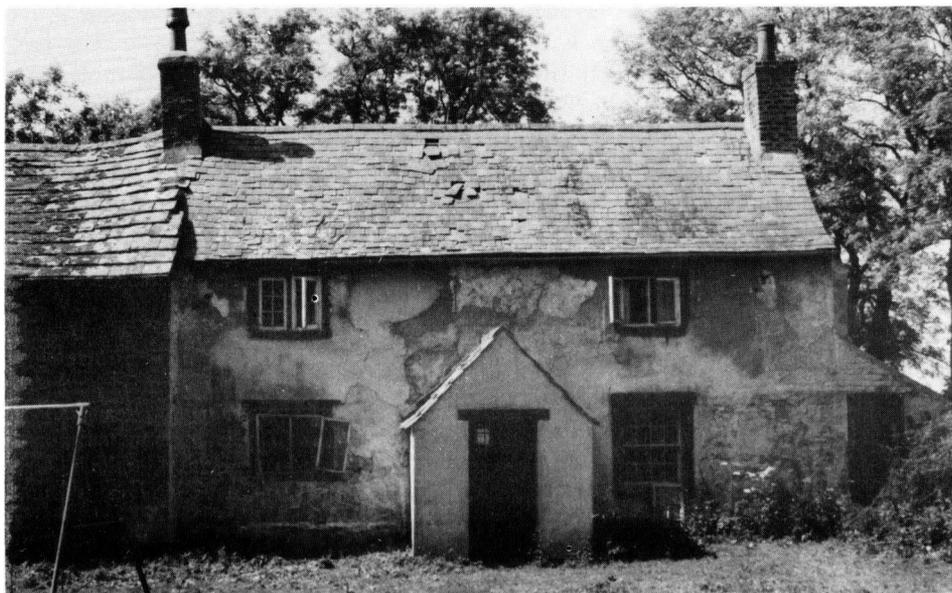
Fig. 30

Plan and section of a house at Kingside Hill, Abbeytown. Stair to upper floor contained in brick-built outshot (early 1980s, prior to refurbishment)

Figures 29 and 30 show the move to a different structural approach under which the first floor was fully integrated into building structure by raising the crucks still higher up the wall. Sometimes, as in figure 30, this development was combined with a double-height, type-plan/section. Brunskill describes this as the 'two-unit' house and dates it in its two-storey form as far back in the region as the cross-passage type, from which it differs radically.²³

Continuous building of tall mud walls, such as those shown in figure 30, may not have been possible. Whether carried out by group or by contract, the erection process would have involved delays while the material hardened sufficiently to accept an upper 'lift'. Modern oral tradition on the Plain has it that clay-work was 'rested' at intervals during construction. Of the quick method there seems to be no memory.

Figures 30 and 31 show a little house at Kingside Hill, Abbeytown, brought to the author's attention by Mr Blackshaw, conservation officer for Allerdale District Council, in 1982. One gable adjoined an 'in line' barn, the other was free-standing. The walls were thicker than in many other, lower, dwellings. The crucks were raised up on the ends of tie-beams which also supported the timbers of the first floor. The internal partition between 'best room' and living room was non-load-bearing, the entire roof load being taken by the crucks and the thick mud gables. There was a disproportionately tall first floor, perhaps produced by the desire to use crucks giving good head-room close to the side walls. The crucks were at quite close, if unequal, centres with wide bays to each end. The best room possessed a bolection-moulded fireplace surround, an up-to-date feature in early eighteenth-century Cumberland. The kitchen, by contrast, must originally have been equipped with a fire-hood. A vestigial heck-screen wall, in a now inappropriate position, was thus required in order that the flue here would be set clear of the ridge. From its roof-pitch and single purlins it is clear that the building was originally intended for thatch, though it had subsequently been roofed with thin slates. It could thus be a relatively early example of its type, perhaps dating from before the introduction of the heavy stone roofing-slab in the region. Of this, however, we cannot be certain since thatch probably

Lastly, in a two-unit house at Kelsick (Fig. 35), now destroyed, the hybrid structure of cruck metamorphosing into triangulated frame (Figs 30 and 32) disappears altogether and is replaced by the simplest of trusses comprising two low-pitched and rough principal rafters connected at first-floor ceiling level by a tie. Mud walls raised to two full storeys support the roof timbers—the first occasion in any of the examples so far considered where this occurs (Fig. 36). As with the other two-unit cases described, this house was attached at one end to a range of farm buildings, one roof-truss being positioned quite close to the ‘freestanding’ mud gable. A series of floor-beams and a nine-inch thick load-bearing mud partition-wall supported the first floor. There were two chambers above, and the rear outshot, again for the first time in the examples considered, appeared to be of one build with the main house. Its walls were also of clay. Many features about it suggested a nineteenth-century building date and the generally skimpy nature of the timber used throughout was in contrast to the usually ‘adequate’ scantlings of the carpentry elsewhere on the Plain. An alternative interpretation of the evidence here is however possible. The ground floor of the house may have dated from an earlier period, the walls being subsequently raised, crucks removed and the outshot added. The existence in the front ground-floor elevation of a stone window-surround of considerable quality and a stone door-surround (see Part I, figure 17) with a colossal lintel, could be taken to lend weight to this view. Whatever the history of its development, the Kelsick house confirms the persistence of the ridge-beam theory—the ridge-beam remains, supported in the ‘V’ formed by the crossing of the ends of the truss principals.

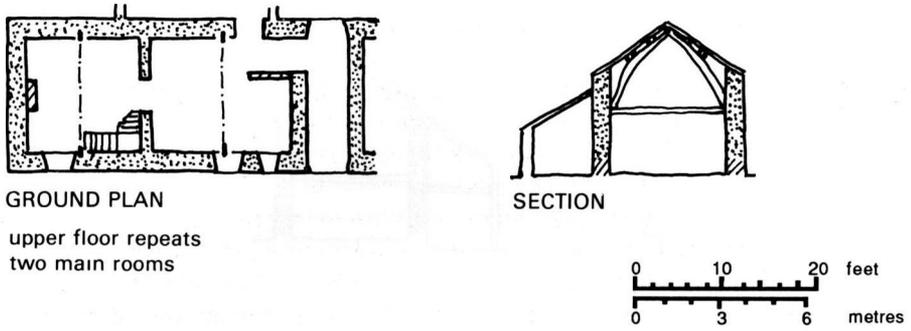
Fig. 32

Plan and section of cross-passage house at Aikhead Hall recorded by Dr R.W. Brunskill

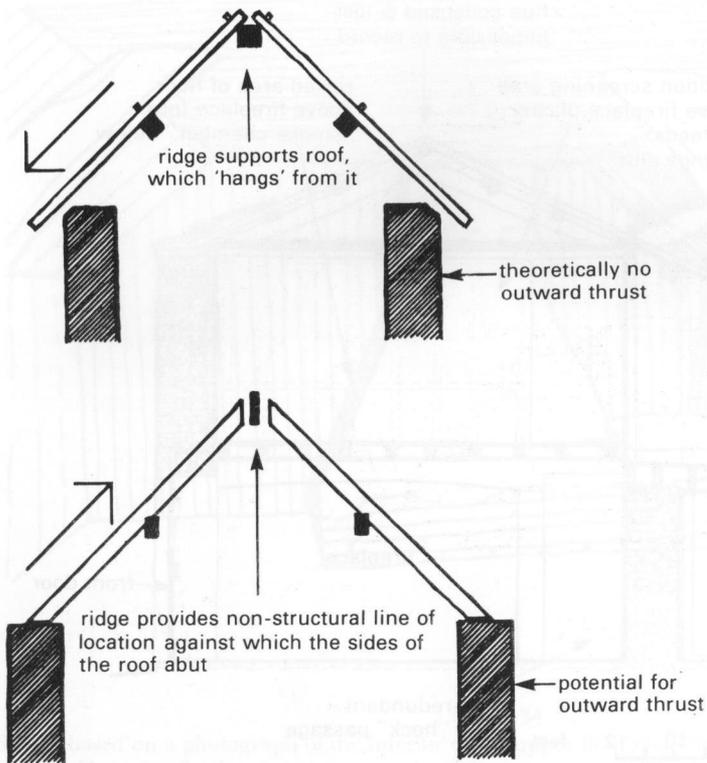
Fig. 37
Diagrams illustrating
ridge-beam and ridge-
board roof-support
systems

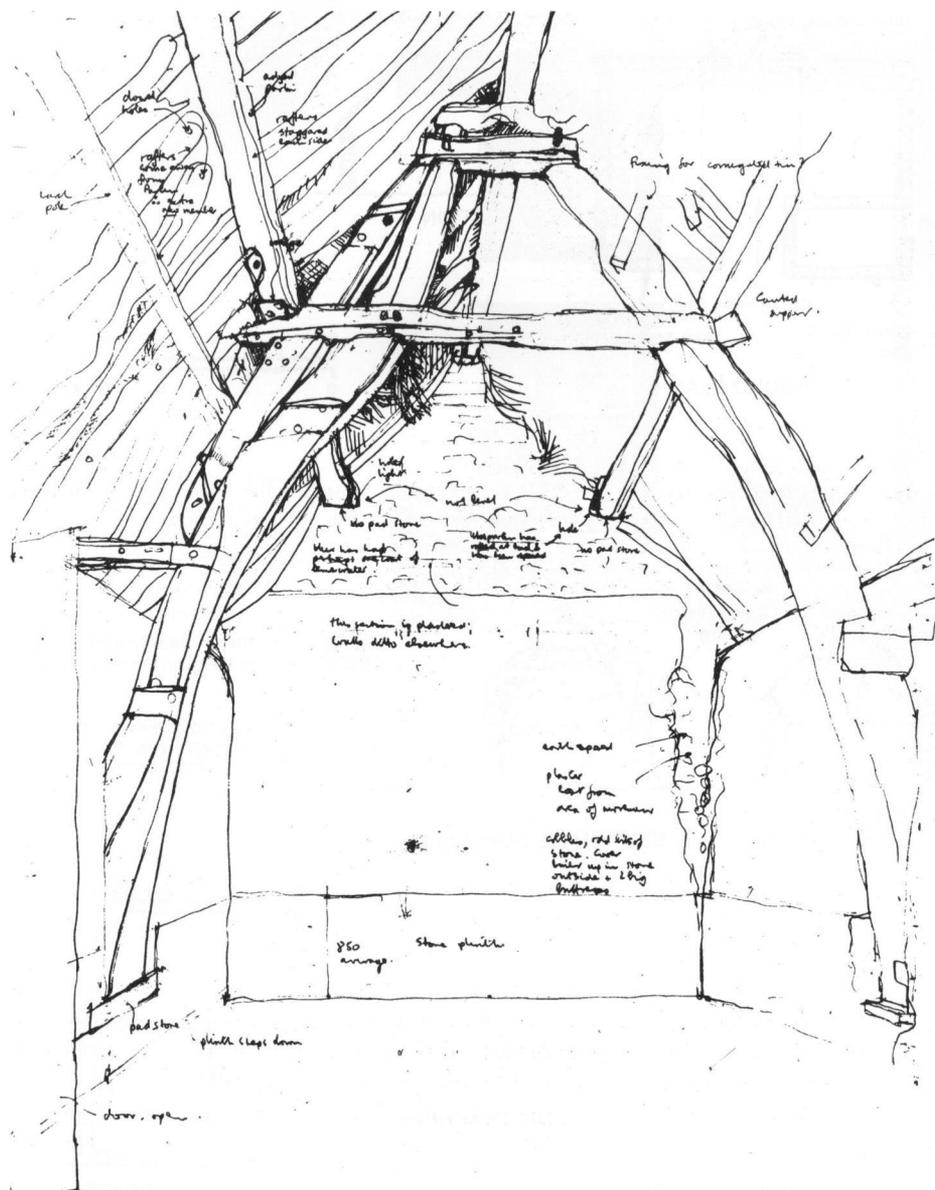
Fig. 38

Interior of a three-bay threshing barn, Green Lanes, Dalston, 1979. Probably the last building on the Plain with its 'thatch-over-sods' roofing exposed to the elements. The roof was intact and still shedding water satisfactorily at the time of survey although seeds were beginning to germinate in it. In the ten years since the survey, the thatch has been allowed to fail, and the building is now a roofless ruin (1988). The survival of this roof, fully staple-thatched in the traditional way, into the early 1980s is evidence of just how much longer an understanding of the thatching method persisted on the Plain, when compared to an understanding of the framing and walling methods

Figure 38 shows the interior of a small barn near Dalston-on-the-Plain, now roofless and derelict. In 1980 the roof was of sod underthatch with a straw overcoat in the usual way and there were two crucks, each spaced a full bay from the mud gables. The latter had survived though the usual failure at the corner was visible. This may have been a late building, judging by the wide end-bays, by the nature of the cruck trusses and the fact that there was worked sandstone in the plinth. The crucks had been cobbled together, from all sorts of bits and pieces of other trusses, to an unusual degree. The raftering was very variable in quality but of an identical system to that at Lamonby Farm. Plan and section of this barn are shown in figure 39. In its framing, such work represents the demise of the tradition.

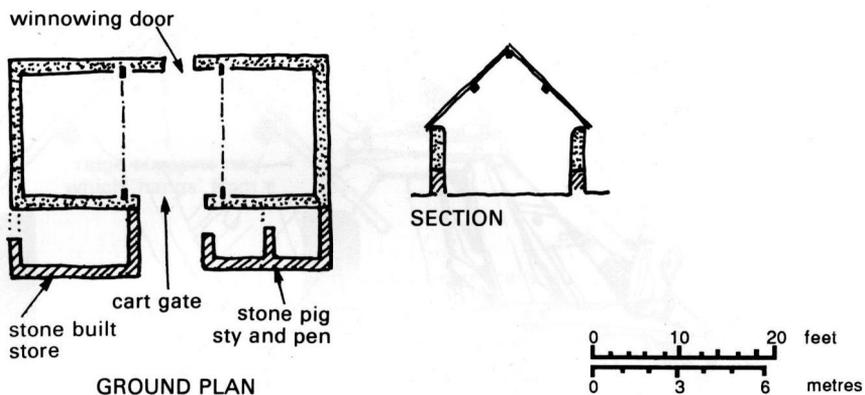
Fig. 39

Plan and section of threshing barn at Green Lanes, Dalston, now derelict. Note the attached pigsty and pen (as well as lean-to store), in stone, for obvious reasons

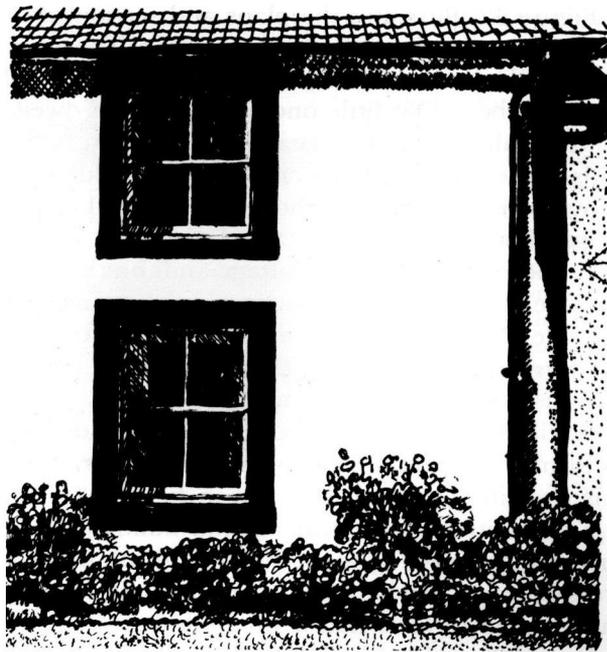
Fig. 41

Part of a house at Great Orton, 1988. The lower, original, clay section of wall shows as a bulge to the right of the drawing and is also reflected in the position of the cill of the upper window which rests on top of it

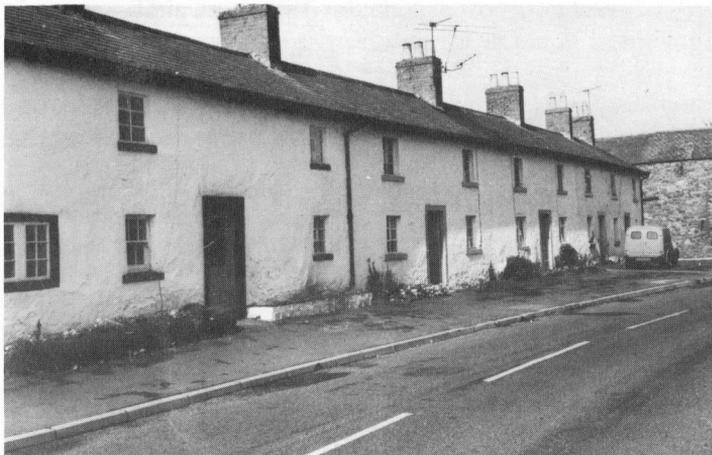
Fig. 43
Terrace of small dwellings in Burgh-by-Sands converted from a former clay statesman house and other attached outbuildings. The original statesman house is on left of the picture, the first door being that of the former cross-passage. The fire-window to the left of this door has been enlarged but the window on the far left, ground floor, belongs to the earlier phase. The raising of this building is visible externally at the rear throughout its length, confirming a former structure of considerable size (1980)

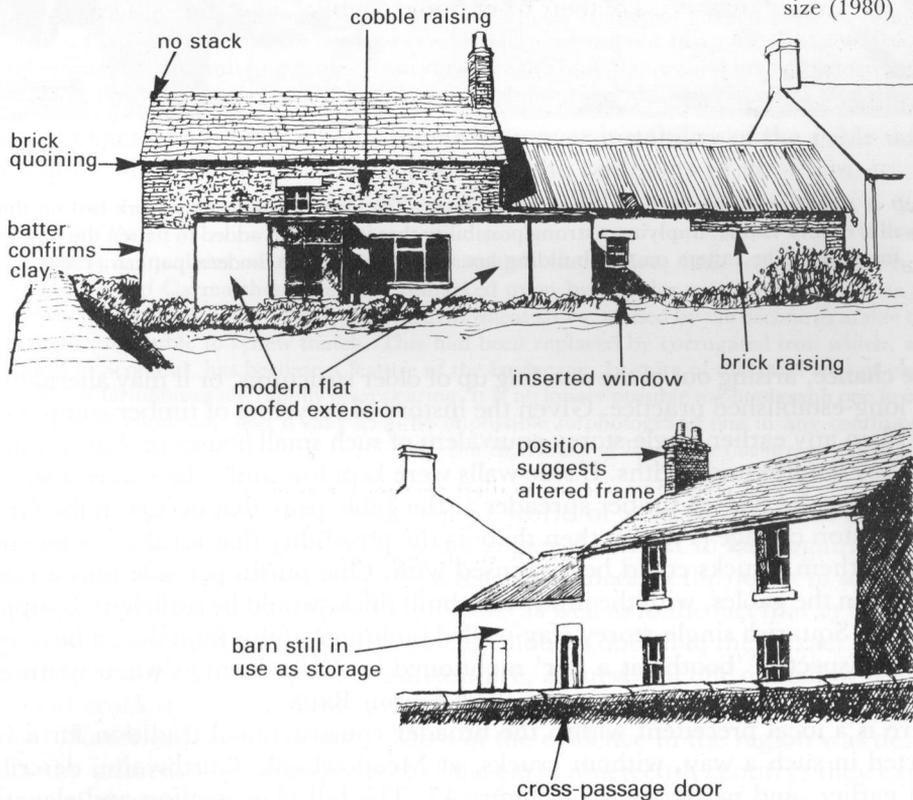
Fig. 44

Front and rear of a former statesman house with attached outbuilding, Great Orton. The 'parlour' end appears never to have been heated (1988)

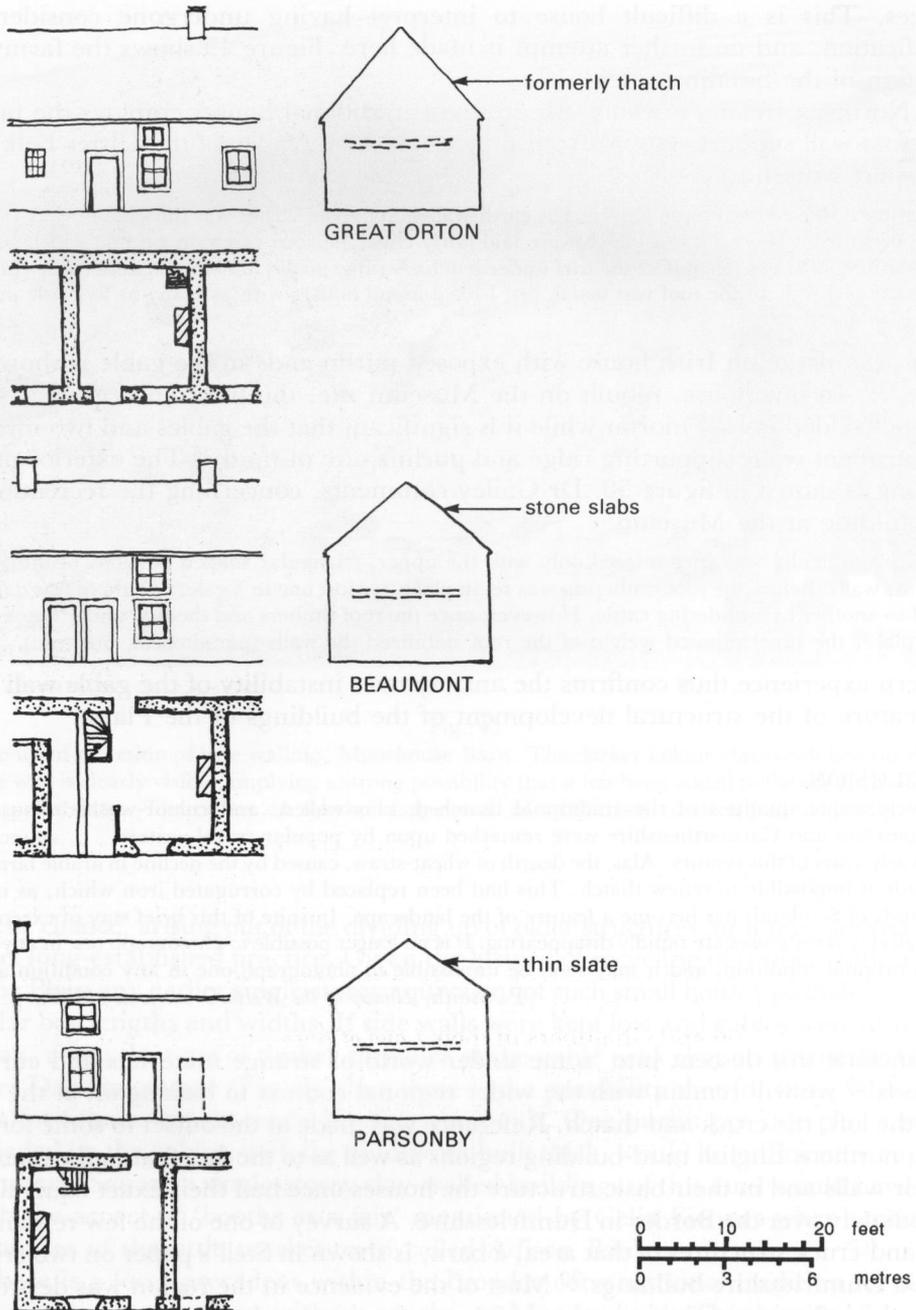
Fig. 46

Three examples of small units on the Plain, recorded by Dr Brunskill and reproduced with his permission. The cottage at Parsonby must have been stone-walled and rendered

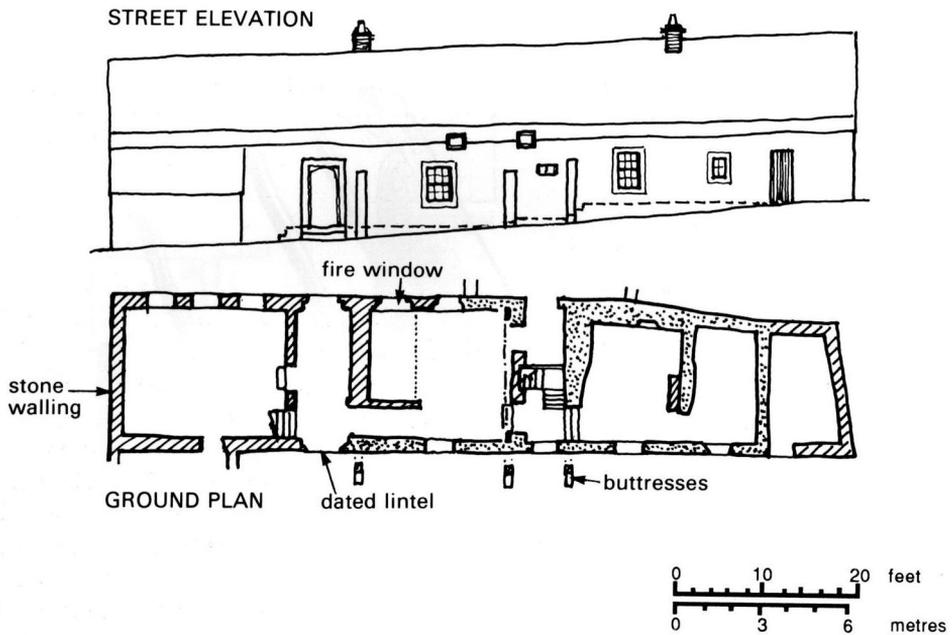
Fig. 48
Meadowbank Farm, Curthwaite, ground-floor plan and elevation to street.

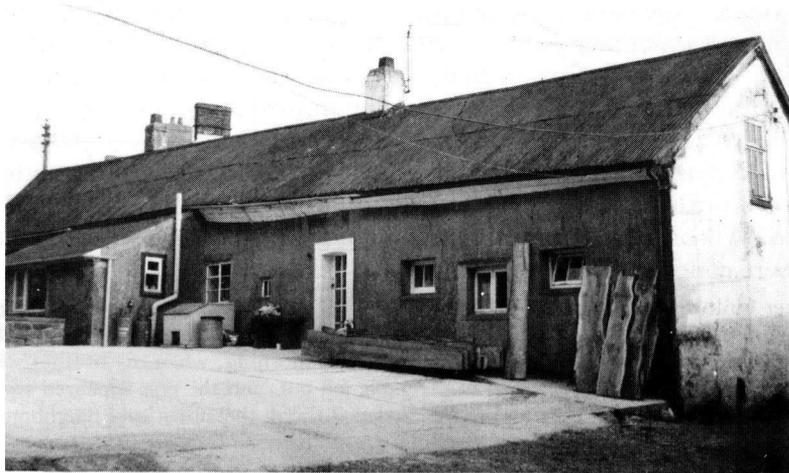
Fig. 49
Meadowbank Farm, Curthwaite, viewed from former farmyard. All the walling up as far as the outshot is of stone. This was once the entrance side of the building since it possesses the (minute) fire-window. The late seventeenth-century date-stone has perhaps been re-sited as it is over the cross-passage door facing the street; alternatively it may commemorate the point at which the house was modernized

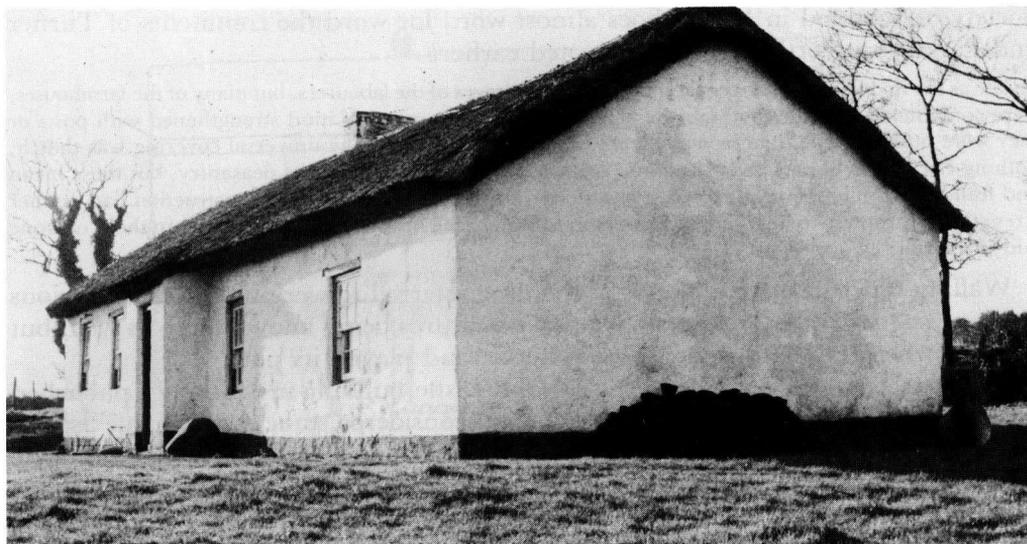
Fig. 50

Mud and stone weaver's house, Ulster Folk and Transport Museum, Holywood, Co. Down
Ulster Folk and Transport Museum

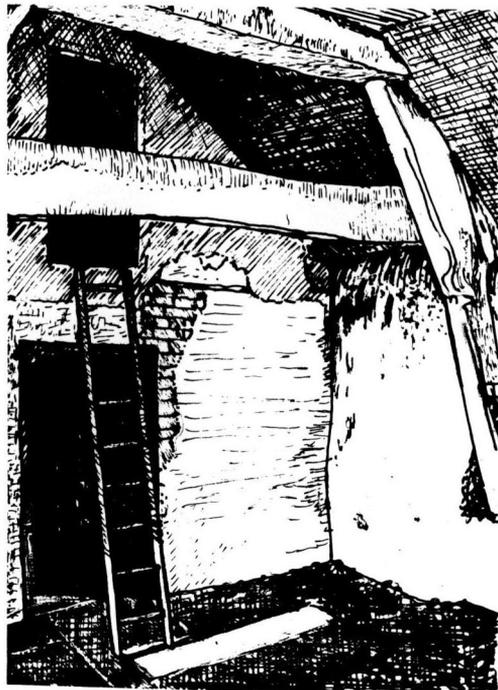
Fig. 54 (Below)

'Highland couples' at Cusig, Applecross, Ross-shire, 1971, crucks jointed at the elbows. The basic method was formerly known in Northumberland, is found in South Wales and in high quality Devon and Somerset work, as well as having been recorded in Northern Ireland.

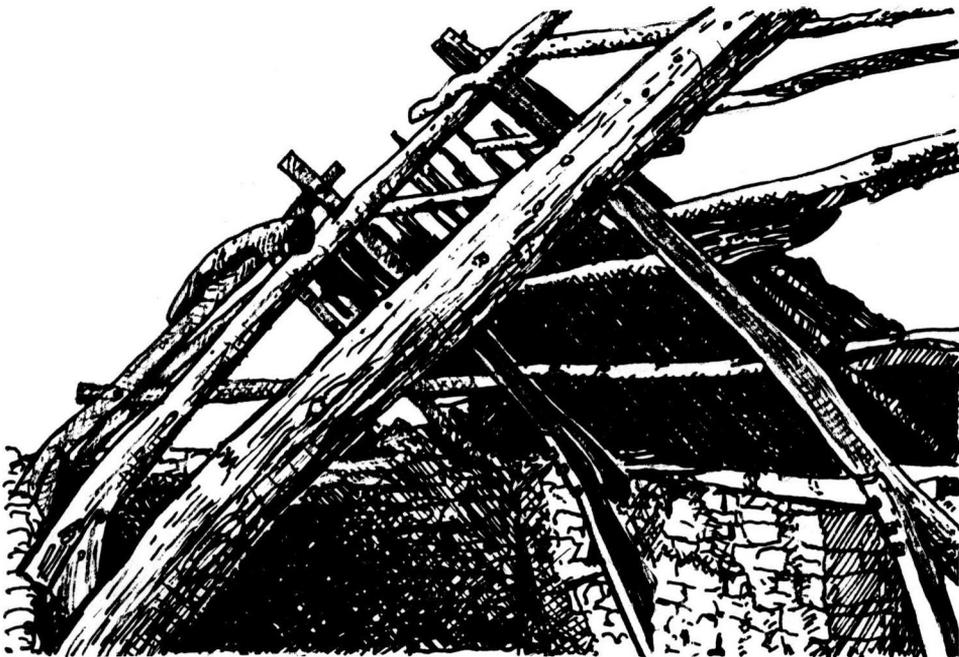
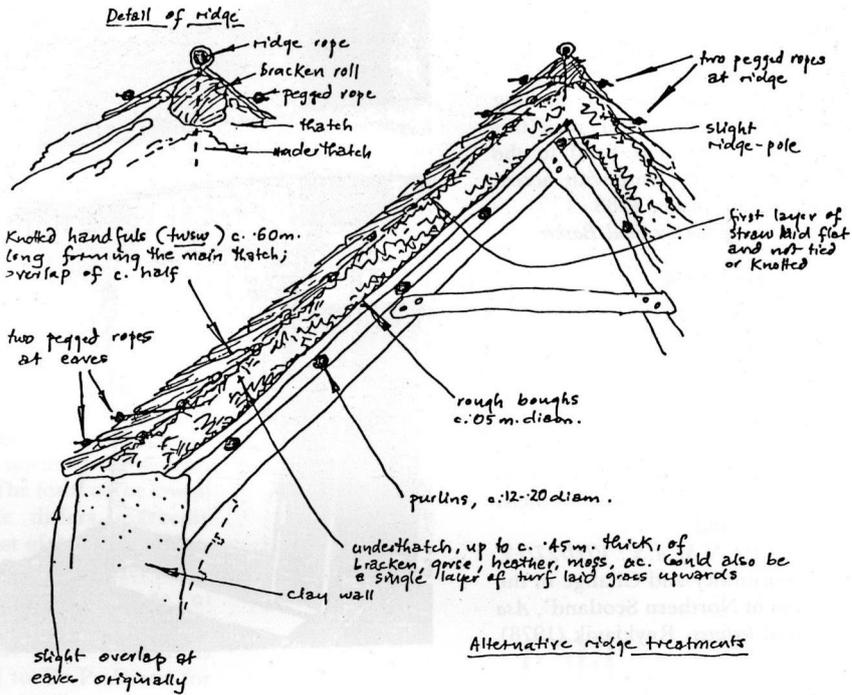
Cardiganshire Thatch: Sketch Sections

Alternative ridge treatments

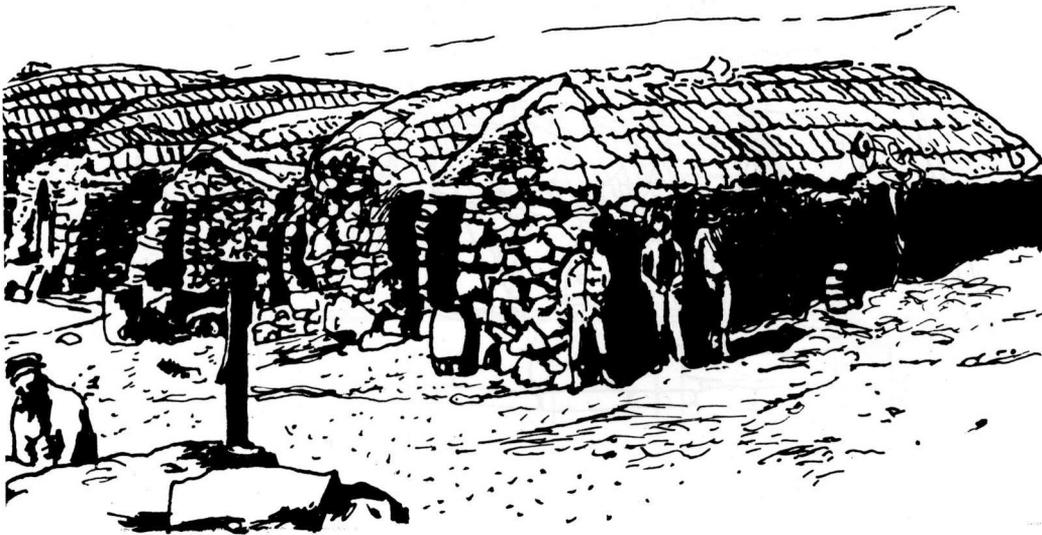
Fig. 56

Exposed turves on the roofs of fishermen's huts, Stenness, Shetland, after a photograph (National Museum of Antiquities of Scotland, iii/44/34) in Fenton and Walker, *The Rural Architecture of Scotland* (1981)

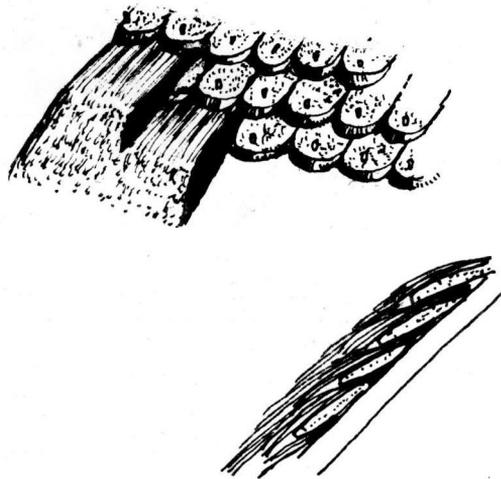
Fig. 57

Highland 'scalped' and pinned sod underthatch after Grant, *Highland Folkways*

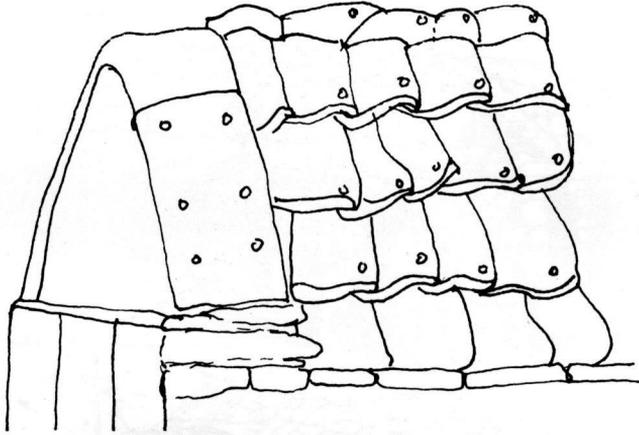
Fig. 58

Shetland. Pegged sods or divots, laid like pantiles, with pinned divot gable copings, based on illustration, from Roussel A, *Norse Building Construction in the Scottish Islands* (1934), p. 65

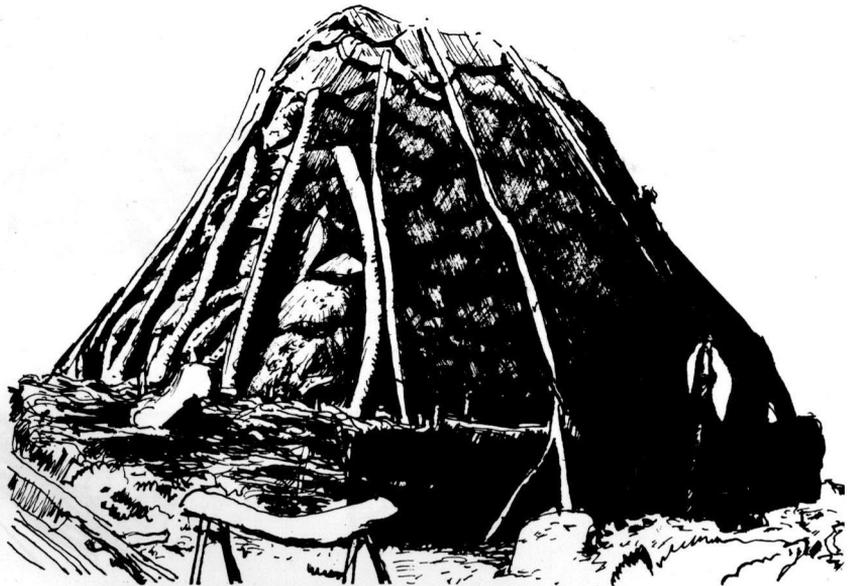
Fig. 59

High Furness Cumbria. Charcoal burner's hut after a photograph in Innocent, C.F. *Development of English Building Construction* (1916). Walls of earth rammed between permanent wattle shuttering. Roofing of sods held in place by sticks

which the fibre overcoat with relatively thin sod or other material as support, was seen as the only 'correct' way to cover a roof. If as in Shetland, overcoating material was unavailable, then there was no choice but to expose the weaker undercoat (Figs 58, 59). The minds of the builders allowed no amendment of the basic system. As noted earlier, over much of Ireland—and incidentally the Isle of Man—yet another established method ruled—the 'long-sod' base, laid grass-side out to support fibre over-coating. Exposed, living long-sod was used on the roofs of Icelandic houses, so here there is the possibility of a marriage between recent mainland British 'overcoating' and recent Scandinavian sod-roofing practice, a marriage at the back of which may also lie echoes of earlier transhumant practice (Fig. 60).⁵⁰

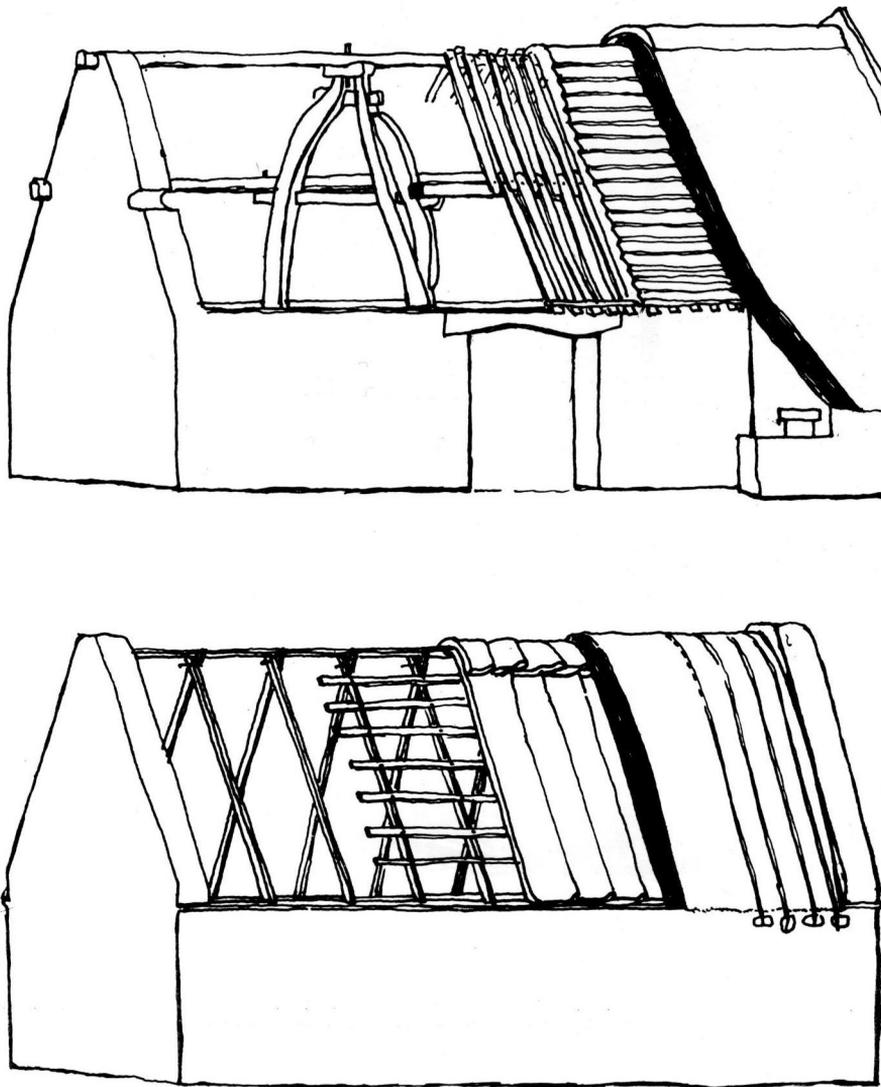
Fig. 60

Cumbrian and Irish thatch roofing systems. Cumberland—rafters support sods ('divot') laid like tiles beneath which the thatch is thrust. Ireland—laths/purlins support 'long sods' lapped at joints and at ridge, into which thatch is sewn and over which it may be held down with ropes. Sketch derived from various sources. Long sods were known recently in Britain also
