Some Clay Dabbins in Cumberland: their Construction and Form Part II

J.R. HARRISON

This paper, of which Part I was published in Transactions, 33 (1989), summarizes the results of field studies of a number of cruck-framed and clay-walled houses on the Solway Plain in Cumbria, undertaken between 1979 and 1982. Part II presents a number of individual case-studies of building plan and section and considers the way these changed with time. It concludes with a brief survey of the wider structural, material and plan-form context of the tradition.

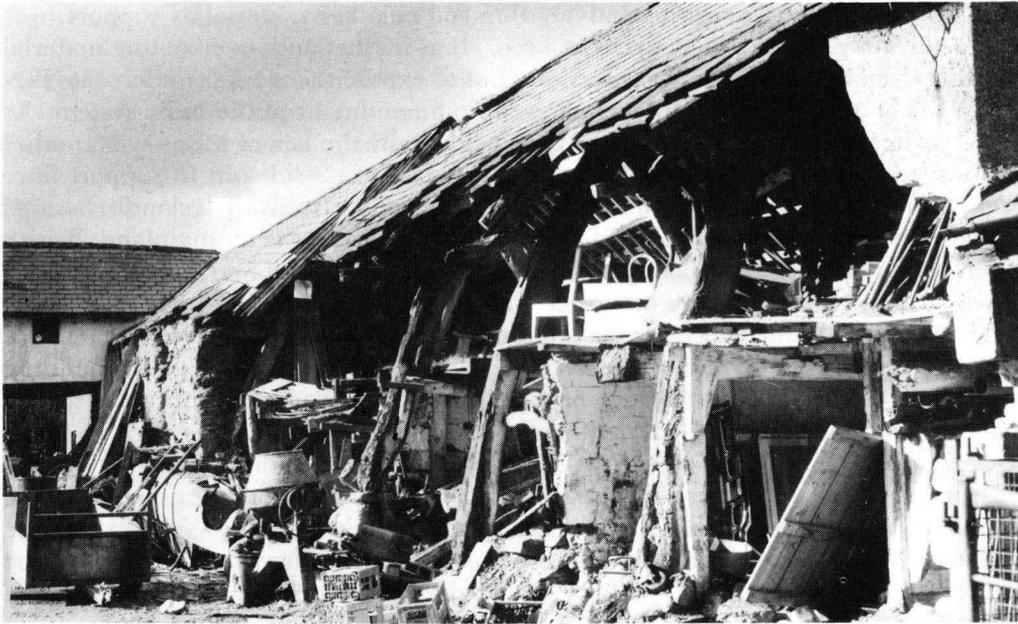
Fig. 62

Moorhouse barn, 1988, close-up of farmyard elevation. The substantial abutting clay farmhouse, a section of which is visible as a 'fly over' with passage beneath on the left of the photograph, was at that time pronounced unsafe and was to be demolished entirely. The frame of the barn may survive
