Keeping Pigeons in Parish Churches

FRANK PEXTON *and* JOHN McCANN

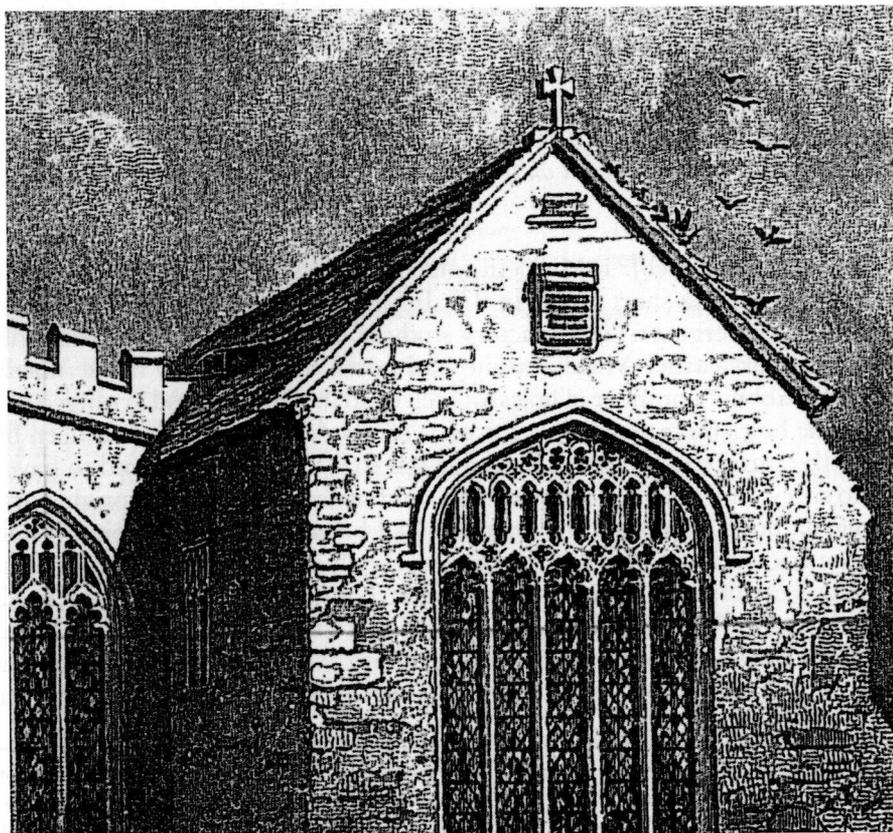
Fig. 1

Marlborough, Wiltshire. The east gable before 'restoration'. An enlarged section of plate 1, from J. P. Kneale and J. Le Keux, *The most interesting Views of Collegiate and Parochial Churches*, 2, London, 1824.

Marlborough (Fig. 1), designed to admit the pigeons while keeping out the larger birds of prey, but no evidence of it remains. The remainder of this wall and the whole of the other three walls are occupied by nest-holes in chequer pattern without alighting ledges (Fig. 7, 8 and 9). Some nest-holes have been destroyed or blocked by a brick stitch executed to repair a crack in the north wall, others for the insertion of a steel bell-frame above. Some are obstructed by a large clock mechanism installed in 1871, but 181 of the original 258 nest-holes are still present and in good order. A more detailed report was published in *Wiltshire Archaeological and Natural History Magazine* in 2009.¹⁵

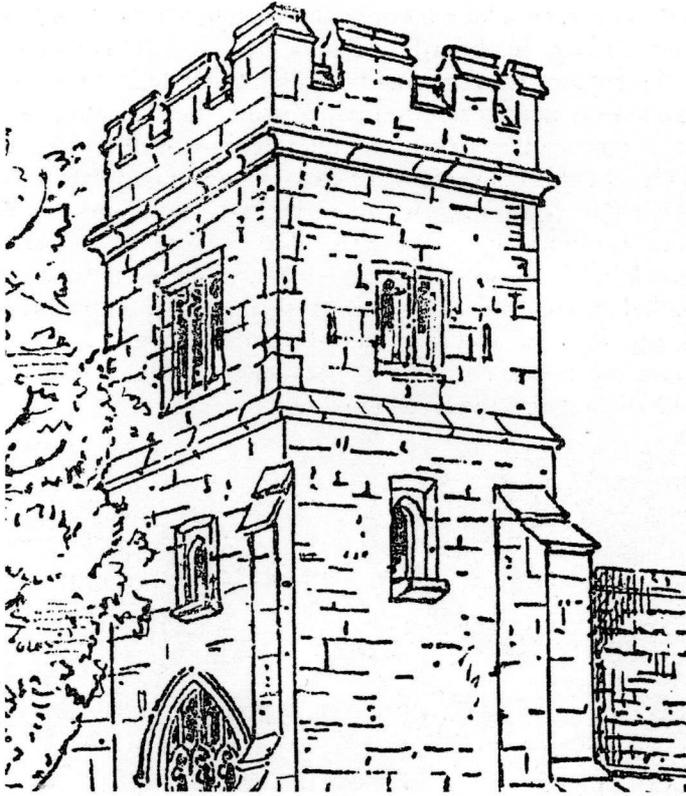
Fig. 2

Birlingham, Worcestershire. An enlarged part of the parish church tower, c.1818, from J. T. Micklethwaite, 'On pigeon houses in churches', *Archaeological Journal*, 45, 1888, 377.

Of the church at Birlingham, Worcestershire, he quoted a description of the middle stage of the west tower: 'Internally the walls are chequered with square recesses for the birds to nest in, such as are found in any old dovecote'. He reproduced an illustration of c.1818 which showed that 'on the south and west sides are arched loops with projecting shelves or sills below them for the birds to alight on' (Fig. 2).⁷ He quoted a description of a similar pigeon loft in the west tower of Collingham [*sic*] Ducis church in Wiltshire: 'A window or rather opening with a sill on which the birds might alight is still preserved'.⁸

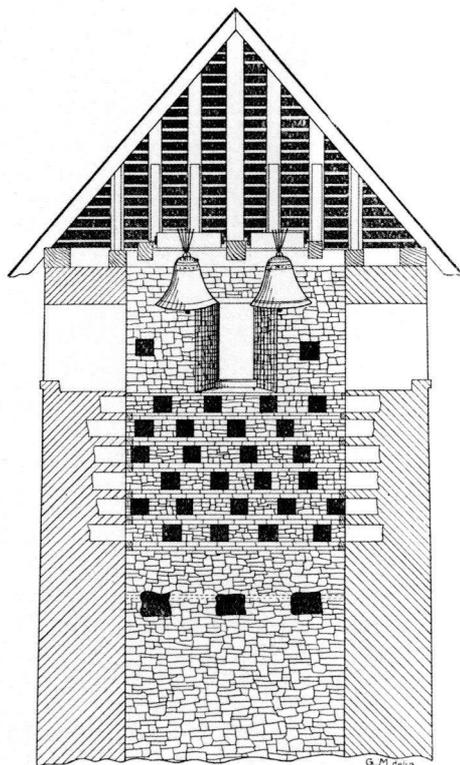
Fig. 4

Sarnesfield, Herefordshire. George Marshall's measured drawing of the nest-holes in the west tower. From *Transactions of the Woolhope Naturalists' Field Club*, 1904, 264.
By courtesy of the Editor

The study of pigeon lofts in churches, or *columbaria*, as they are better called, was extended by George Marshall in 1903. He found nest-holes for pigeons high in the thirteenth-century west tower of Sarnesfield parish church, Herefordshire (Fig. 3), and concluded that they were part of the original fabric. There were 106 nest-holes 6 in. square and 15-18 in. deep in regular tiers, which entered the walls at an angle, widening out at the rear, with an alighting ledge below each tier (Fig. 4). The nest-holes are in the middle stage of a three-stage tower, 8 ft square internally, with a window of two lights

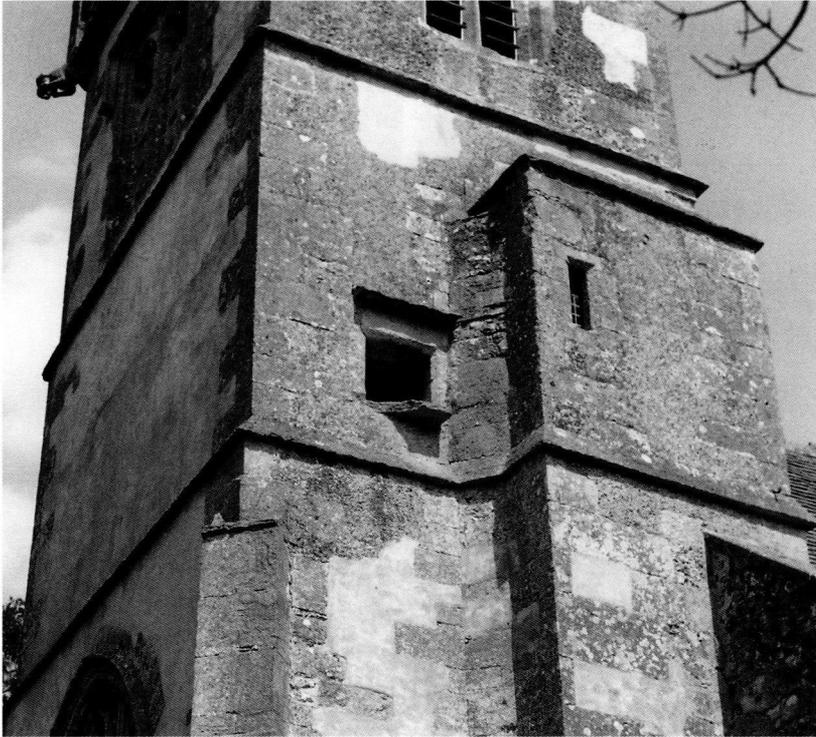
Fig. 6

Collingbourne Ducis, Wiltshire. The second stage of the west tower, showing at right the stair turret to the columbarium, and in the middle the flight hole for the pigeons, with a broken ledge on which they could alight. The same aperture served for removing accumulations of pigeon dung.

This is the most complete and datable columbarium found. At the church of St Andrew it occupies the middle stage of the west tower (Fig. 6), which C. E. Ponting dated to c.1480.¹⁴ It is entered by a doorway with a four-centred arch from a winding stair in a turret against the south elevation (Fig. 7). Also in the south elevation is an aperture 3 ft square at knee height which served both as the flight hole through which the pigeons entered, and as the chute through which accumulations of droppings could be shovelled out, to be collected on the ground for use as fertilizer. In use it would have been protected by a removable wooden frame with parallel slats at six-inch intervals, as at

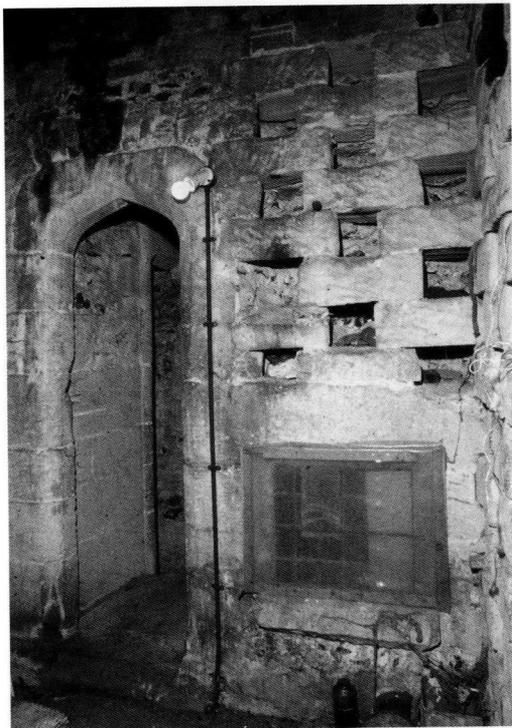
Fig. 7

Collingbourne Ducis, Wiltshire. The south side of the columbarium. The flight hole at lower right is angled so that it emerges clear of the stair turret.

Since it passed out of use it has been glazed in twenty-four lights, and is additionally protected by heavy gauge polythene. Note the broach stops on the jambs of the doorway.

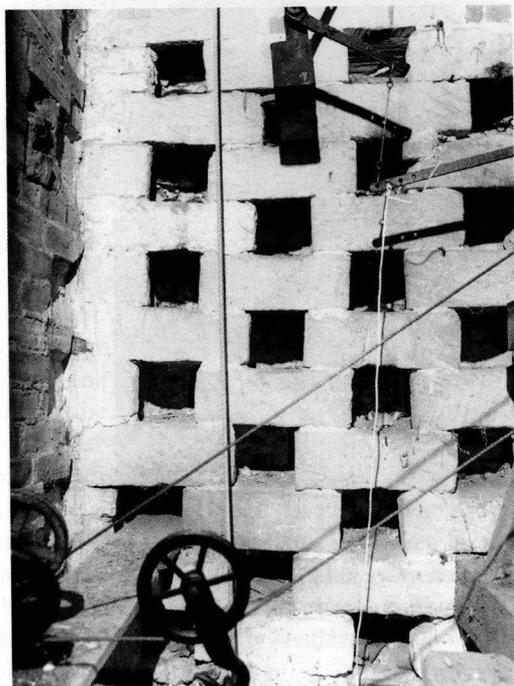
Fig. 8

Collingbourne Ducis, Wiltshire. The south-west corner of the columbarium, with the late Frank Pexton. The timber at the bottom supports the clock installed in 1871. Some nest-holes at the top have been blocked to support a steel bell-frame.

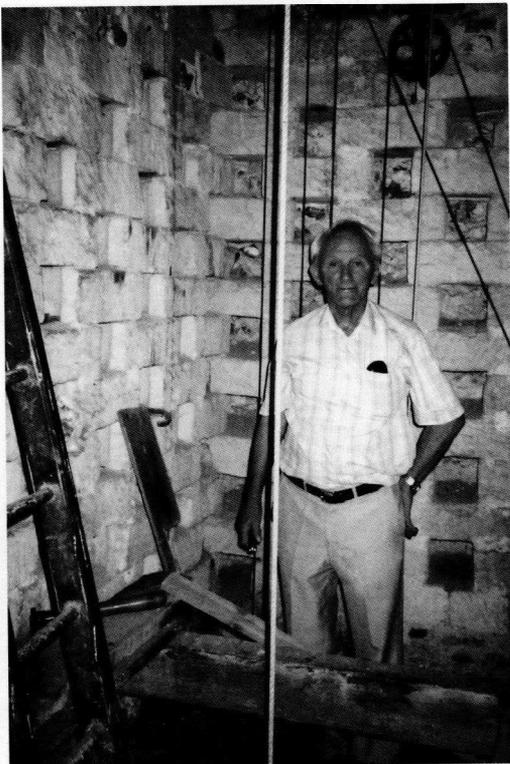
Fig. 9

Collingbourne Ducis, Wiltshire. The north-east corner of the columbarium, to north of the clock, of which the pulleys and rope are part. The brick stitch can be seen at left.

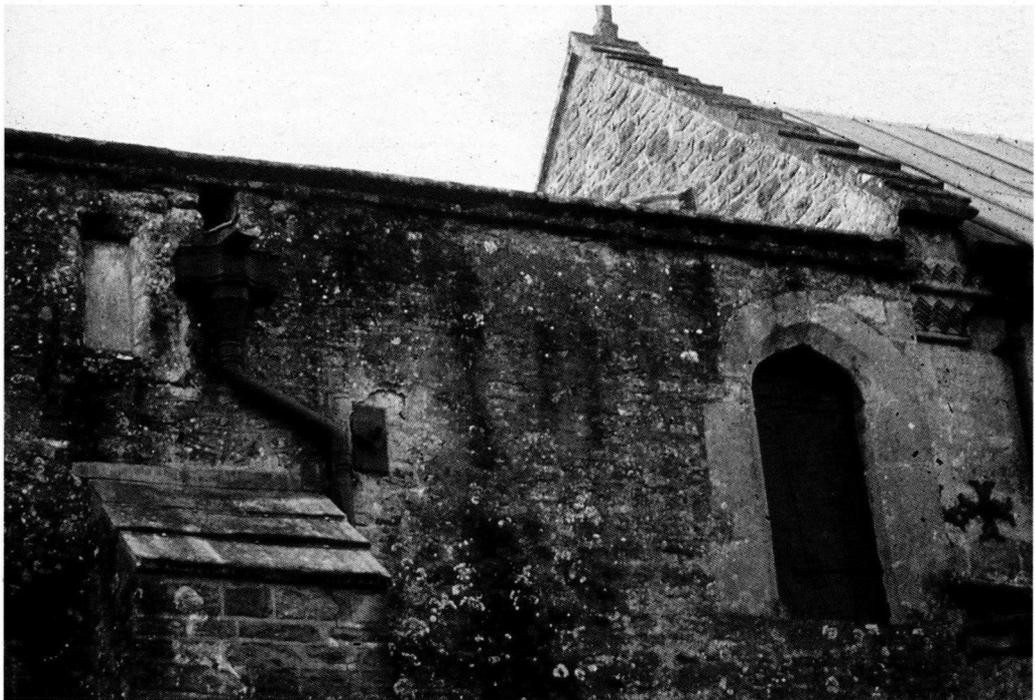
Fig. 10

Compton Martin, Somerset. The upper north wall above the chancel. At right, the door to the columbarium, accessible only by ladder. To the left of the rainwater head is an original flight hole, also used for removing accumulations of pigeon dung, now blocked. There is a similar blocked aperture in the south wall, now inside a later roof.

The existence of a columbarium above the chancel of the church of St Michael and All Angels was noted briefly by F. Bligh Bond in 1909 and by Ethelbert Horne in 1936, but it was not described or illustrated.¹⁶ In the fifteenth century the walls of the Norman chancel were extended upwards to incorporate nest-holes, and covered by an almost flat roof. In the north elevation the low doorway with a four-centred arch is still present, 14 ft above ground, accessible only by ladder (Fig. 10). There were identical rectangular

apertures in the north and south walls, serving as flight holes for the pigeons and for the removal of their droppings. They are now blocked on the inside, but are still visible outside; the southern one is now enclosed by a later roof. Eighty nest-holes 6 in. square without alighting ledges are still present in the north and south walls (Fig. 11). The east and west walls were rebuilt in the nineteenth century, but if they formerly contained nest-holes the total would have been about 130-40. There is no floor other than the upper surface of the chancel vault, with barely 6 ft of headroom to the roof.

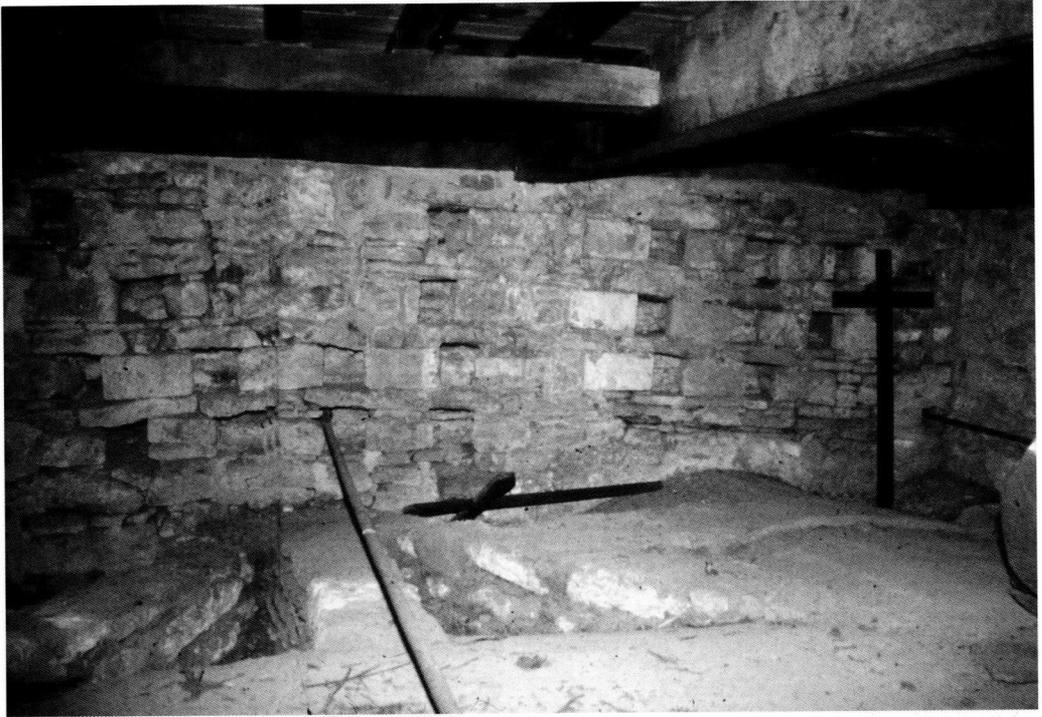
Fig. 11

Compton Martin, Somerset. The south wall of the columbarium.

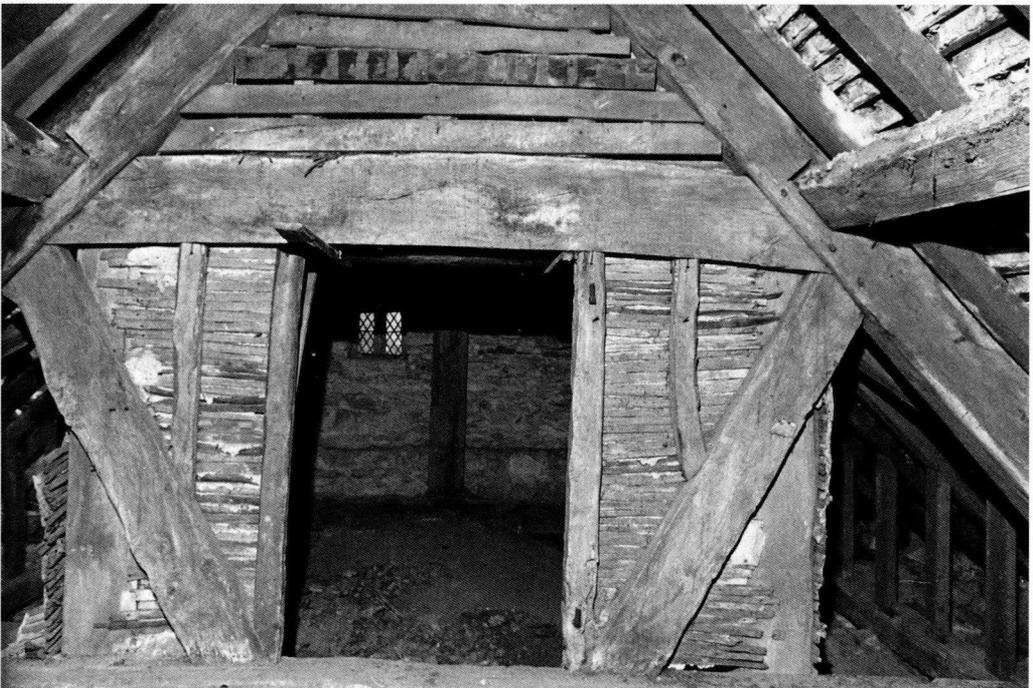
Fig. 12

Overbury, Worcestershire. The entrance to the columbarium constructed of laths and plaster, from above the west vault of the chancel. It is 4 ft 3 ins high by 3 ft 2 ins wide, with pintle hinges in the right jamb for a door opening outwards, now missing.

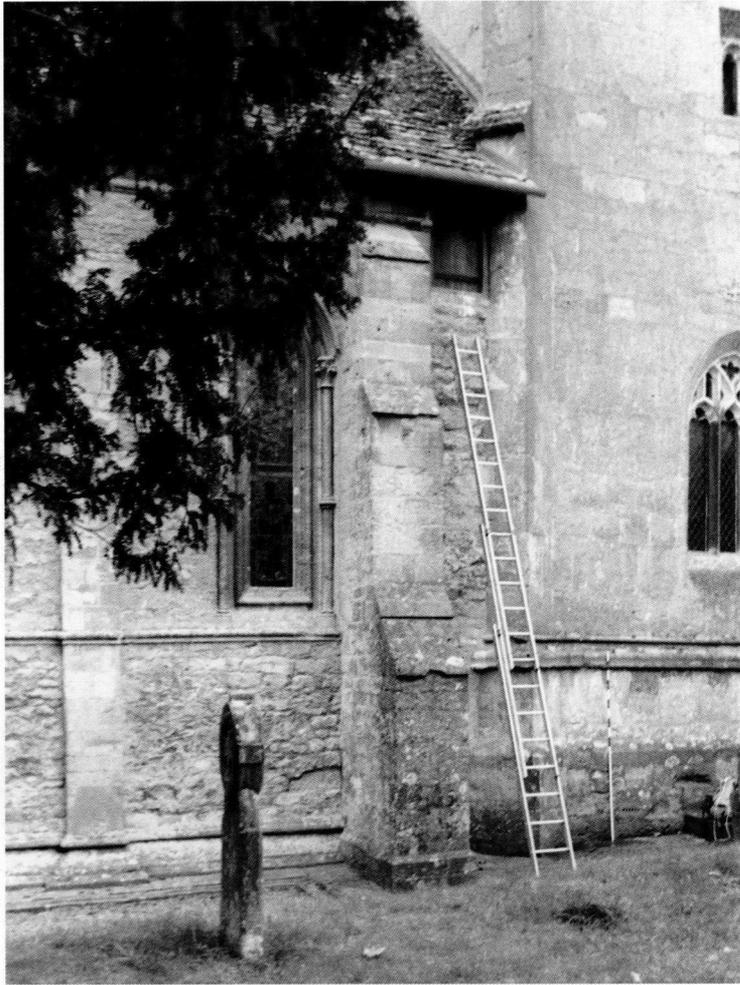
Fig. 13

Overbury, Worcestershire. The doorway high in the north wall of the chancel, the only access to the columbarium. Two-metre scale at bottom right.

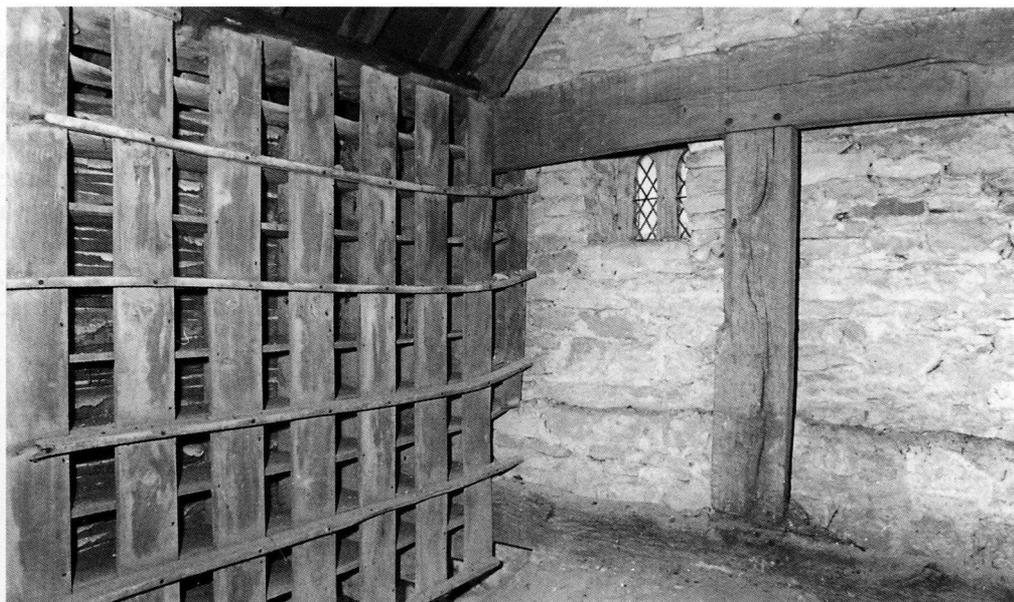
Fig. 14

Overbury, Worcestershire. The north-east corner of the columbarium. The wooden nest-boxes against the north wall are hung from the purlin, unsupported below. The east window is placed asymmetrically to avoid the vertical timber of the roof structure.

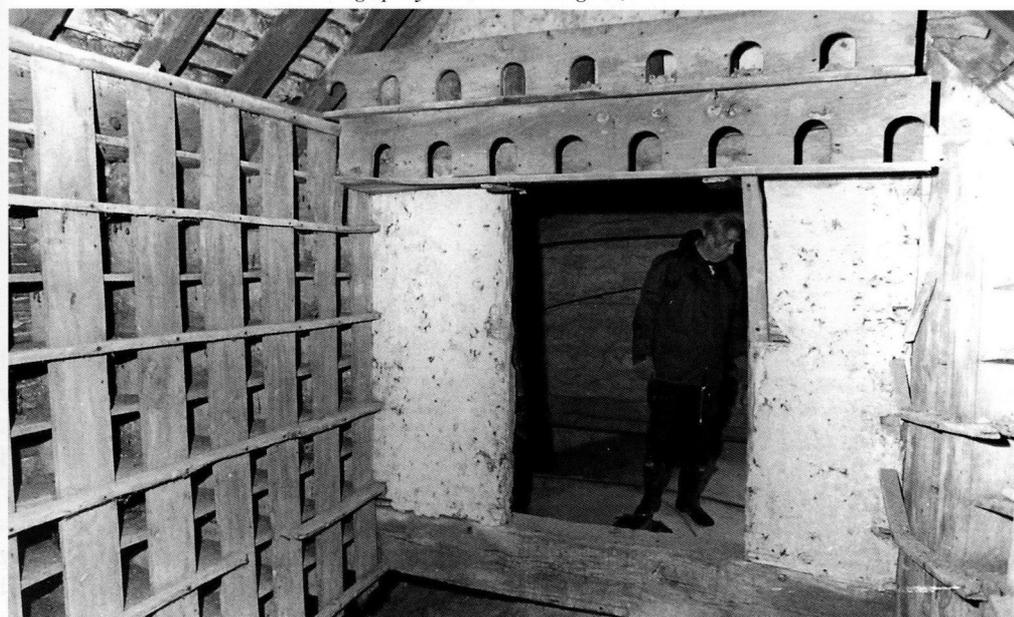
Fig. 15

Overbury, Worcestershire. The west end of the columbarium. The nest-boxes over the entrance are re-used from a dovecote elsewhere.

In addition, two tiers of wooden nest-boxes of a different type with entrances of inverted-U shape are supported over the doorway at the west end, re-used from another dovecote (Fig. 15). There were 220 of the original nest-boxes, and this addition increased the total to 234. This is 'the space above the vaulting of the chancel [which] was used as a pigeon house' which Micklethwaite reported as still in use about 1845. A more detailed report will be published in *Transactions of the Worcestershire Archaeological Society*.²⁰

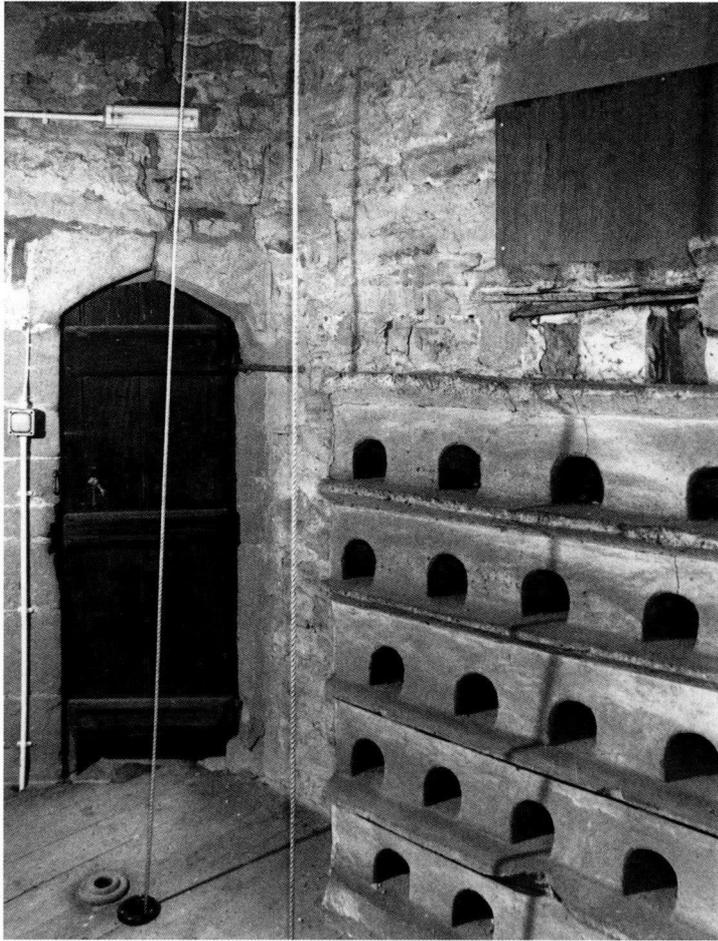
Fig. 17

Upton, Nottinghamshire. The south-west corner of the columbarium with the doorway, the blocked south window at upper right, and nest-boxes erected against the south wall.

from east to west and 13 ft 9 in. from north to south, and is 10½ ft high. There is a small window with a two-centred head in the west wall, now covered inside by plywood, and a rectangular window 3 ft 3 in. high by 1 ft 8 in. wide in the south wall which evidently became the flight hole for the pigeons, and through which the pigeon dung was removed. The fireplace has splayed jambs and is hollow-moulded all round. It is now blocked by a pier of brickwork supporting the cracked lintel (Fig. 18). (The flue vented through the wall.) A hardwood shelf 1 ft 5 in. wide by 3 in. thick spanning the chamber above the fireplace appears to be an original feature. Banks of nest-boxes 8 ft 10 in. high by 6½ ft wide have been formed of laths, tiles and hard lime plaster against the east and west walls, with entrances of horse-shoe shape 4½ in. high by 4½ in. wide (Fig. 17, 18, 19 and 20).

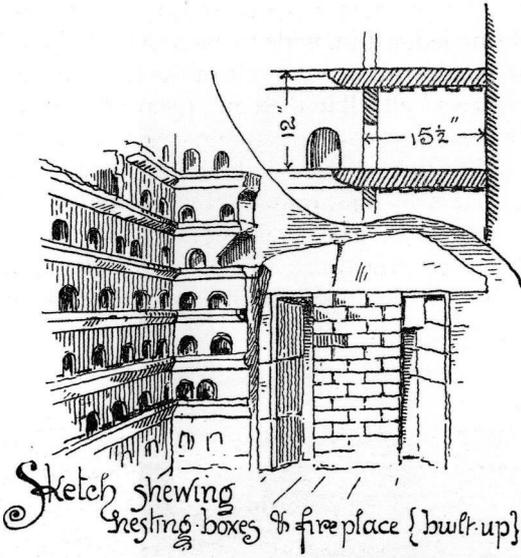
Fig. 18
Upton, Nottinghamshire. The north-west corner of the columbarium in the second stage of the west tower, with a detail of the nest-boxes. From H. Gill, 'Upton', *Transactions of the Thoroton Society*, 17, 1913, 44.
By courtesy of the Editor

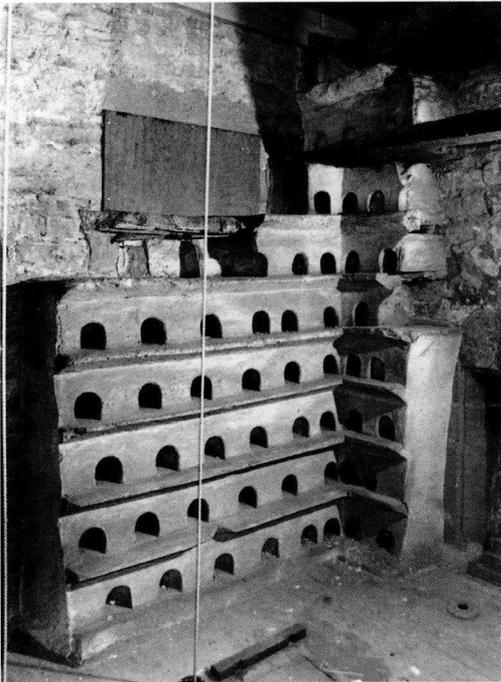
Fig. 19
Upton, Nottinghamshire. Nest-boxes against the west and north walls of the columbarium. The edge of the fireplace is visible at right.
Photograph by John McCann

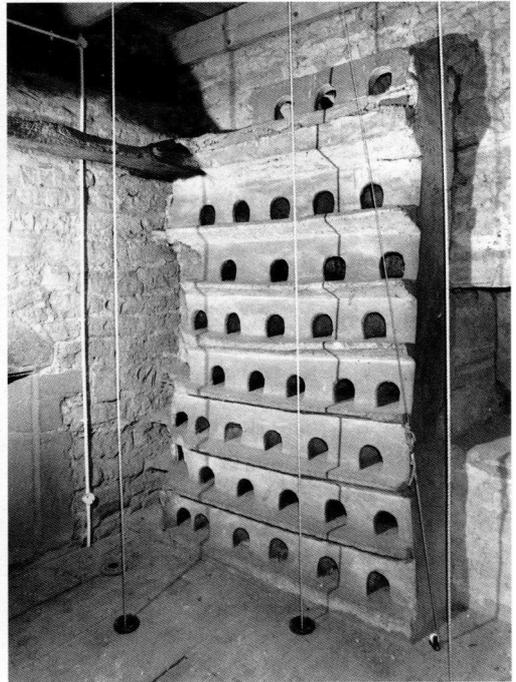
Fig. 20
Upton, Nottinghamshire. Nest-boxes against the east wall of the columbarium. The aperture into the nave is visible at right.
Photograph by John McCann

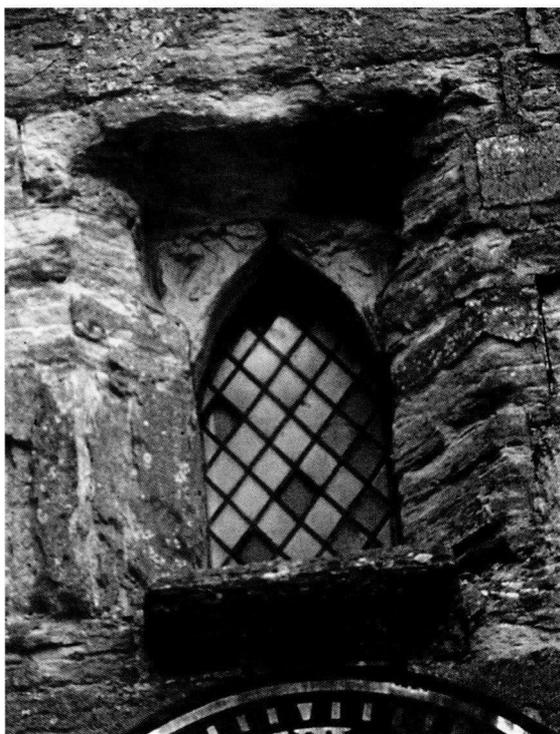
Fig. 21

Birlingham, Worcestershire. The south window in the middle of the west tower, retaining a ledge on which pigeons could perch.

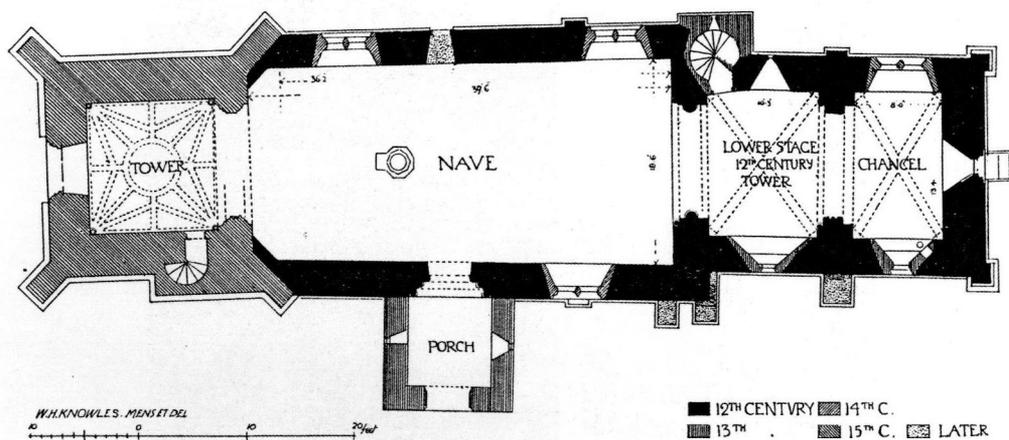
Fig. 22

Elkstone, Gloucestershire. Plan of the church. From W. H. Knowles, 'Elkstone', *Transactions of the Bristol and Gloucestershire Archaeological Society*, 52, 1930, 189.

The church of St John the Evangelist was built *c.*1160-70, with a tower between the nave and the very short chancel, as were several others in nearby villages (Fig. 22).²⁵ In the thirteenth century the upper part of the tower collapsed or was taken down, and evidently the heads of the chancel walls were damaged – although the handsome groined and carved vault survives. The damaged walls were built up again, a roof was built over the chancel and the surviving part of the tower, and the space thus enclosed became a columbarium (Fig. 23). Originally it was entered by a doorway high in the north wall, accessible only by ladder.

3 ft 4 in. beyond the chancel (Figs. 22 and 23). As Micklethwaite perceptively noted, it has no other function than to provide access to the columbarium.

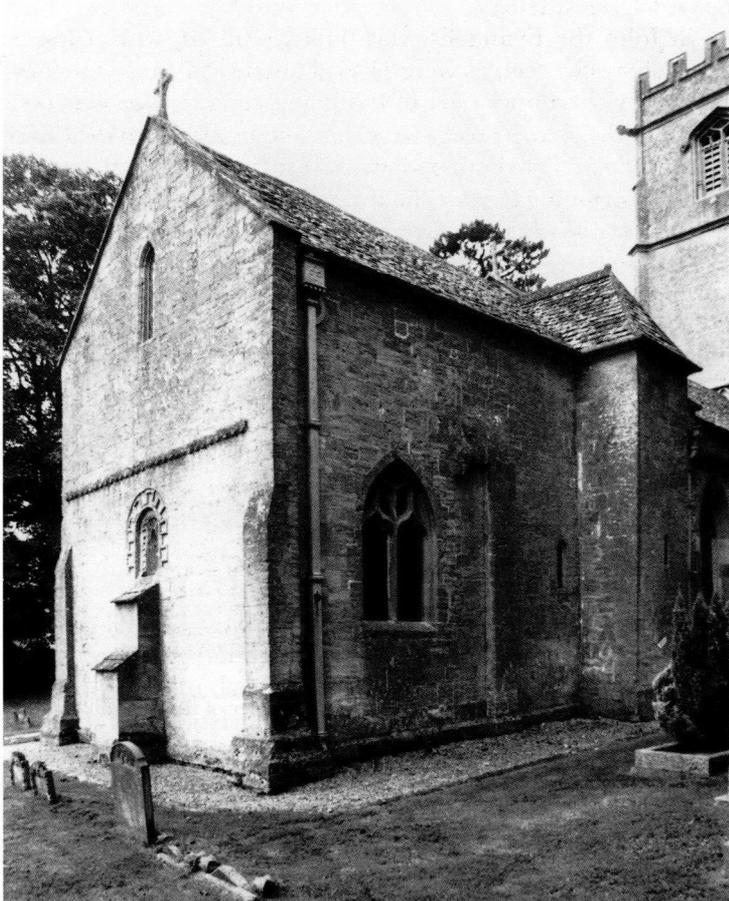
Fig. 23

Elkstone, Gloucestershire. The east and north sides of the chancel and columbarium, and the stair turret to it. The doorway was formerly above the large north window, accessible only by ladder. Note the interrupted corbel-table to west of the window.

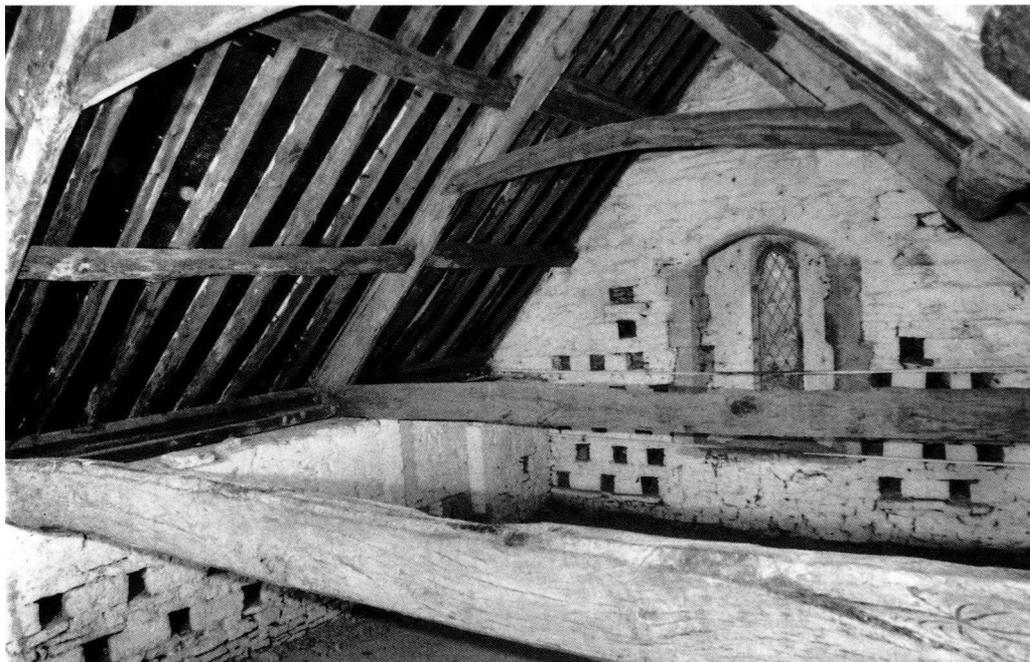
Fig. 24

Elkstone, Gloucestershire. The north-east corner of the columbarium.

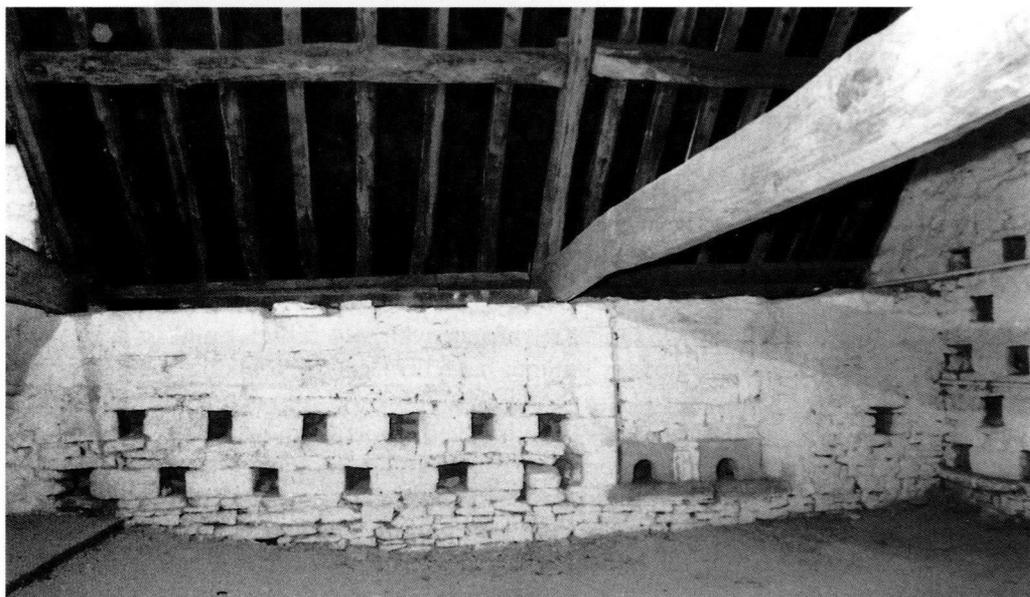
Fig. 25

Elkstone, Gloucestershire. The north wall of the columbarium, showing the blocked doorway.

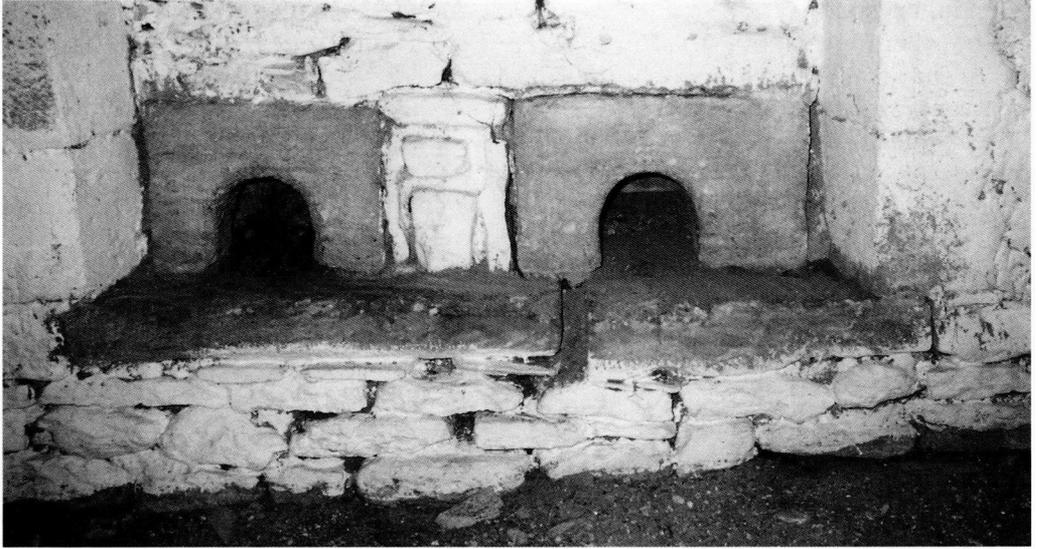
Fig. 26

Elkstone, Gloucestershire. Two nest-holes in the blocked north doorway, the entrance stones recovered from a columbarium in the demolished twelfth-century tower.

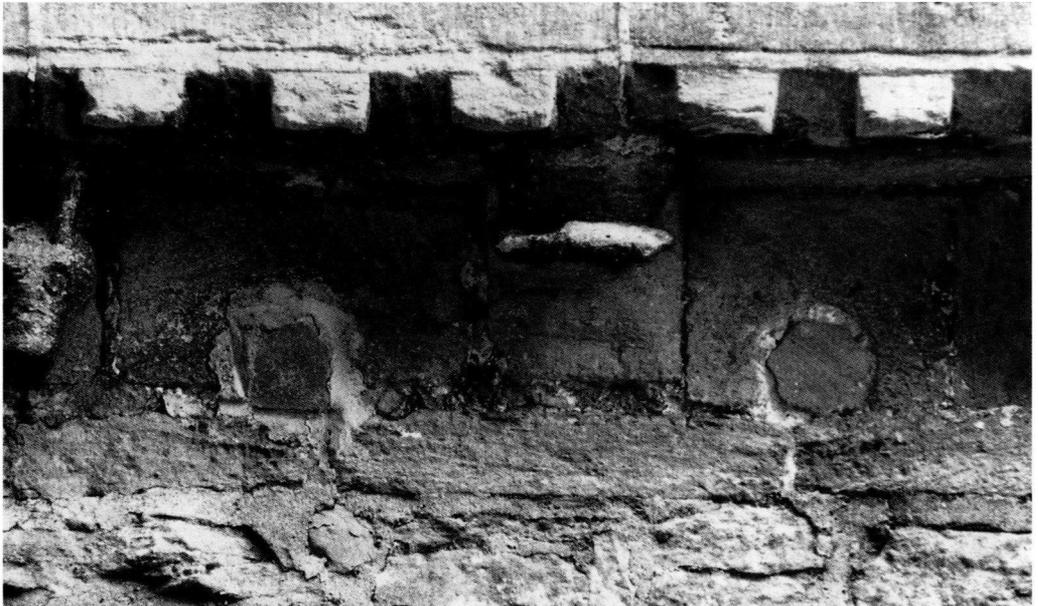
Fig. 27

Elkstone, Gloucestershire. Finely formed stones from the original columbarium in the twelfth-century tower, re-used in the south wall of the nave to west of the porch.

In 1930 W. H. Knowles drew attention to more of these finely-shaped stones re-used under a corbel-table in the south wall of the nave (Fig. 27). He concluded that they had been recovered from an earlier columbarium in the upper part of the tower, which must have been built in the twelfth century.²⁶ Apparently the present columbarium was provided to fulfil an existing obligation, for by then the right to keep pigeons in the church would have been established in common law.

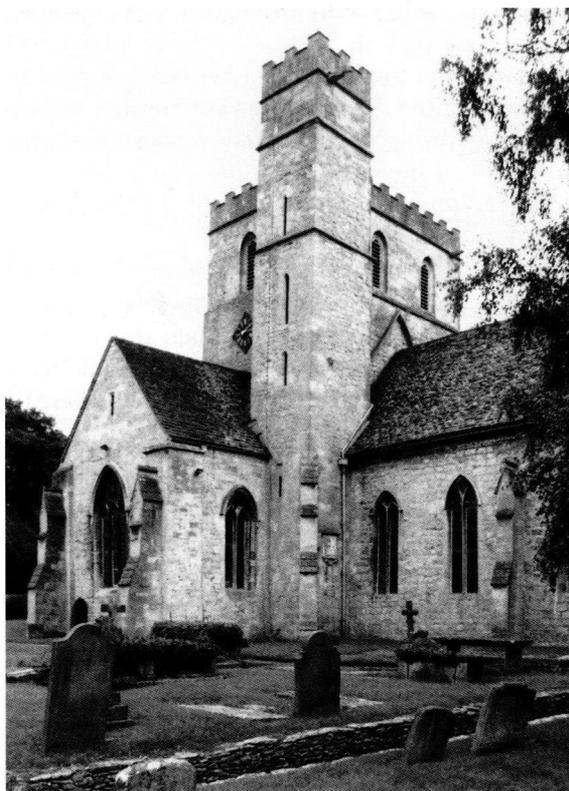
Fig. 28
Leonard Stanley, Gloucestershire. The church of St Swithun from the north-west.
Photograph by John McCann

What is now the parish church of St Swithun was built as an Augustinian priory founded between 1121 and 1129; by 1138 it had been handed over to the Benedictines of Gloucester.²⁹ The present building is substantially of that period – a cruciform plan consisting of a central tower, chancel, nave and two transepts. In the fourteenth century a stair turret was added at the north-west corner of the tower (Fig. 28). Most of the nest-holes noted by Middleton are in the gable of the *south* transept, now seen – with extreme difficulty – from the second stage of the tower, but they cannot now be approached because since his visit a ring-beam of reinforced concrete has obstructed the doorway. In 1982 it was further obstructed when the bells were re-hung at a lower level.³⁰ Fifty-two nest-holes are arranged round a small window in eight tiers with an alighting ledge to each tier (Fig. 29). Two other nest-holes appear to have been blocked to provide a small pier supporting the upper east purlin. The flight hole by which the pigeons entered in the peak of the gable is too inaccessible to measure, but is estimated to be 10

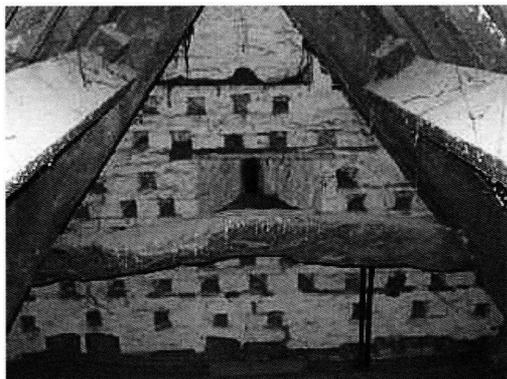
Fig. 29

Leonard Stanley, Gloucestershire. Nest-holes in the gable of the south transept.

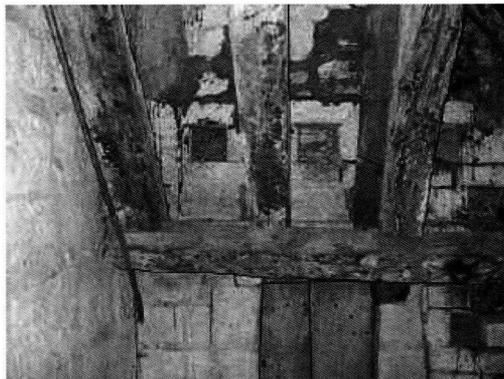
Fig. 30

Leonard Stanley, Gloucestershire. Nest-holes in the stair turret, within the north transept.

In addition there are ten nest-holes without alighting ledges in the west wall of the stair turret, effectively within the north transept, accessible from a door adjacent (Fig. 30). The roof of this transept was rebuilt in the fourteenth century; the rafters obstruct some of the nest-holes, so by then this columbarium may have been already disused. Later alterations have made it impossible to determine exactly what space the north columbarium occupied. Therefore there were two columbaria, from which at least sixty-four nest-holes are still identifiable.

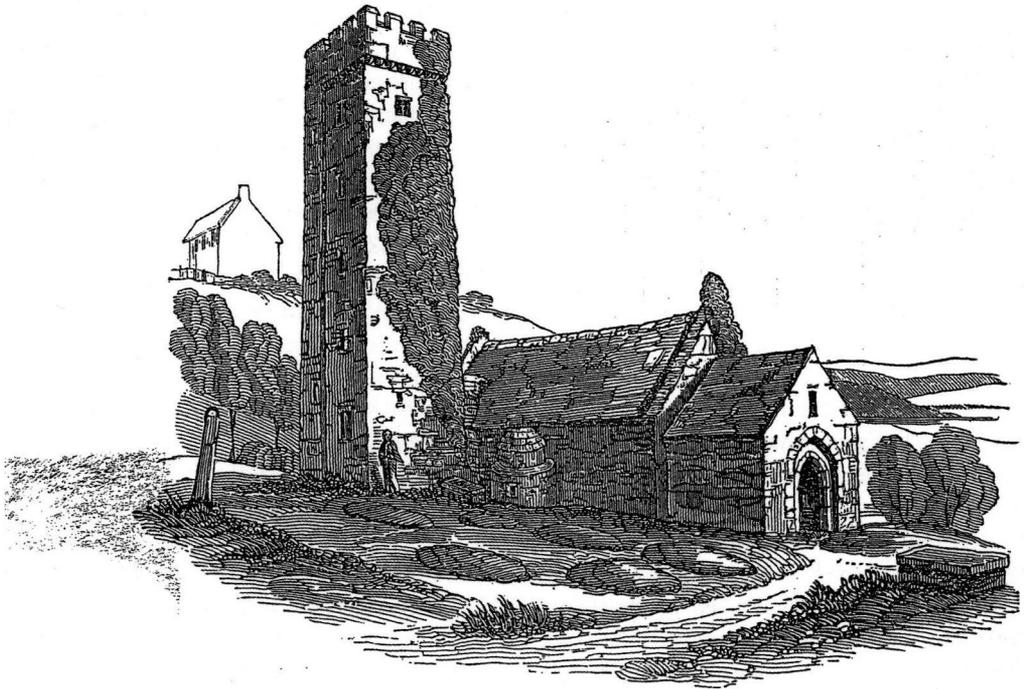
Fig. 31

Gumfreston, Pembrokeshire. The parish church of St Lawrence from the north-west.

The parish church of St Laurence was built in the twelfth century. In the fifteenth century a tower was added to the north of the eastern end of the nave, forming a transept. It is of five storeys, with a stair turret in the north-east corner (Fig. 31). A report of 1849 stated that 'the fourth storey was intended for a pigeon-house, and has its walls regularly fitted up with holes pierced all round the sides'.³² The Royal Commission inventory of 1925 added that the 'dove-cote is said to have been used as such until a comparatively recent date'. The listed building report of 1996 states: 'there are four rows of seven nesting holes'.³³ Because the floor is missing they are too inaccessible to examine. The chamber is lit by a narrow loop in the north wall.

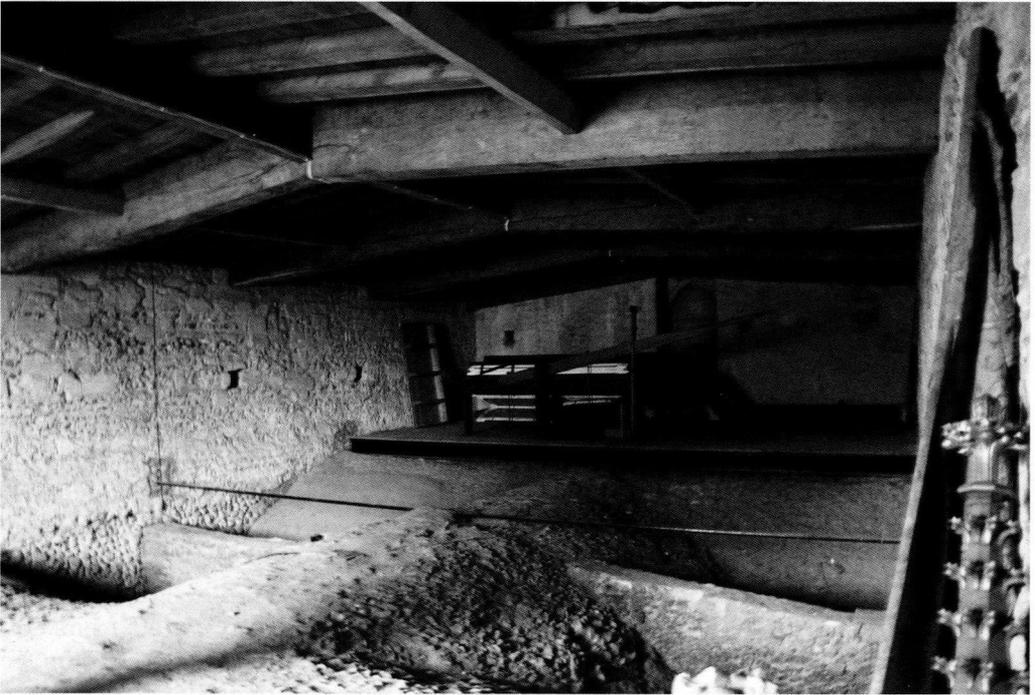
Fig. 32

Blakeney, Norfolk. Above the chancel facing south-west. The arched doorway at the far end leads only to the rood. Note the putlog holes, which may have suggested that this space was used for pigeons.

century to replace an earlier roof of the same shape. The space enclosed is 33 ft long by 21 ft wide, lit by a two-light window in the east gable, and is now used only for part of the organ (Fig. 32). He found strong evidence of an earlier roof of much steeper pitch, set 5 ft lower in the chancel walls and with a ridge standing 6 ft above the present one, probably built in the fifteenth century. At that stage there would have been insufficient height above the vault for a columbarium. Outside, the walls are cement-rendered. Inside, the north and south walls are exposed, and are of re-used freestone and flint rubble; the east and west walls are concealed by lime render. Access is from a large tapering stair turret at the north-east corner which extends high above the roof (Fig. 33). Richard Butler-Stoney believed that it was erected as a navigational aid to seafarers. The former entrance to Blakeney Harbour was opposite Cley; aligning the tall turret against the west tower would guide them through the channel between sand-banks.⁵¹ A horizontal line of six putlog holes 6 ft apart may have led the unknown writer to assume that the space enclosed by the low-pitched roof had been 'long used as a pigeon house'. (Putlog holes and nest-holes appear so similar that in French the same word, *boulins*, is used for both.) Alternatively he may have been reporting an oral tradition, but if it was true the space above the vault can only have been equipped with inserted nest-boxes which left no evidence when they were removed.
