A Tale of Two Barns: Paston and Waxham

The great 16th-century barns at Paston and Waxham near the north-east coast of Norfolk were falling into disrepair by the closing years of the 20th century. This article discusses their context, significance and decline, and describes their rescue, in which the author was closely involved.

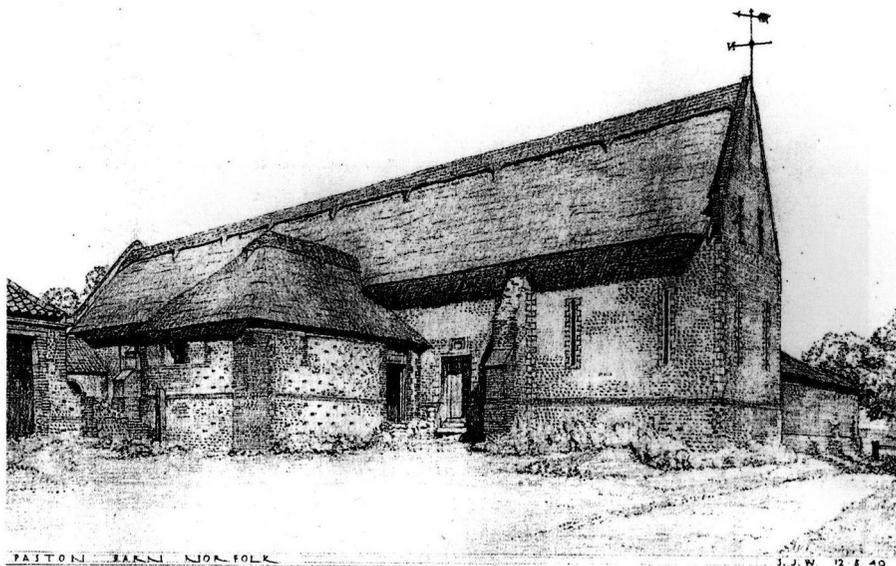
Fig. 1

Paston barn from the south-west; drawing by the late Stanley J. Wearing, August 1949.
S. J. Wearing, Beautiful Norfolk Buildings, III (Norwich 1960), 21

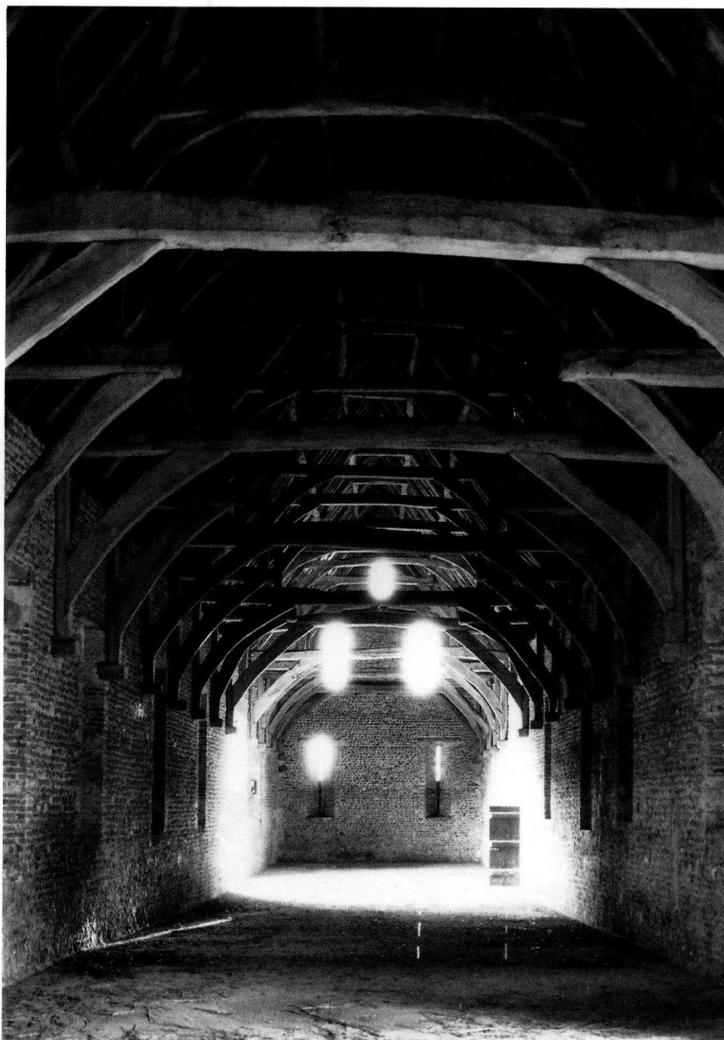
Fig. 2

Paston barn, the interior looking south, in December 1989.

Both barns are constructed of local flint with freestone and brick dressings, and have fine oak roofs with alternating hammerbeam and tie-beam trusses covered with thatch (Figs 1, 2). Waxham at approximately 180ft (55.4m) is marginally longer than Paston, which is about 164ft (50.5m) long.² At the lost village at Godwick, south of Fakenham, is a smaller brick barn of similar age with a similar roof structure. This is the surviving agricultural wing of a late 16th-century house that has disappeared and it includes a domestic element at one end and a pseudo-domestic architectural treatment on the side, which originally faced the house and forecourt.³

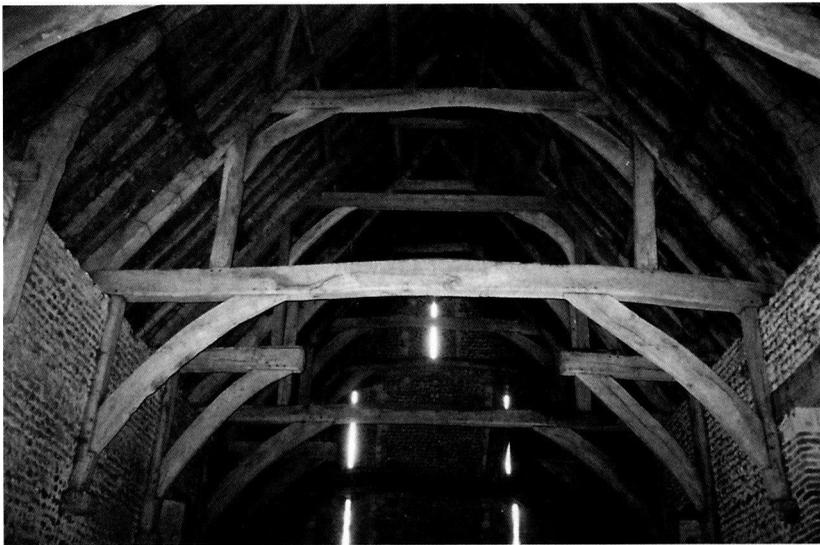
Fig. 3

Paston barn. General view of the roof timbers with alternating tie-beam and hammerbeam trusses regularly spaced; also partly visible at top left and right is one of two arch-braced trusses which occur opposite the threshing doorways.

These great barns with their majestic roofs (Fig. 3) are obviously for display as well as function and the families who built them were members of the Tudor *nouveau riche*, whose wealth derived at least in part from the dissolution of the monasteries earlier in the century. There was probably some rivalry between the builders of two such barns a short distance apart and so close in date. They appear to continue the tradition of the pre-Reformation monastic tithe barns, while their roofs in particular echo the carpentry of the late medieval church roofs which are such a feature of East Anglia, including two fine hammerbeam roofs at Trunch and Knapton just a few miles from Paston, and a number with alternating hammerbeams and tie-beams further afield in the county.⁴

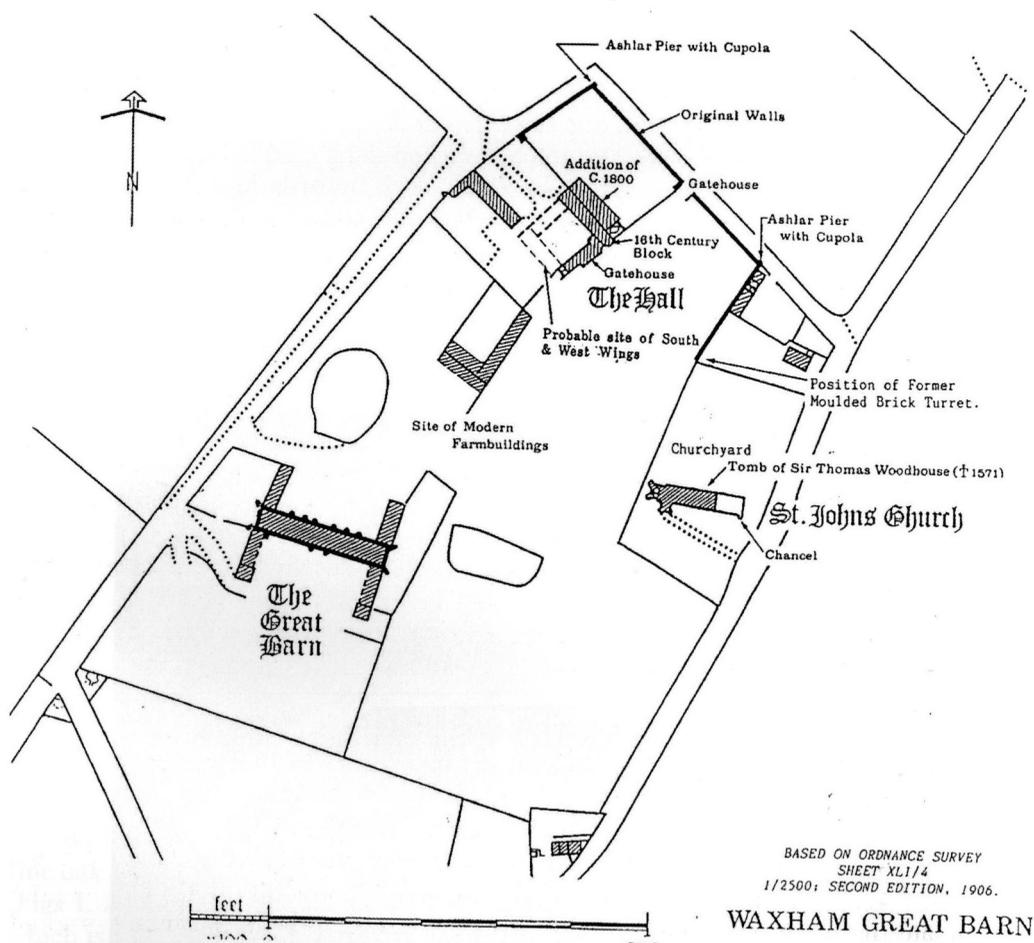
Fig. 4

Waxham. Map showing the barn within its surviving though compromised manorial context of church, hall, gatehouse and boundary walls; also the four later wings attached to the corners of the barn, and the walled yards which relate to them.

Waxham barn retains a recognisable though compromised manorial setting, including hall, gatehouse, boundary walls and church (Fig. 4). At Paston the barn is near the church and the site of the hall, but the original hall has gone and the barn remains more of a stand-alone monument, though with considerable accretions as a result of changes of ownership and later developments in agricultural practice. At Waxham there are also developments but they are less extensive and this barn remained in limited agricultural use until the late 1980s. Paston had ceased to be used for agriculture some years previously and alternative uses had been considered. Towards the end of the 1980s it was acquired by a local industrialist who approached the author regarding its conversion to a prestigious company headquarters. However, his company failed in the recession of the early 1990s and the buildings were subsequently acquired from the receivers by the North Norfolk Historic Buildings Trust. Following this a colony of rare bats took up residence and this led to a repair programme both protracted and intermittent.

with walls linking the ends of the wings to form enclosed yards (Fig. 4). On the south side each wing ended in an enclosed and roofed space with access from outside the yard, and the remainder were also roofed but open-fronted, an arrangement clearly relating to fodder storage and over-wintering of cattle, and probably dating from the mid-18th century. It is less clear whether the wings to the north were similar in date and purpose, but they have additional enclosed areas on their outer sides which extend past the ends of the barn.

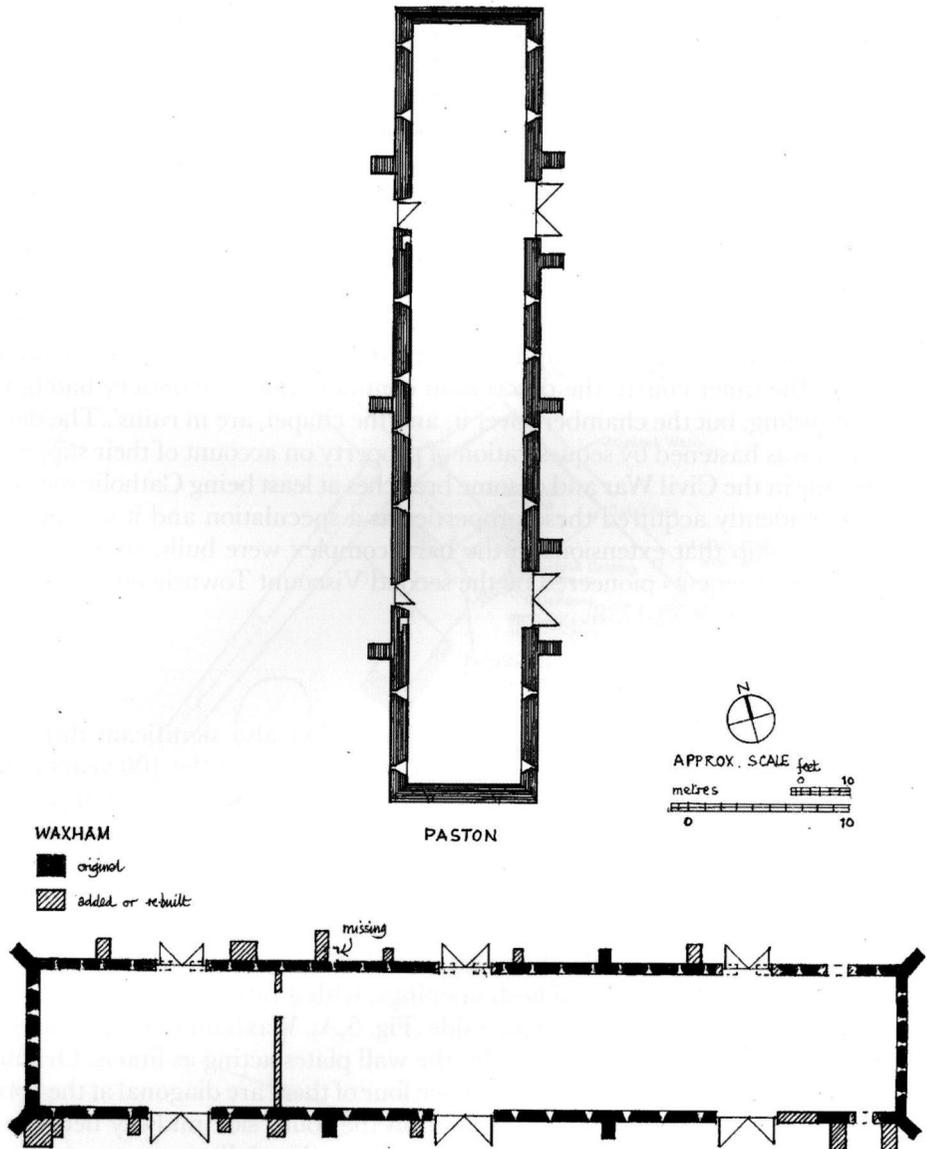
Fig. 5

- Ground plans of the two barns, showing their orientation, principal openings and buttressing.
- (A) Paston has benefited from its thicker walls, fewer large doorways and a better distribution of buttresses.
- (B) Waxham, where significant structural deformation has occurred, especially to the south wall and west gable, and over its life no less than fourteen extra buttresses (hatched) have been added; its plan also shows the widened north doorways and inserted cross wall.

Although the barn at Waxham is marginally larger, the walls at Paston are thicker and are continued on its east side above the two threshing doors, which have lintels. There are buttresses on each side of both openings, with a fifth buttress between them and three more equally spaced on the west side (Fig. 5,A). Waxham has three threshing doors on its south side which are full height, the wall plates acting as lintels. Originally there were eight buttresses as at Paston, but since four of these are diagonal at the corners of the barn, the others are widely spaced and on the south side midway between the adjacent threshing doors and some distance from them (Fig. 5,B).

Other alterations at Waxham were made for structural reasons, with the construction of additional buttresses (Figs 5,B and 17) and the rebuilding of one section of the south wall. These were of various dates, the most recent probably dating from the mid-20th century, and were the consequence of structural movement especially to the south wall, caused by the southern aspect, high water table and shallow foundations.⁹ This instability was reflected in movements elsewhere which had to be addressed when the building was repaired (see below).

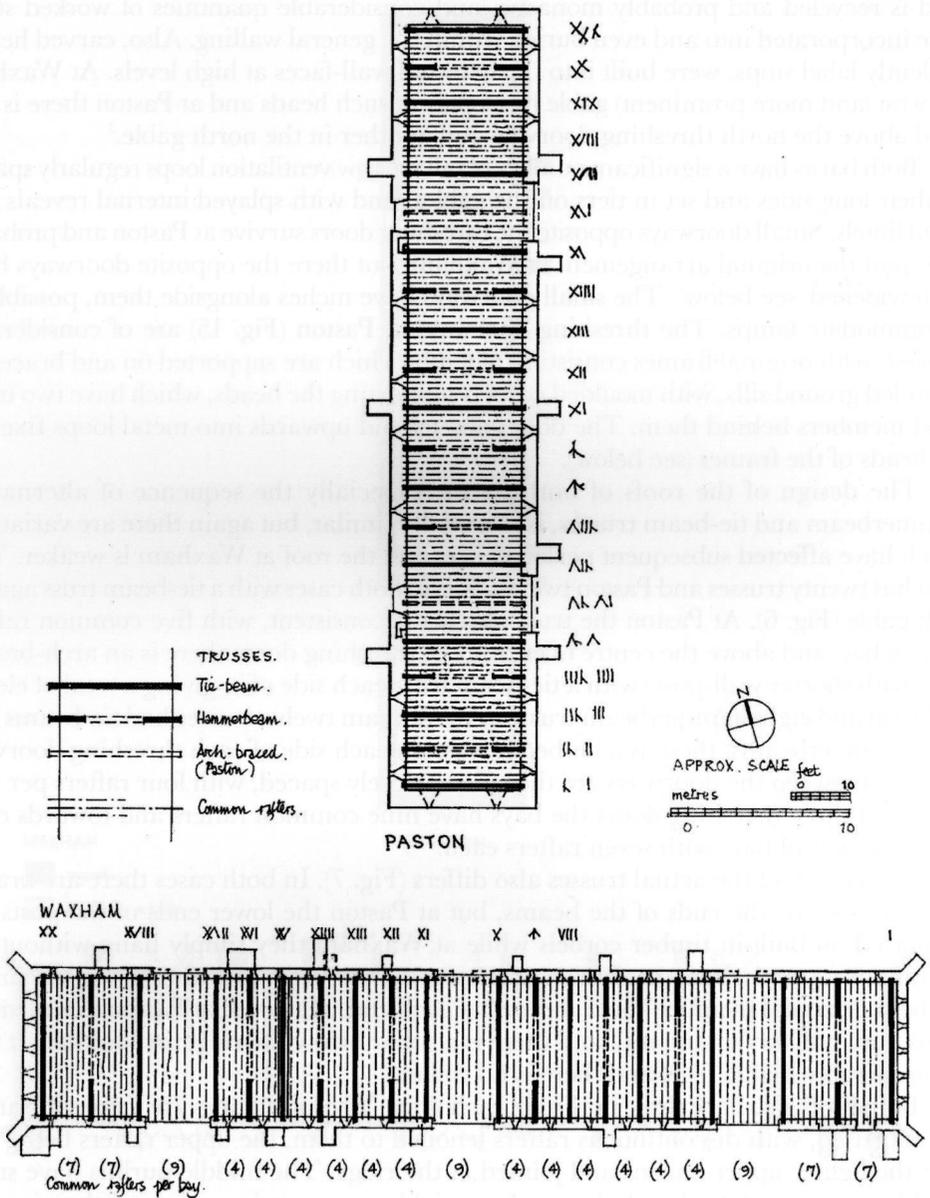
Fig. 6

Plans of the barn roofs: (A) Paston, showing the regular spacing of alternating tie-beam and hammerbeam trusses, with the two arch-braced trusses centred on the large doorways and five common rafters in each bay. (B) Waxham, showing the varied bay widths, with nine common rafters at the doorways, four in each of the bays between them, and pairs of bays with seven rafters at each end of the building.

not easily be turned around within the barn. A brick cross wall was also constructed, coinciding with the sixth roof truss from the west (truss 15; Fig. 6,B), and a larger, probably pitching, opening was inserted in the west gable at high level.

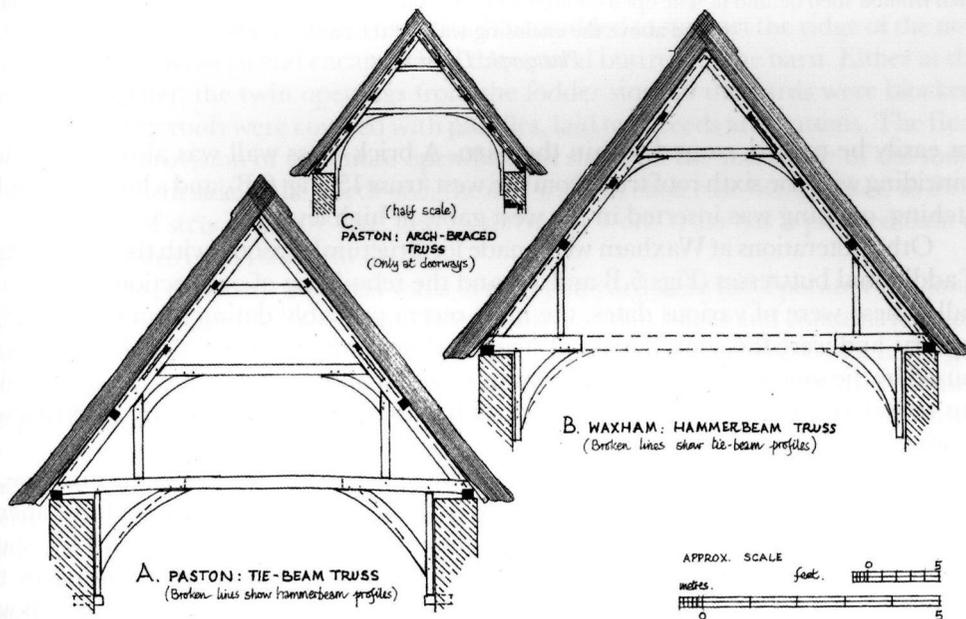
Fig. 7

The roof truss types. Both barns have alternating tie-beam (A) and hammerbeam (B) trusses with pairs of queen-posts and a braced horizontal tie. At Paston (A) this member is lower and there is a high level collar, while the wall-posts are supported on built in timber corbels, resulting in a stronger roof. At Paston there is also an arch-braced truss (C) opposite the centre of each threshing doorway.

The design of the actual trusses also differs (Fig. 7). In both cases there are braced wall-posts below the ends of the beams, but at Paston the lower ends of the posts are supported on built-in timber corbels while at Waxham they simply hang without the additional support. Both roofs have queen-struts carried up to the principals and a further horizontal member above, braced at each end. However, at Paston this member is less than halfway up the roof and there is a collar below the ridge: at Waxham it is at a considerably higher level and there is no collar.

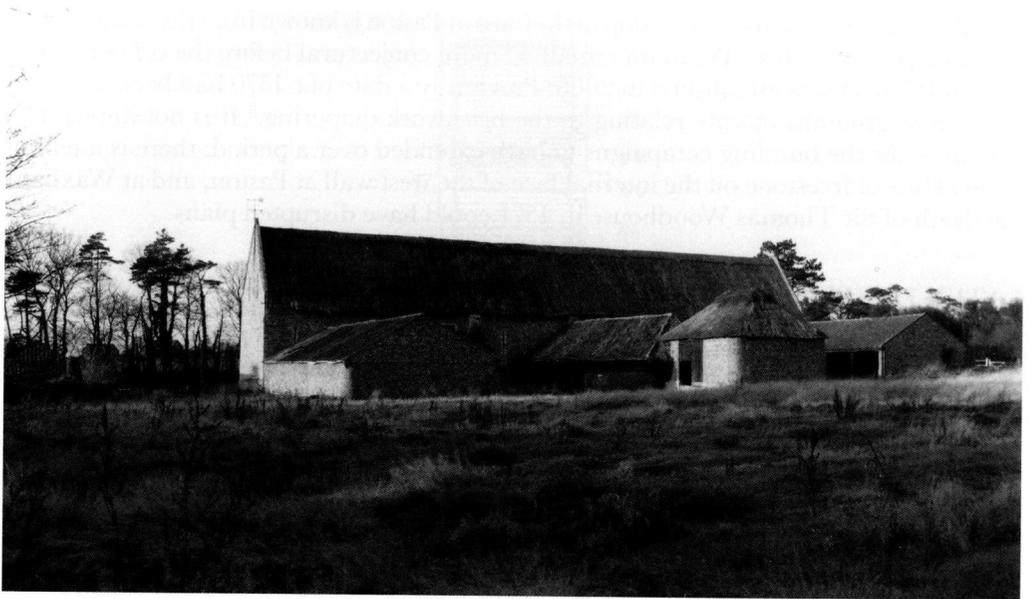
Fig. 8

Paston, the farm buildings from the south-east, December 1989, prior to repair. The original barn with its long roof is behind, the 18th-century thatched fodder shed in the foreground and the slightly later open fronted shed behind it. The open-fronted sheds at each end are late 19th-century, with their gables raised above the enclosing walls of the earlier yards.

At Paston additions to the agricultural complex are considerably more extensive than at Waxham and show clear evidence of successive phases (Figs 8, 9). On both sides of the barn enclosed yards and fodder stores were added and this seems likely to have occurred following Lord Anson's acquisition of the Paston properties in the mid-18th century, reflecting the changes in agricultural practice then being introduced. To the east, twin yards were created with a detached fodder store which had an opening to each yard (Fig. 9,B); the yards themselves were also linked. To the west was a single yard with another fodder store built against the west face of the barn (Fig. 16). The north and west enclosing walls of this yard were subsequently encapsulated in later buildings, but the coping line can be clearly seen, on the west side following the slope of the site. The roofs of both these fodder stores were hipped and thatched.

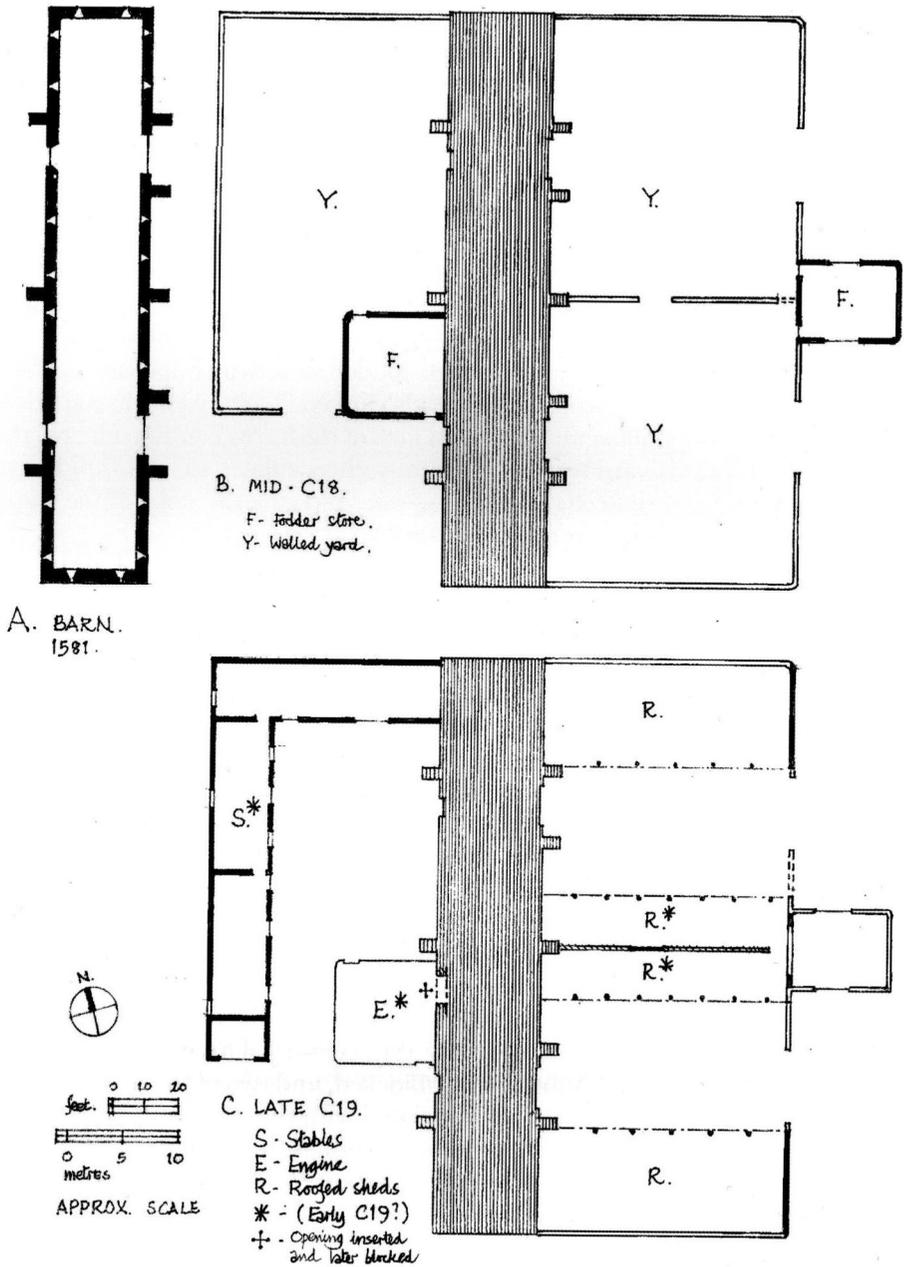
Fig. 9

Paston, the development of the farm buildings: A, the original barn; B, the (assumed) mid-18th-century additions of walled yards and winter fodder stores; C, the 19th-century provision of covered sheds on the east and the L-shaped stable block to the west, probably coinciding with the provision of a horse-gin in the former fodder store. (Note: this drawing omits the separate building on the south boundary of the site).

Two further phases of development can be identified on the east side of the barn (Fig. 9,C). First, back-to-back covered open-fronted sheds were provided with a shared roof spanning over the dividing wall between the yards, and a hipped end forming a valley with the fodder store. The dividing wall was raised and the opening within it blocked, and above the wall a row of rather flimsy studs was added to support the ridge of the new roof, which at its western end encapsulated the central buttress of the barn. Either at the same time or later, the twin openings from the fodder store to the yards were blocked. This and all later roofs were covered with pantiles, laid over reeds and battens. The final phase was the provision of two more open-fronted sheds on the south side of the south yard and the north side of the north one, the end walls in each case being raised to form gables. The roof structures are late, and in softwood – one truss has a painted date of 1880, which there is no reason to doubt.

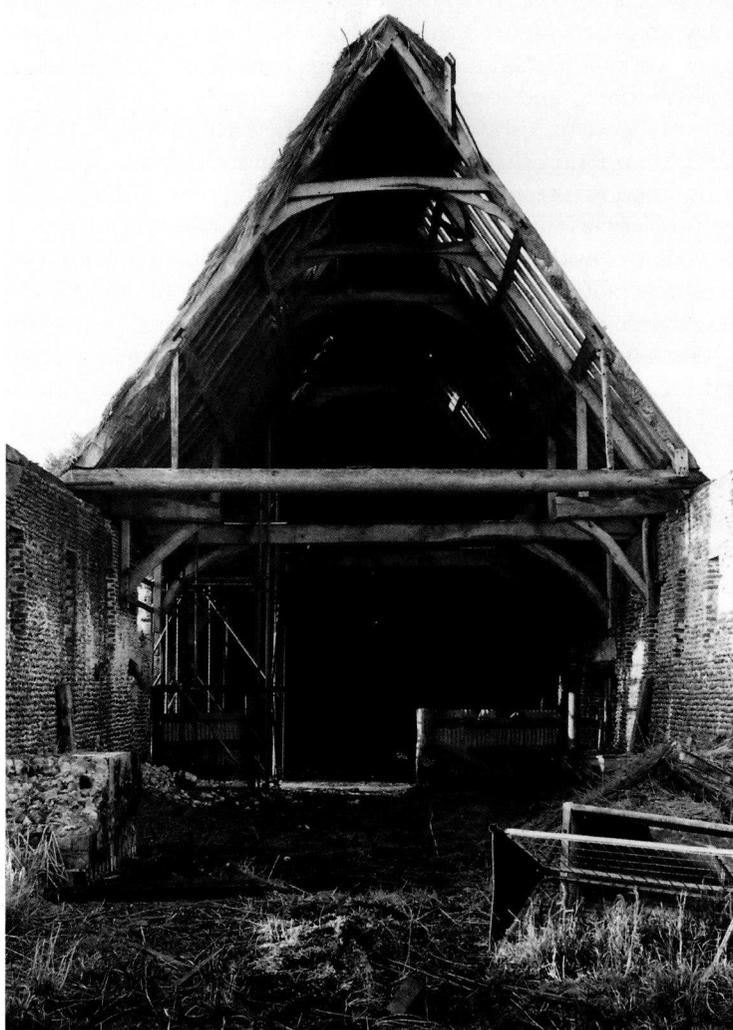
Fig. 10

Waxham barn, interior in January 1989, looking west from the collapsed east end, following the great gale of 23 October 1987. The truss in the foreground (truss 8) shows an earlier repair with a slightly tapered pole, probably a ship's mast.

Earlier repairs to the roof had included the renewal of three tie-beams in pine, at truss 15 above the inserted cross wall and at trusses 8 and 13, using slightly tapered circular poles which are probably recycled ships' masts (Fig. 10). At truss 19 the south hammerbeam was missing and a pine member had been inserted spanning to the hammerbeam opposite. During the repair programme this inserted member was removed and the missing hammerbeam reinstated.

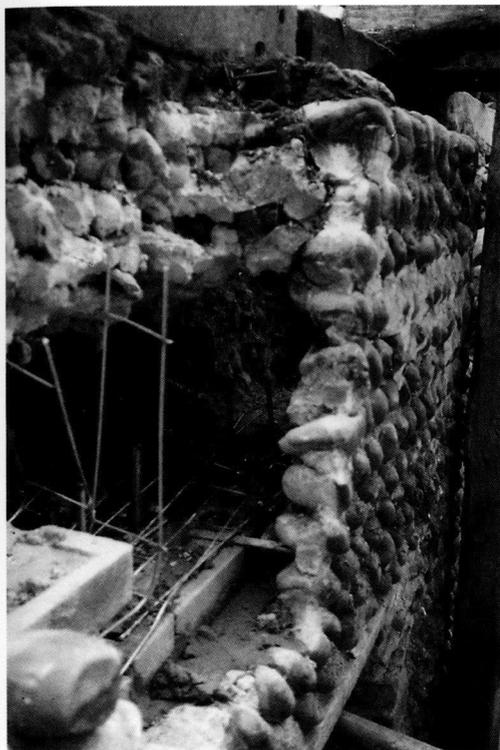
Fig. 11

Much of the walling, including added buttresses, was sound apart from localised cracking and face collapse, but as mentioned above the south wall had over a long period become seriously distorted and the roof, and to a lesser extent the north wall, had followed it. The roof was also racked from west to east and had dragged the gables with it so that their upper parts were seriously out of the vertical, in addition to which the recent gale had brought down some of the east end including part of the gable.

Waxham barn. Insertion of a concealed brick beam within the wall thickness of the barn, with overlapping reinforcement to permit installation in small sections; this forms a continuous ring around the building and includes short piers to anchor the wall-plates (seen above).

An opinion was sought from a sympathetic structural engineer, Brian Morton, who broadly agreed with the writer's diagnosis and advised the insertion of reinforced brick beams to aid stability. In most cases it was possible to insert these by cutting pockets in the internal wall faces and building the beams in short lengths, which were subsequently linked by the reinforcement, leaving the external wall faces undisturbed. Thus a complete

ring was provided just above the heads of the ventilation loops, with short piers at intervals rising to the wall-tops and anchoring the wall-plates (Fig. 11). The beams were inserted at this level as it was considered that if they were higher and movement continued, they would be less stable, though the wall-plates had to be tied over the full height south openings. The leaning upstanding sections of the east and west gables were additionally reinforced with grids of beams, including raking ones following their triangular shapes, and when the roof was repaired this too was braced with diagonal boards between the thatch underlay ('fleaking') and the main covering. All of this work was invisible on completion. While strengthening the walls, significant quantities of recycled and worked stone were found built in and are now on display at the site.

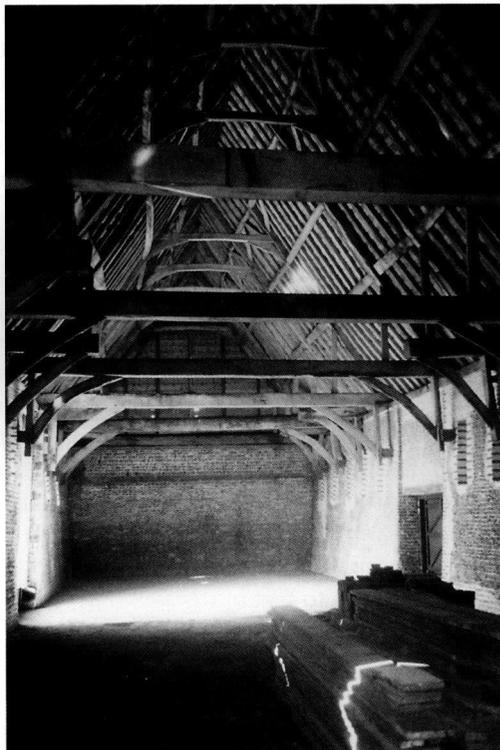
Fig. 12

Waxham barn. The interior of the barn after repair, looking west towards the inserted cross wall; note the wall-posts floating clear of the wall face, the varying numbers of rafters in individual roof bays, the widened north doorway and the previously replaced tie-beam near the cross wall.

The dragging of the roof as a result of the distortion of the south wall had left most of the wall-posts on the north side hanging clear of the wall face and some of the dovetailed tie-beam bearings on the wall-plates much reduced, while the south side wall-

plates were seriously out of line. The replacement or insertion of four tie-beams has been mentioned, but only that at truss 19 (a hammerbeam truss) was removed. Otherwise general strengthening was undertaken, including blocking the hanging posts off the wall-faces (Fig. 12). In some ways, once the fallen timbers had been sorted, re-erection of the collapsed third of the roof (from the east gable to truss 8) was more straightforward than the repair of the standing section, and although some renewal was necessary, it remains substantially original.

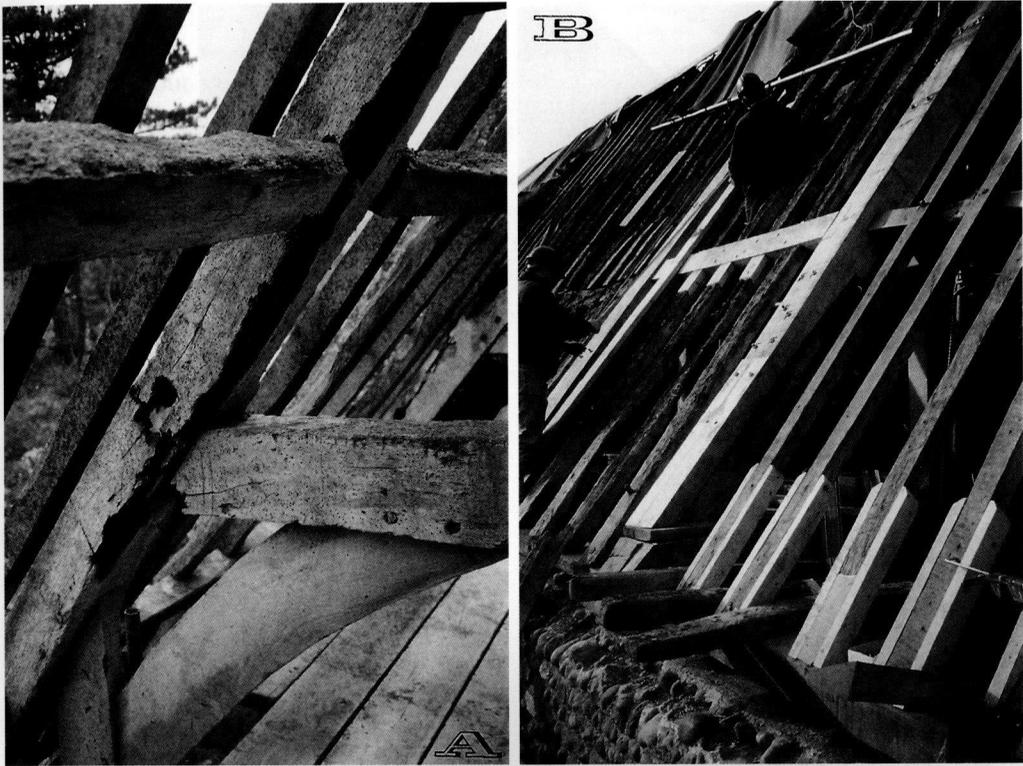
Fig. 13

Paston barn: A, decay in the roof timbers; B, roof repairs in progress. Despite appearing superficially sound, the roof timbers needed quite extensive repair because of pockets of death-watch beetle attack in sapwood and where timber had been damp due to leaking thatch or contact with masonry.

Repairs to the main barn at Paston, also generously supported by English Heritage, were similar but less extensive. Nevertheless, as work proceeded, considerable strengthening and some renewal of roof timbers was needed due to decay, mainly from death watch beetle, in sapwood and in timbers which had been in contact with masonry or beneath defective thatch (Fig. 13A-B). In both barns original jointing, generally with mortices, tenons and oak pegs, was replicated, but where new timber was joined to old in the same structural member, the scarf joints were made rigid by the use of stainless steel bolts. At Waxham the bolt ends were pelleted with raised pellets to distinguish them from original pegs, but at Paston it was decided, in view of the low light levels, that bolt ends could simply be left exposed without being obtrusive.

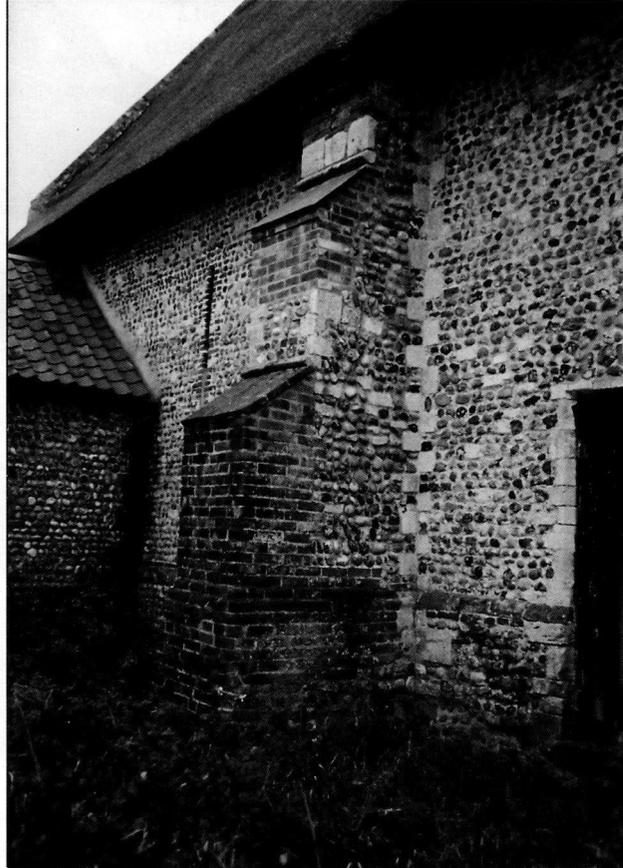
Fig. 14

Paston barn, the north-west buttress following repair. Original stone dressings at offset cappings survived in part on most buttresses but there had also been much brickwork repair, generally of poor quality, necessitating considerable rebuilding. Note the original purpose-made brick plinth capping continuous along the main wall-face and round the buttress, and the stone dressings of the internal angle and doorway (right).

The structural walls at Paston were so sound and stable that virtually no repair was needed except to the buttresses, although previously lowered ground at the south end of the barn was reinstated to its original level, which was a visual improvement as well as structurally stabilising. However, the buttresses needed quite extensive repair and some localised rebuilding. Generally these have three stages with a plinth: the upper stages appeared mostly original with stone quoins and cappings and were sound (Fig. 14); whereas the lower stages, for reasons that were not apparent, had been rebuilt or re-faced with later work, generally of brick, and in some instances also to a different profile. This work was not all of one period, but in most cases appeared 19th century and included re-capping the offsets with slabs of Welsh slate, which could have been transported by sea or rail. There was considerable instability and vegetation growth so that re-facing or more radical reconstruction was needed, replicating what was there rather than attempting any 'restoration'; except that where the slate cappings were either missing or unserviceable the offsets were capped with brick, which was felt to be more sympathetic. The slate slabs were not the only evidence of the railway age, since the posts on one of the open-fronted sheds were recycled railway sleepers. It proved possible to obtain additional ones for use in repair.

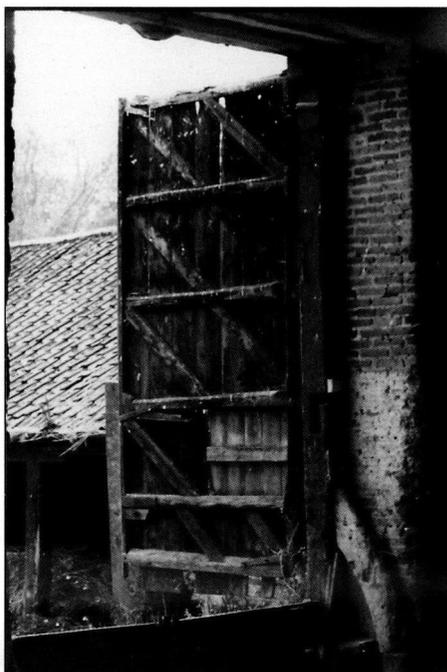
Fig. 15

Paston barn, a threshing door and frame before repair. The jambs have a sill and curved brace at their lower ends and corbels at the upper; the doors, which are probably later, appear to have been harr-hung originally and their hinge stiles extend upwards at the heads into iron retaining hoops.

The threshing doors at both locations consisted of large hinged pairs of doors above lift-out panels, and were probably considerably later than the buildings. However, at Paston, besides the original frames already mentioned, the south set of doors was less recent and of interest with ledges that were nicely tapered and chamfered (Fig. 15). They were in poor repair, but as a result of the skill of the joiner it proved possible to salvage much of the framing and replicate missing members; the interesting door frames were also repaired. The presence of the extended stiles and iron hoops at Paston suggests the possibility of harr-hung doors originally,¹⁰ but as found the hanging arrangements at the lower ends were very makeshift, with inadequate hinges. These were replaced with

full width double hinges made by a local craftsman blacksmith, Bill Cordaroy, who also supplied the ironmongery for Waxham.

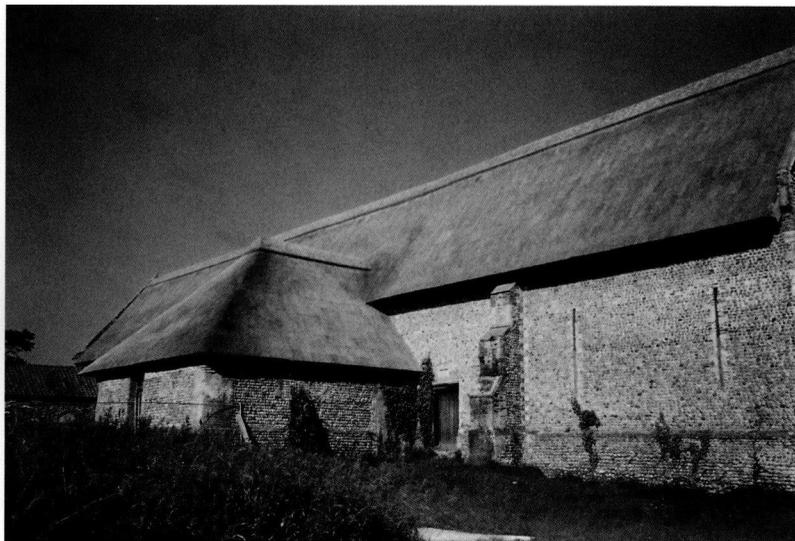
Fig. 16

Paston, the barn and attached fodder store from the south-west, after roof repair and rethatching but before the completion of masonry repairs. The original small doorways, which have been adapted for carts at Waxham, survive here, and the later fodder store is attached and thought at one time to have contained a horse-gin.

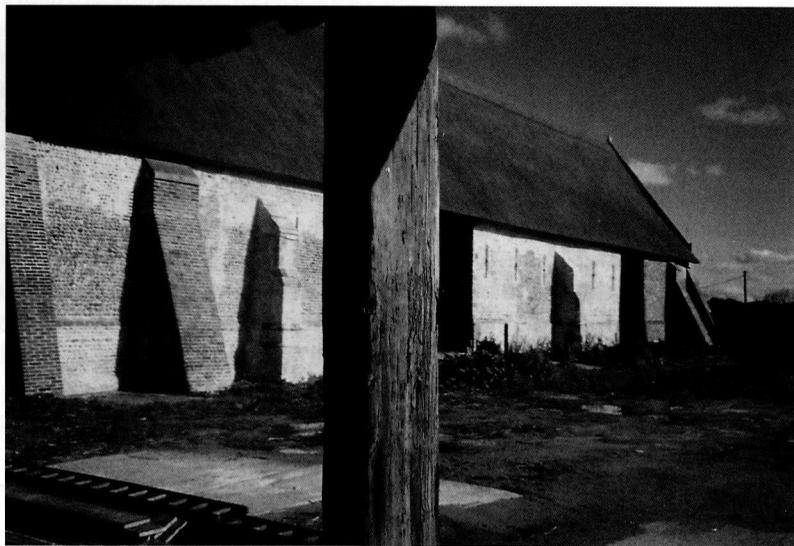
Fig. 17

Waxham barn, the south side of the barn after repair, seen from one of the later wings; two original buttresses can be seen along with four added brick ones.

The barn at Waxham (Fig. 17) is now periodically open to the public, the Norfolk Historic Buildings Trust having repaired the wings, one of which houses some modest visitor facilities. At Paston, however, public access is restricted because the maternity roost of rare barbastelle bats discovered in 1998 resulted in the designation of the site as a nature reserve of European significance. The presence of the colony also permitted only intermittent phased winter working and led in places to revisions of proposals to facilitate their access and maintain moisture levels and vegetation. Natural England, who now have a lease on the site, also have obligations to maintain the buildings.
