Manufacturing amidst green fields: the buildings of a mid-Victorian dairy farm

ANTHONY PEERS

WHITEGATES FARMSTEAD – A CASE STUDY

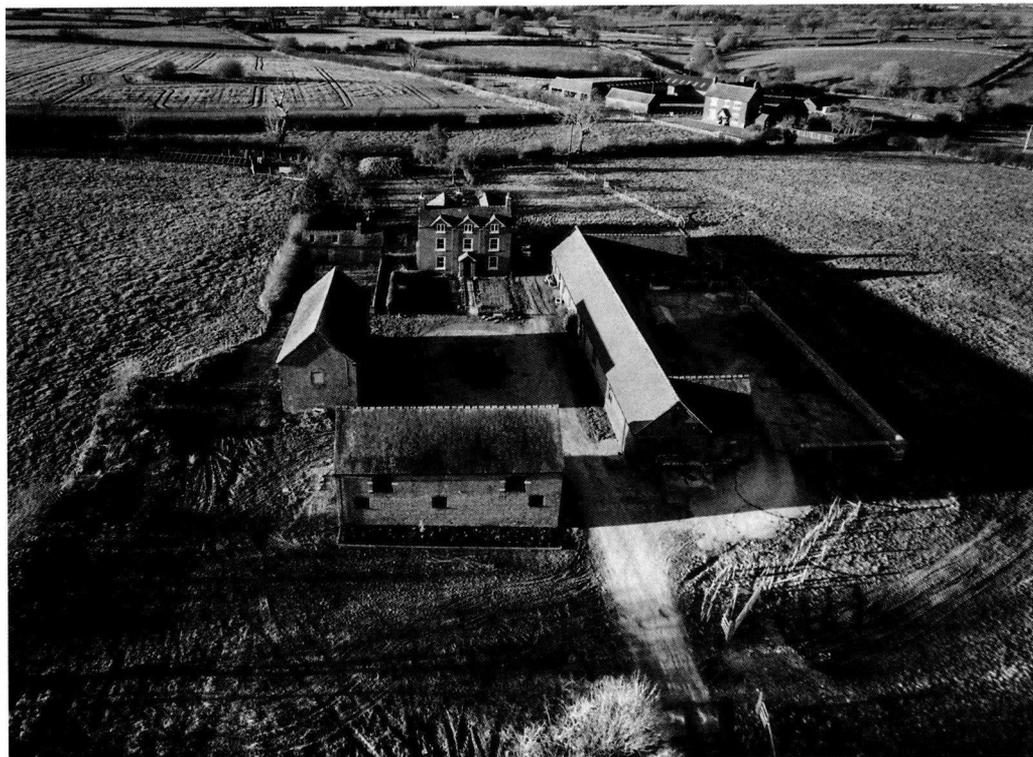
Fig. 1

Whitegates Farmstead, March 2015. In the foreground is the (former threshing barn) carthouse (c.1845 & 1869). The farmhouse (1822) stands at the head (north side) of the stackyard. On the left (to the west) is the stables/grainstore (c.1845) with the site of the pigsties (1865) and the laundry (1865) beyond. On the right (east) side of the stackyard is the shippon and its fold yard (1865).

In 2011 the tenant farmer of Whitegates Farm (Fig. 1) retired. His prize herd was sold and the farmstead's collection of brick built 19th century farm buildings and 20th century portal frame sheds fell quiet. The farm buildings were adjudged to be insufficiently commodious or well equipped for modern farming so the land was let to neighbouring farmers and the farmstead turned to use as a family home. All buildings of a post-High Farming era construction date were removed, returning the arrangement to something of its mid-Victorian appearance.

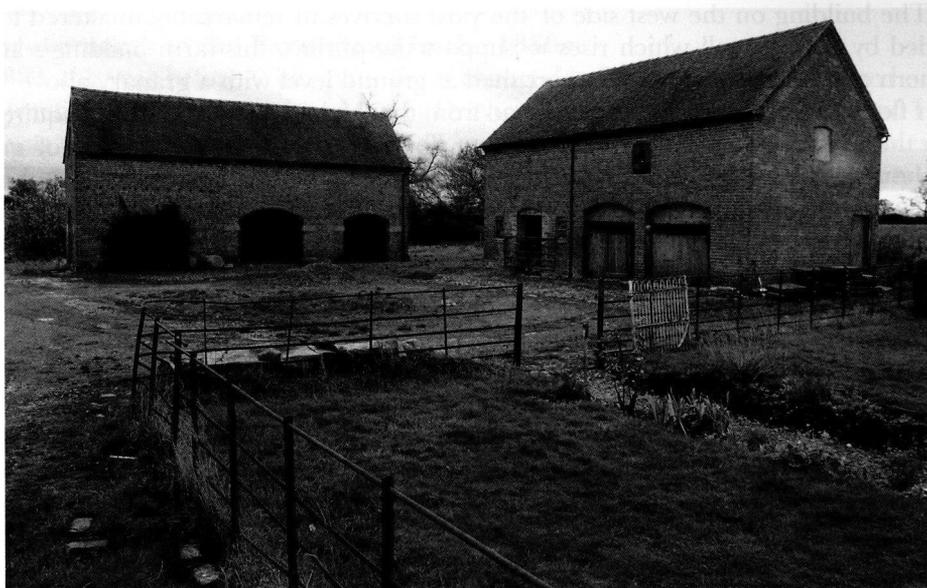
Fig 3

The early High Farming years buildings on the south (left) and west (right) sides of the farmstead's original fold yard (built mid-1840s). In the 1860s this fold yard was to be turned to use as a stackyard and the threshing barn on the south side of the yard remodelled for use as a cart house and implement shed. Its loft was used for hay storage. The south (left hand) end of the building on the west of the yard was always used as a stable (with hay loft above), the remaining part of this building being used as a cart shed with grain store above.

The building on the west side of the yard survives in remarkably unaltered form. Divided by a cross wall which rises to support the purlins, this farm building's larger northern part served as a two-bay cart shed at ground level with a granary above. The upper floor's primary purpose can be read from the thickness of its flooring (required to carry the weight of the grain), the trap door (for hoisting and lowering sacks of grain) and the glazed windows (to illuminate the interior whilst providing a barrier to birds). This two storey building's southern part was occupied as stables with hay loft above. On the stables' west wall can be seen evidence of the primary high level hay rack which will have been charged through the gap at the western end of the loft flooring. Home to both waggon and hackney horses, the stables' 19ft breadth was sufficient to accommodate four stalls measuring 4ft 9in. each.¹⁰

The primary form of the early High Farming years building on the south side of the yard has been obscured for it was significantly modified in the 1860s. However, sufficient evidence survives to appreciate that this mid-1840s building was constructed as a threshing barn. The brickwork at the eastern end of its north (yard fronting) elevation is all that survives of the primary construction. The only walling in this building to have lost-brick ventilation, the primary walling extends to a point some nineteen feet from the building's north east corner. It is understood that the westernmost of these surviving primary bricks originally formed part of the jamb walling of a substantial full height door opening. Providing through-access for fully laden carts, this door opening would have given onto

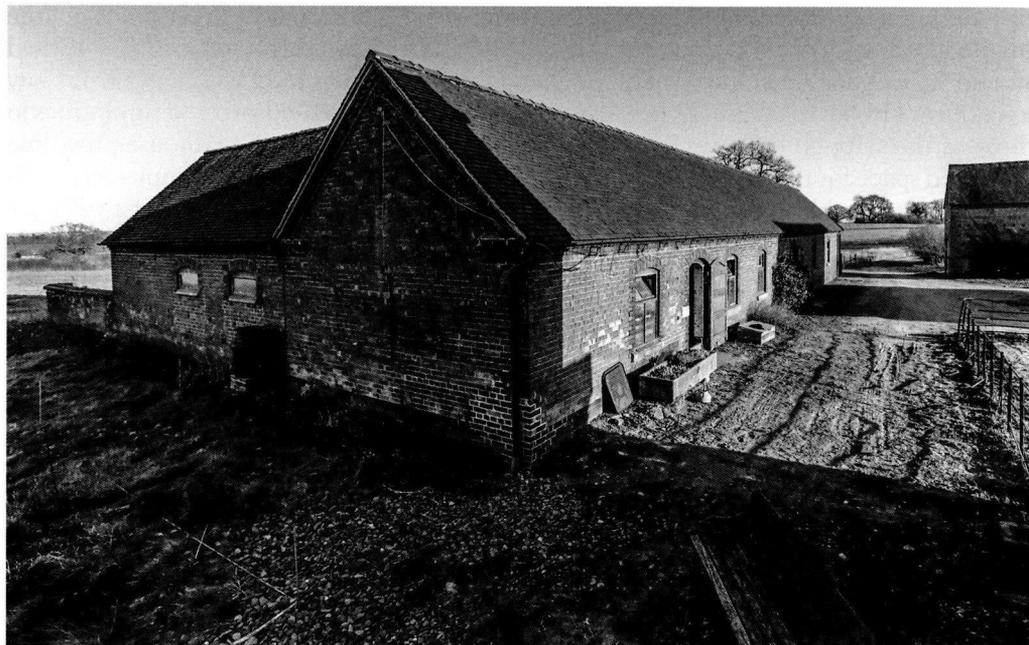
Fig. 4
The shippon photographed from the north-west.

old and two of the three key farm buildings had been up for no more than two decades. However, Heywood wasted no time in calling for work to commence on the replacement of the old shippon (Fig. 4). The new building was sited in a location which further regularised the rectangular 'in front of the house' yard arrangement (Fig. 5). The new shippon comprised a forty yard long rickyard-flanking cowhouse with projecting eastern wings at its northern and southern extremities. Providing winter accommodation for fatstock, milking cows, their calves and indeed for bulls, the new shippon had numerous door openings, was generously fenestrated and well ventilated. Constructed to an exacting design specification with materials of the best quality, the form of the building tells of the new landlord's zealous eagerness to improve. The farm records for 1865 provide evidence of the time and the considerable sums spent on the new building:¹⁵

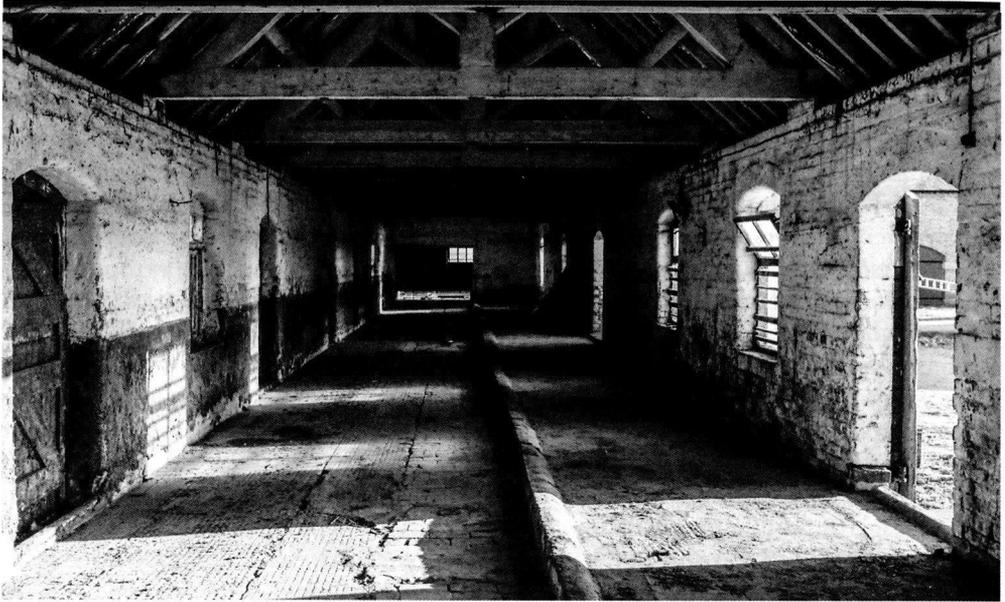
Fig. 7

The cowhouse photographed from the north, prior to the removal of the 1950s flooring. In the foreground can be seen the northern cross passage and at the far end the southern calves pen. In its primary form this long range was divided into two parts separated by the central food preparation room.

The chief elements of Whitegates Farm's shippon were its cow houses (Figs 7 and 8). These would have served as home to as many as twenty-four dairy cows.²³ They were tethered in pairs in 7ft wide stalls running spine-like down the length of the shippon.²⁴ To the west of this alignment of stalls ran a line of mangers from which the animals fed. Between these mangers and the west wall of the cow house ran a 4ft wide north-south aligned front feeding passage (Fig 9). A second passage of comparable breadth ran along the foot of the east wall of the cow house. This, the 'cleansing passage', was made of concrete (Fig 10).²⁵ At the centre of the cow house was a 16ft by 14ft vestibule accessible via door openings to both east and west yards. Further internal door openings provided routes through from this, the feed preparation room, to the north and south feeding passages.

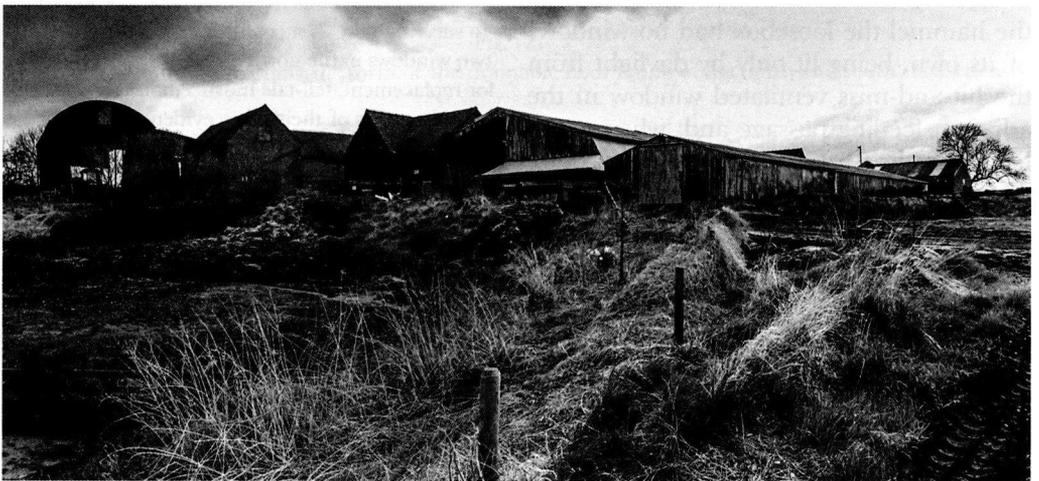
Fig 14

Whitegates Farmstead in its last months as a working farm, April 2010.

of adaptations to render it more compatible with new ways of farming. Less and less well suited to modern farming techniques, in the first decade of the new Millennium it had to be conceded that the shippon and the farmstead's other historic buildings were beyond viable agricultural use (Fig. 14).

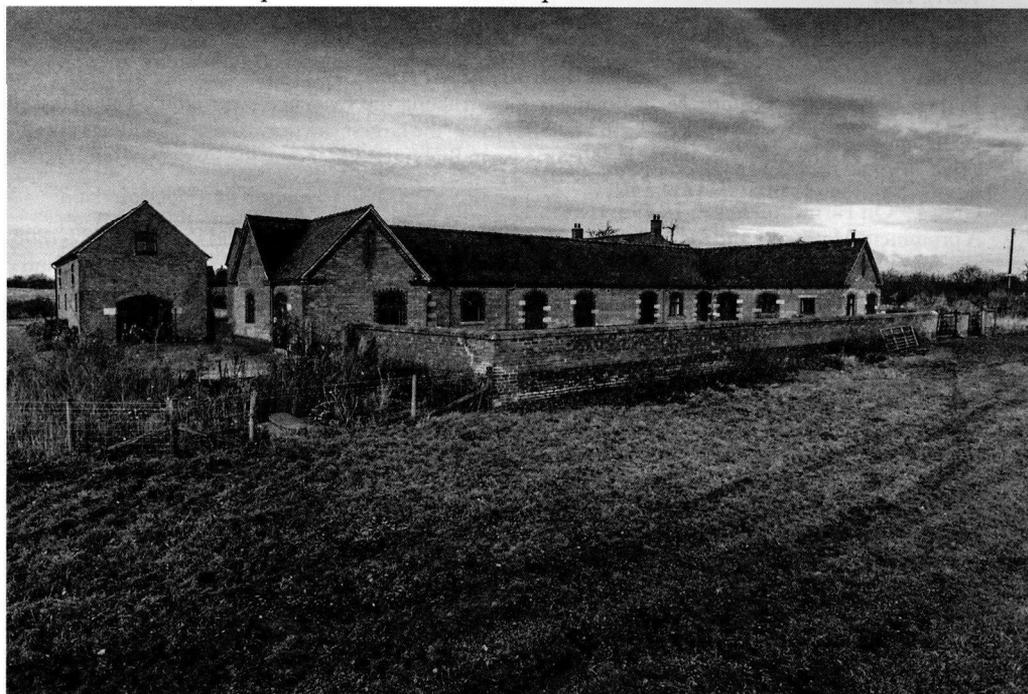
Fig. 15

Whitegates Farmstead in the immediate aftermath of the shippon's conversion, November 2016

In the planning of the scheme to vest the shippon with a new purpose careful consideration has been given to the potential impacts of proposals on the building's historic interest. Handsome, well built and with a generous collection of primary doors and windows, the shippon has proved relatively easy to convert to domestic use (Fig. 15). Retaining its external appearance as a farm building, all primary door openings have been kept, the wooden doors repaired and – in order to render the interiors fit for human habitation – secondary wood framed glass doors installed within the reveals. All window openings have been retained and new building regulations-compliant windows have been made. With their double glazed units, the new wood-framed windows match the primary windows in their functioning as well as their appearance. Rooflights – those 'it's a barn conversion' giveaways - have been studiously avoided. The only tell-tale signs of the new domestic use are the extract vents for the boilers and the black flue pipes for the two wood burning stoves.
