A Welsh Cruck Barn and the Study of Vernacular Architecture in Britain

EURWYN WILIAM

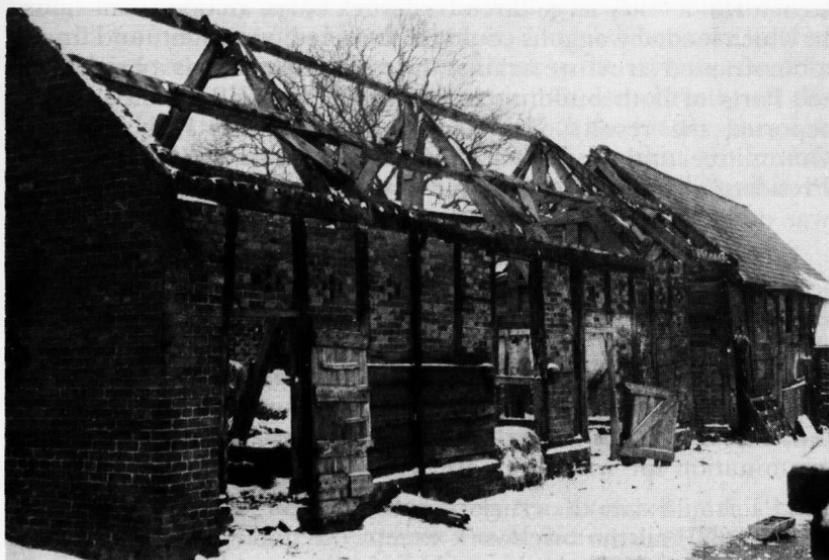
Fig. 1

Dismantling the Stryt Lydan cruck barn, January-February 1950. The cruck barn with its later brick gable is in the foreground, the box-framed additions in the background. The break in the roof-line indicates the location of the drift-house.

Gredington estate in Maelor Saesneg, the detached portion of the old Flintshire that projected into Cheshire (Fig. 1).

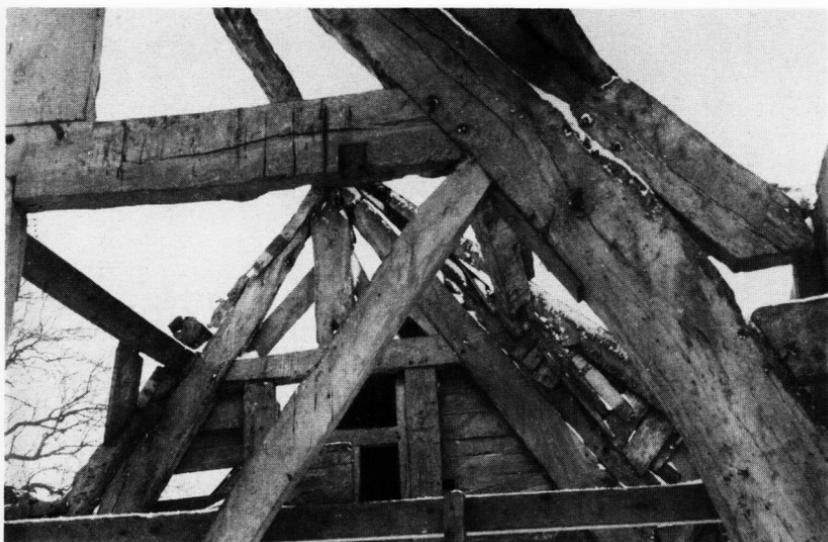
Fig. 4

A close-up view of Cruck III with the gable cruck, IV, in the background. Notice the packing-pieces under the rafters and the internal brace to Cruck III, together with a redundant (but still secondary) cut-out in the tie-beam. The waney edge of the tree is clearly visible along the outer face of the cruck.

Contents apart, today one cannot but be impressed by the speed with which these letters were delivered between Raglan's Monmouthshire home and St Fagans! Fox and Raglan's theory is not commented upon in the standard works on cruck buildings: it was probably ignored as a result of the controversy surrounding Lord Raglan's other claim, that crucks were peasant versions of the Gothic arch, a claim that he put forward in the 1950s but which has not found acceptance.⁵ Examination of the cruck blades of the Stryt Lydan barn in the company of experienced carpenters makes it clear that, in this particular case, at least, Lord Raglan was incorrect in his supposition. It is certain that each of these blades has been used in the same way as the tree from which it grew. The growth rings around the knots are compressed more tightly together at the top, and the considerable amount of sapwood and bark left on the apexes enables the thickness of the branch to be easily calculated: these two factors are conclusive (Fig. 4).

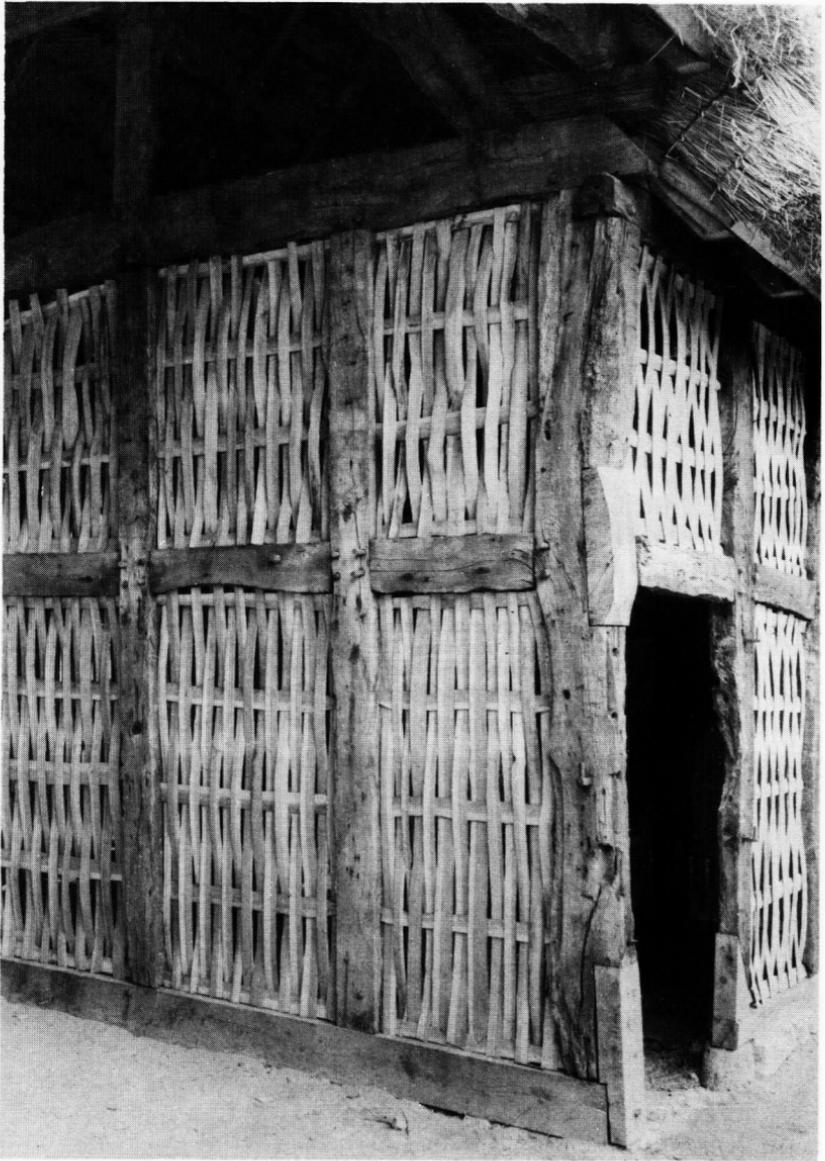
Fig. 6

A corner of the box-framed addition, showing the careful introduction of new timber and the oak laths which gave so much trouble.
National Museum of Wales: Welsh Folk Museum

A flagged floor was laid throughout the building, but this was a concession to the public and would originally have been of earth. Very little new timber was used in the re-erection, and no attempt was made to hide what had been replaced (Fig. 6). Indeed, it was regarded as a central principle that the Museum should be totally 'honest' in its approach to re-erection and renewal. The policy of using as little new timber as possible received a fillip from the fact that all purchases of new material had to be licenced by the Ministry of Works, who because of post-War shortages urged that as much original material as possible be re-used. Several of the cruck blades, however, required strengthening and this was provided by metal plates, some of which had already been inserted before the barn was donated to the Museum. Several of the doors were made anew, as were the massive wooden hinges that held them. A mystery persists regarding the original location of the doors on both sides of the threshing floor: before the barn's removal both doors were sited immediately to the east of where they are now, and it is not clear if this was simply a mistake or whether there was some

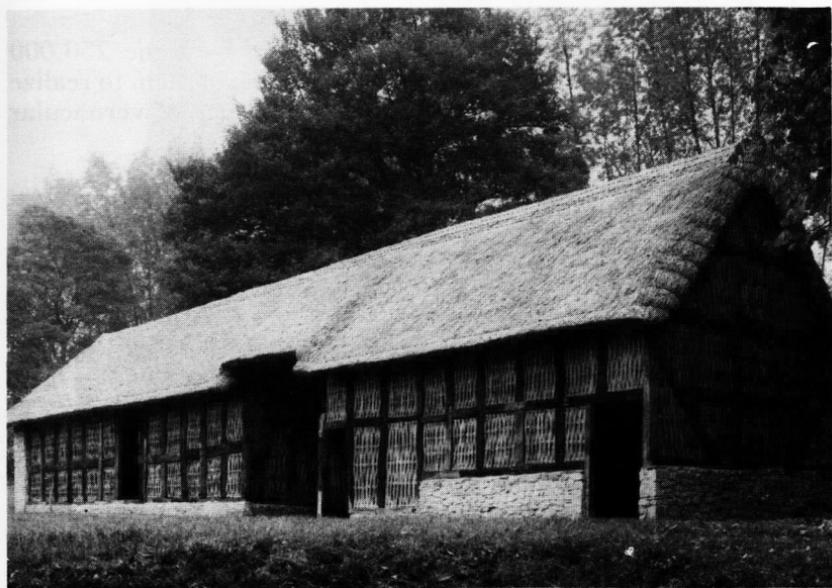
Fig. 8

The completed barn, clearly showing the three separate sections of the building.
National Museum of Wales: Welsh Folk Museum

The Stryt Lydan barn is currently seen by some 250,000 visitors a year (Fig. 8). This note may help some of them to realize its significance in the development of the science of vernacular architecture in Britain.
