# Some Clay Dabbins in Cumberland: their Construction and Form Part I

J.R. HARRISON

*This paper, of which Part II is to be published in Transactions, 34 (1990), summarizes the results of field studies of a number of cruck-framed and clay-walled houses on the Solway Plain in Cumbria, carried out between 1979 and 1982. Part I considers the clay wall, the cruck-frame, and the associated rafting and roofing system. New material is presented, confirming the Cumbrian approach to structure and roofing, now uniquely embodied in the buildings of the Plain, as firmly within recent highland tradition, with the possibility of wider connections. The detailed relationship between mass clay wall and cruck frame is explored and the historical and functional primacy of frame over wall demonstrated. Part II will present a number of individual case studies of building plan and section, will consider the way in which these changed with time and will conclude with a brief survey of the wider structural, material and plan-form context of the tradition.*

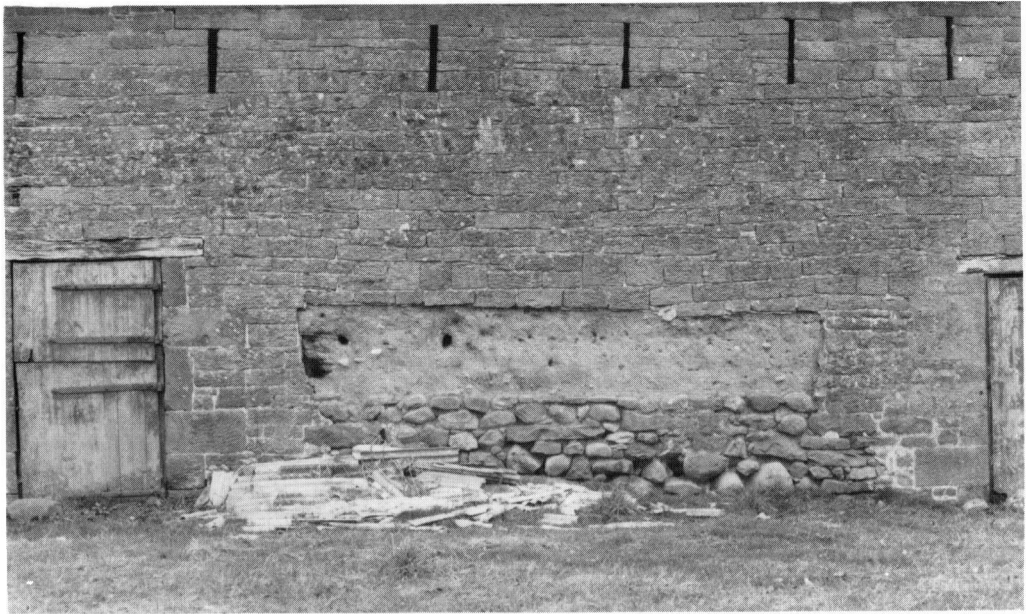
Fig. 1

Building materials succession on the Plain. Part of a barn wall in the south-east of the region, probably dating from the nineteenth century, and made of blocks of quarried sandstone. The stone has been built around, and has protected, a remnant of earlier mud walling. The roughly-coursed split fieldstone base of the mud is in contrast to the regularity of the later walling. Cumbrian sandstone is readily worked compared to the cobble off the glacial till. At the time of its construction the squared stonework must still have been expensive enough to justify the recycling of even this small part of the earlier walling

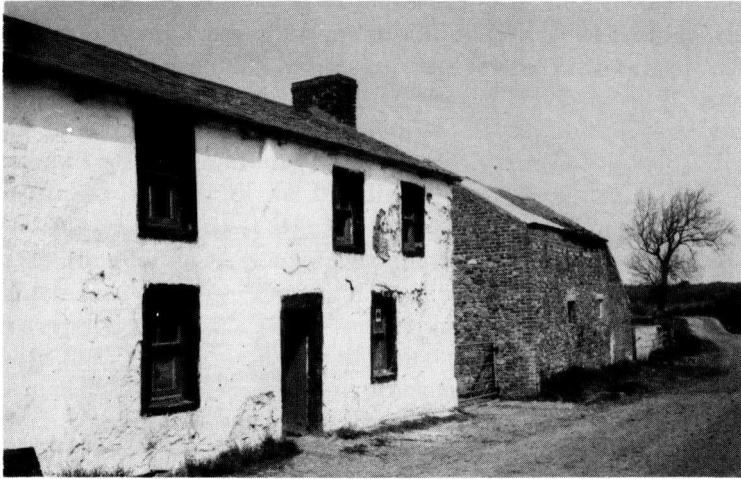
Fig. 3

Mud, cobble, red brick, stone slab and slate-roofed farm buildings near the shore of the Solway Firth. A standard oak in the hedgerow completes the picture of local materials. The course-lifts in the cobble-work of the barn are some 12in. (300 mm.) high in the side walls and are higher in the gable. Lime mortar, to bond cobble walls of this sort, had to be transported from the fringe of the Plain. The most expensive material, brick, was reserved for quoins and for use at the upper levels to give maximum stability there. In the domestic accommodation brick has been employed to raise part of the original building from one to two storeys

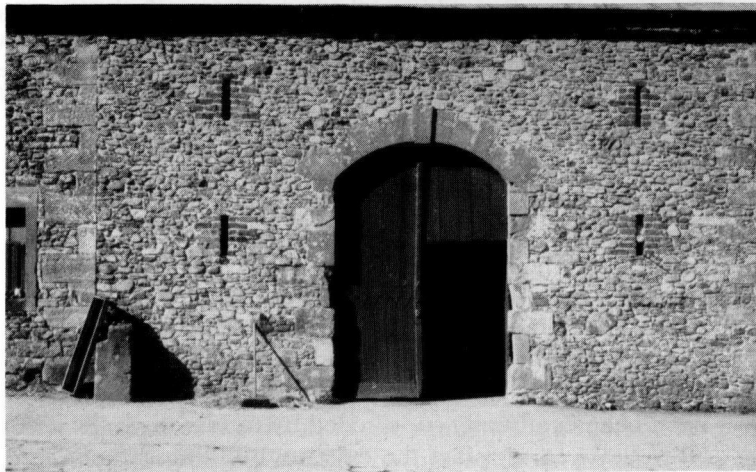
Fig. 4

Another example of the later tradition which produced buildings rich in textural quality and colour through the use of grey cobbles and soft red bricks and red sandstone

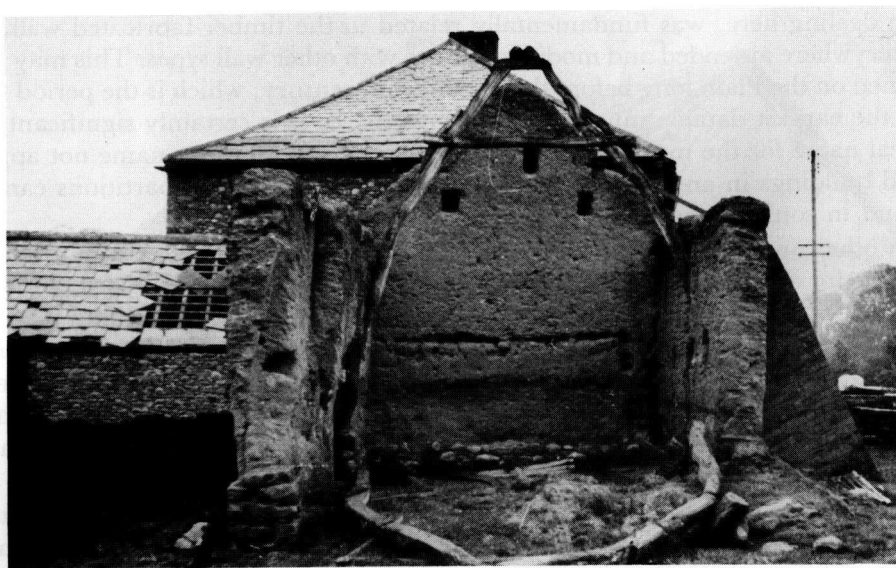
Fig. 6

Cruck frame and mud walls in a barn at Durdar  
*Miss Alice Smith and the Ralph Cross Archive*

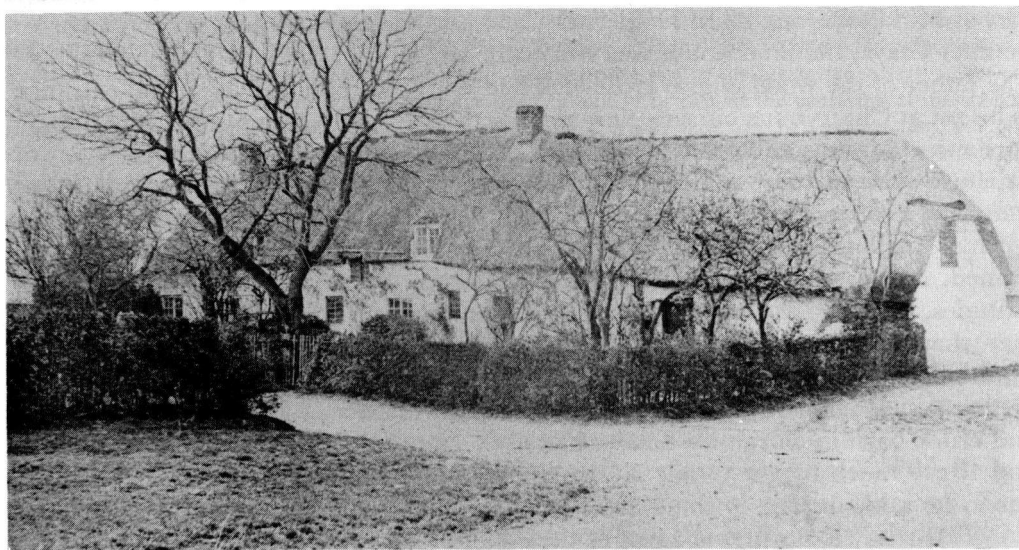
Fig. 7

Thatched cross-passage house, barn and stables at Fimber on the North York Wolds, destroyed in the late nineteenth century. The walls of this house were originally daubed on split oak wattling  
*Kingston-upon-Hull City Museums and Art Galleries*

In other areas of the North, crucks now occur within stone walls but daub as a cladding for cruck houses was still remembered on the Yorkshire Wolds in the early nineteenth century (Fig. 7). It was said there, that, when the wattle and its 'clay' covering decayed, '... they were replaced from time to time by chalk stones, cemented with grit.'<sup>5</sup> Various forms of quite thick external mud walling containing timber armatures have been found in cruck-framed houses on the Fylde Plain of Lancashire. Such combinations contrast strongly with Cumberland where as far as is known the arrangement has yet to be recorded with certainty.<sup>6</sup>

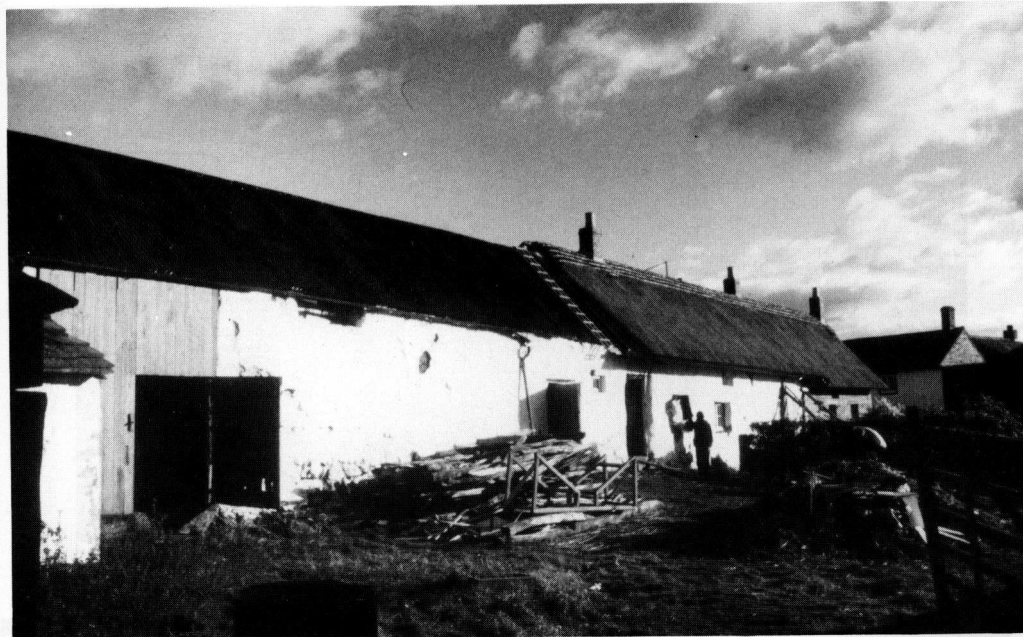
Fig. 8

Lamonby Farm, Burgh by Sands, Cumbria, undergoing repair and reconstruction in 1982. From the left of the illustration are the barn entry, byre entry, cross-passage entry, house and 'cottage'. The whole was at that time mud walled. The buildings were originally thatched throughout  
*Miss Alice Smith.*

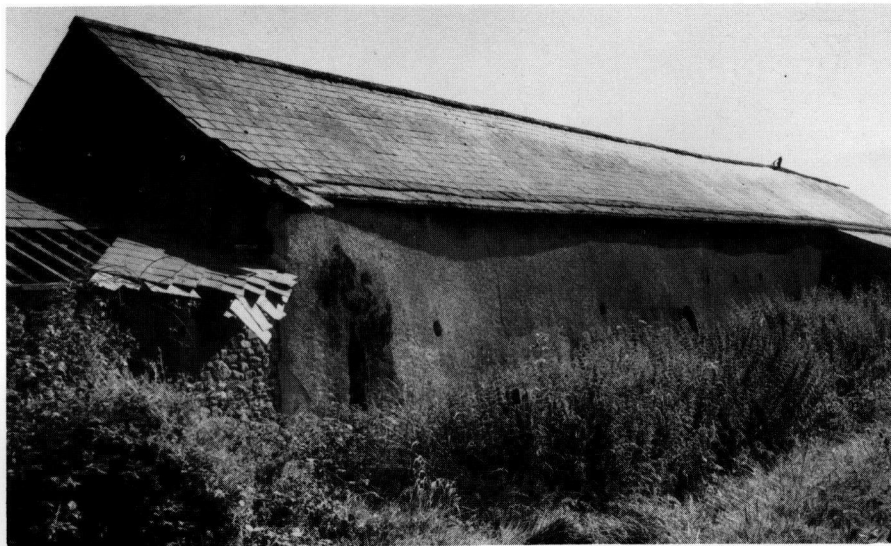
Fig. 9

The barn at Moorhouse, 1980, now tragically destroyed. This building, unique in terms of its great size and numbers of crucks, was of mud throughout. The walls and roof had probably been raised to carry slate. This structure, listed grade II\*, was allowed to collapse in 1988

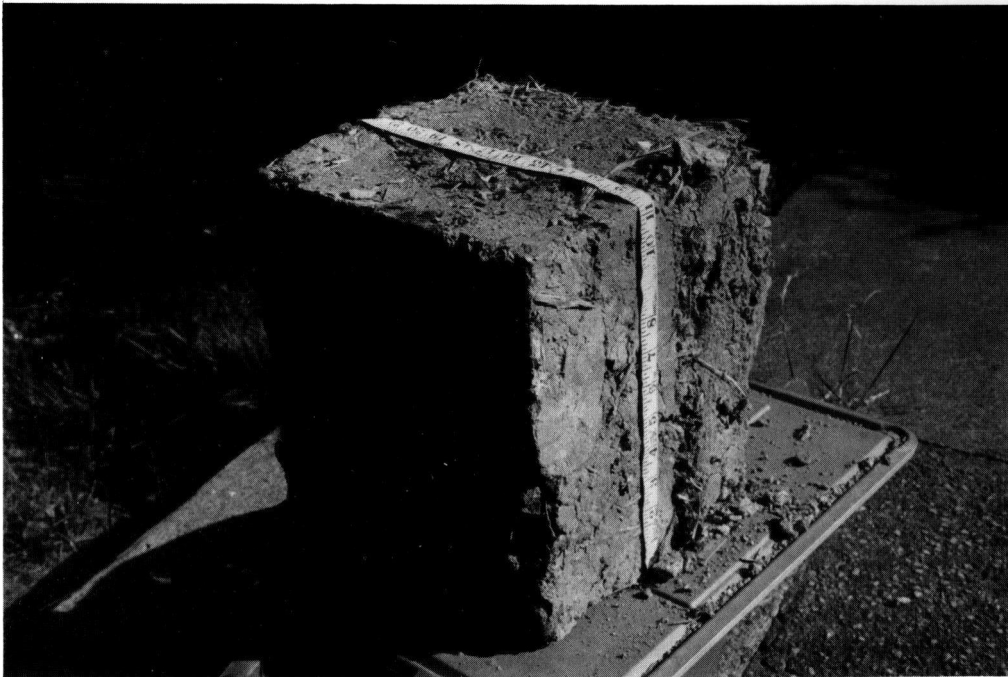
Fig. 12

An experimental 'cube-foot' (300 mm. x 300 mm. x 300 mm.) of Devon 'cob' produced in the early 1980s by the Devon builder Mr Alfred Howard

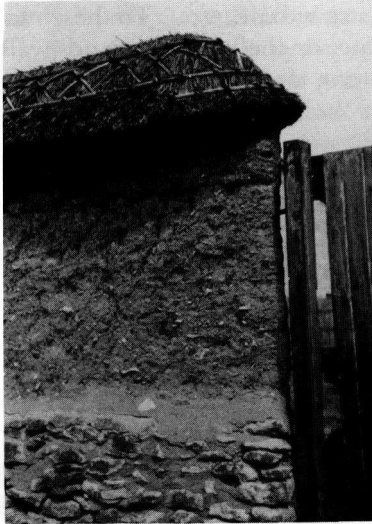
Fig. 14

(a) (*left*) Mud boundary wall in Whittlesey, Cambridgeshire, 1979. Signs of diagonal layering, running from upper right to lower left can be seen in the wall face

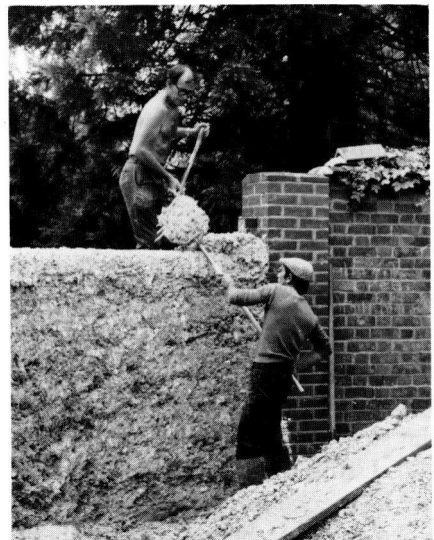
Fig. 15  
Rebuilding a chalk-mud wall at Andover, Hampshire,  
1982

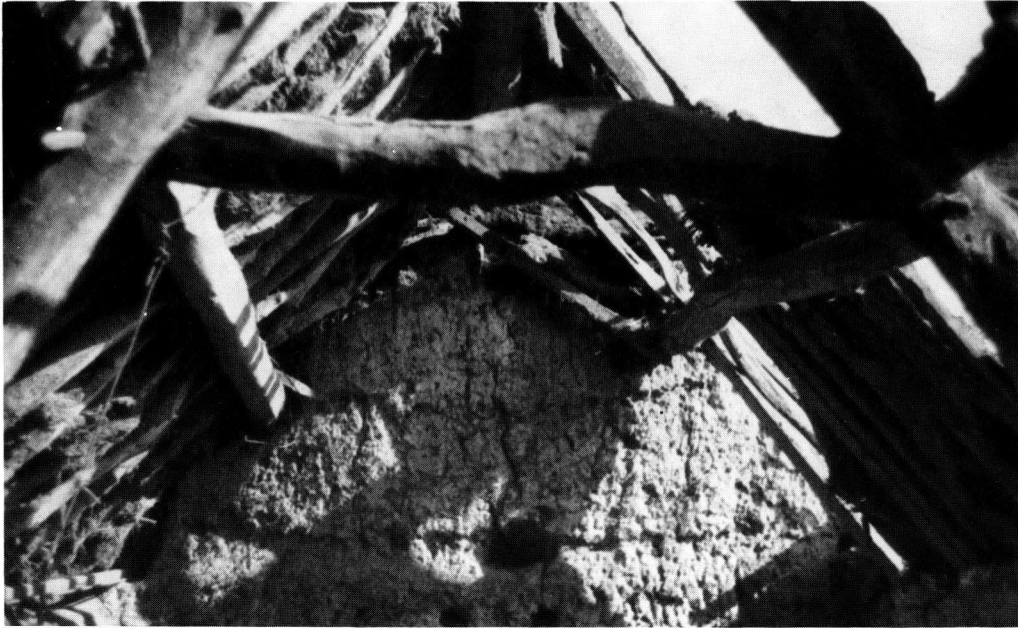
Fig. 16

Conventional deep-course walling in a cottage at Green Lanes, Dalston, Cumbria in 1980. Note the vertical striations made by the paring tool, as well as the 'block' form of shrinkage cracking within courses

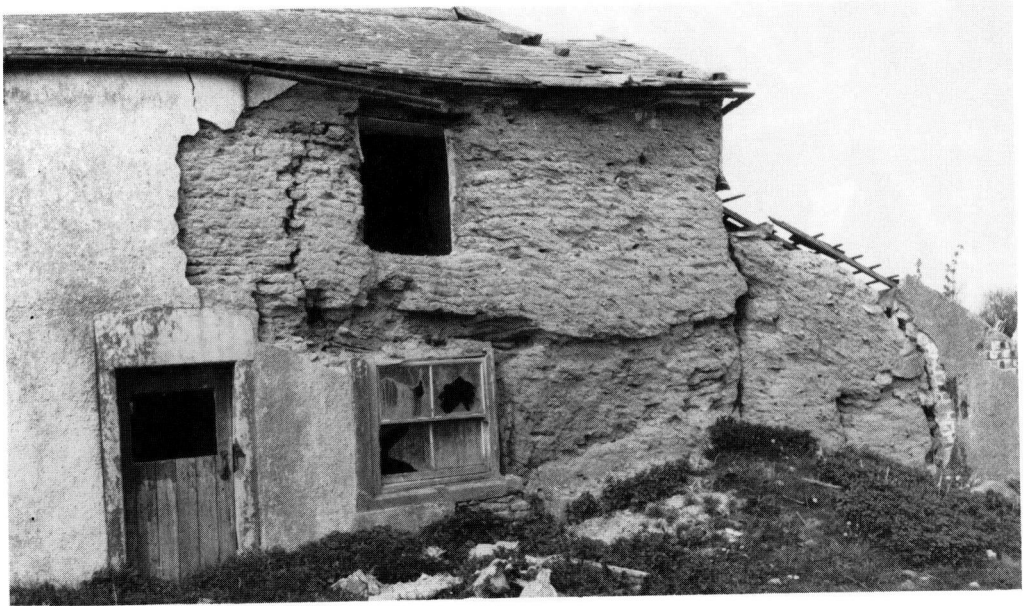
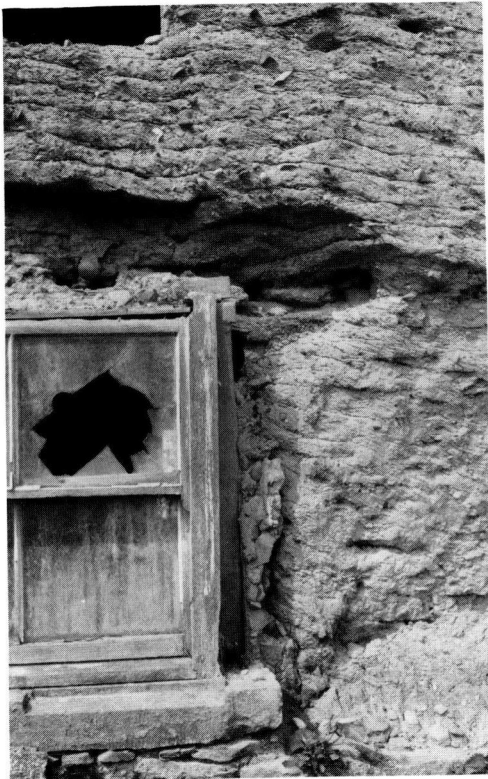
Figs 17 and 18

A farm house at Kelsick on the Plain, 1979, since destroyed. The typical thin beds of clay are separated from each other by layers of straw. There is no evidence of the sort of horizontal 'block' shrinkage to be seen in figure 16. However, major differential settlement failure is visible extending as a crack, vertically, from the jamb of the front door to the eaves. The face of the clay wall to the right of the lower window has sheared away as a result of the settlement. The fixed and rigid nature of the stone door-jamb has been a major factor contributing to these failures. Such stonework is an introduction into the local tradition

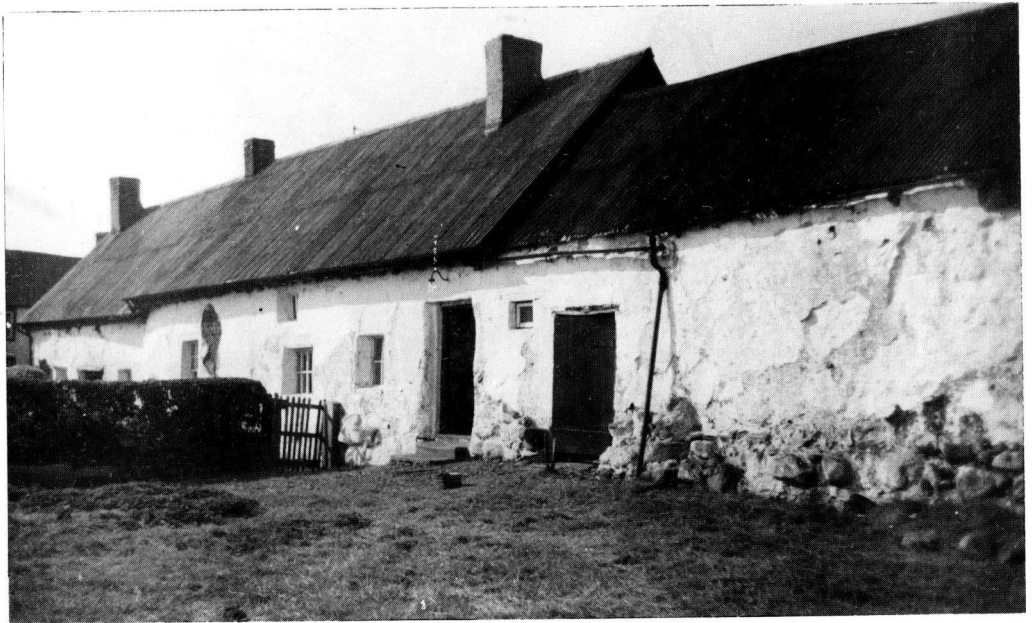
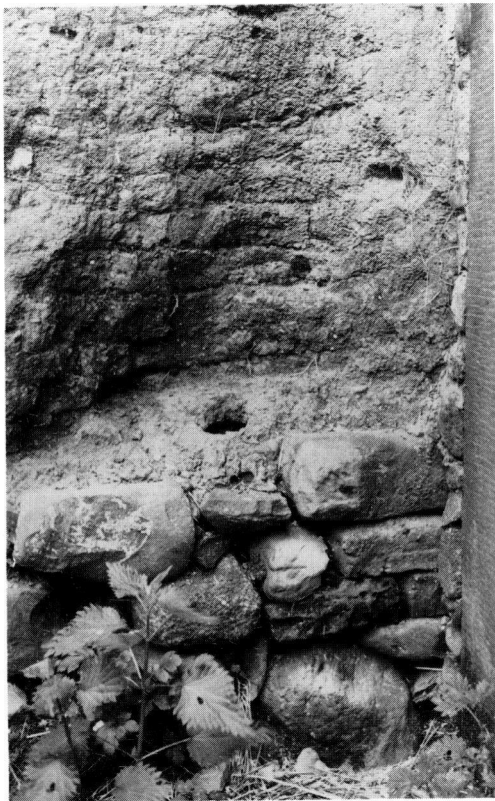
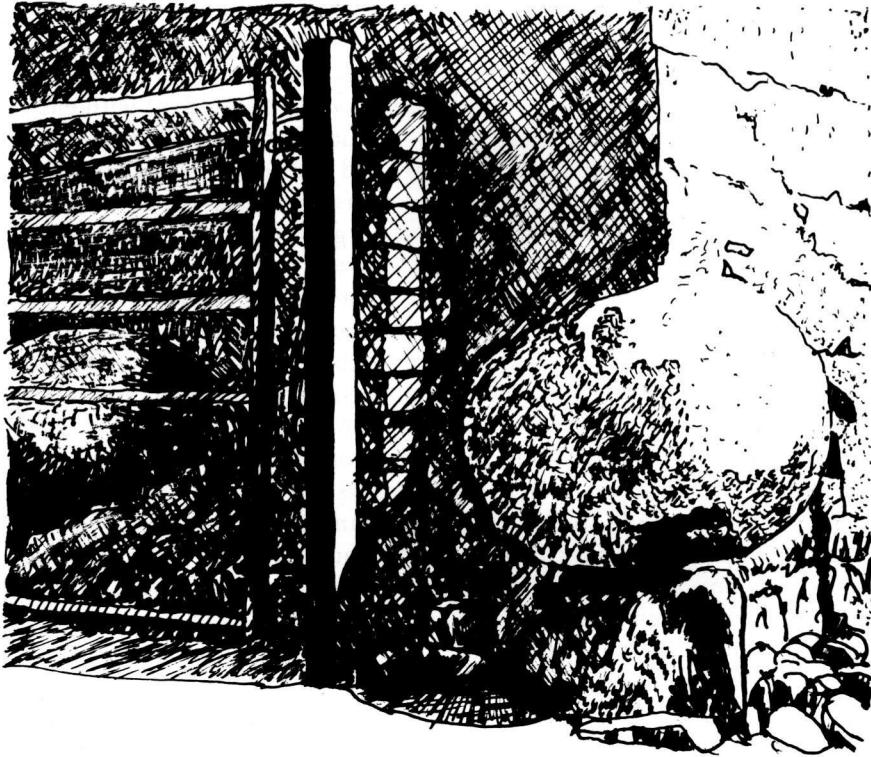
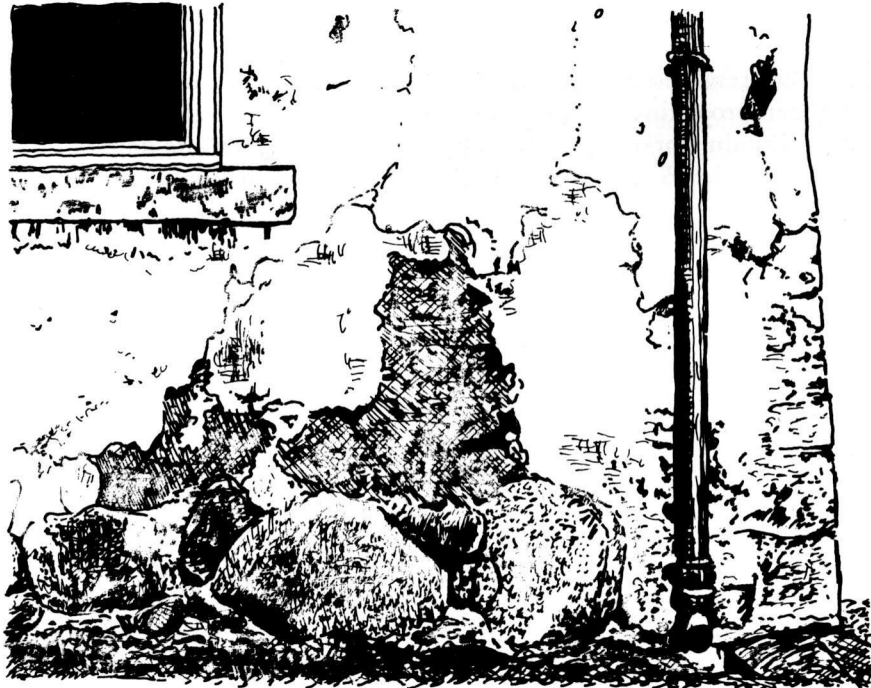
Fig. 20

Details of boulder and cobble wall-plinths on the Plain. (a) shows, nearest the camera, the (later) barn at Lamonby Farm. Fig. 20(b) shows smaller stones used in the base of a house at Kelsick. Fig. 20(c) and (d) relate to other buildings in Burgh by Sands. The huge projecting boulder at (c) clearly proclaims its purpose which is to protect the corner of the building. By contrast the battered mud wall corner at (d) is protected by squared masonry

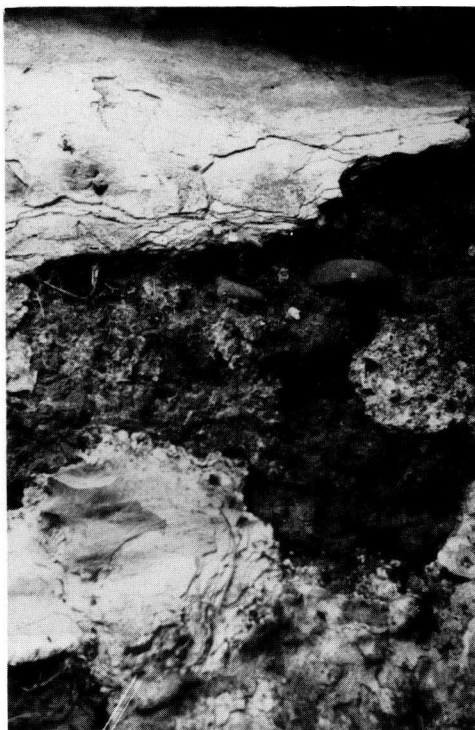
Fig. 22  
(left) Coats of limewash applied to a pre-smoothed  
clay wall-face

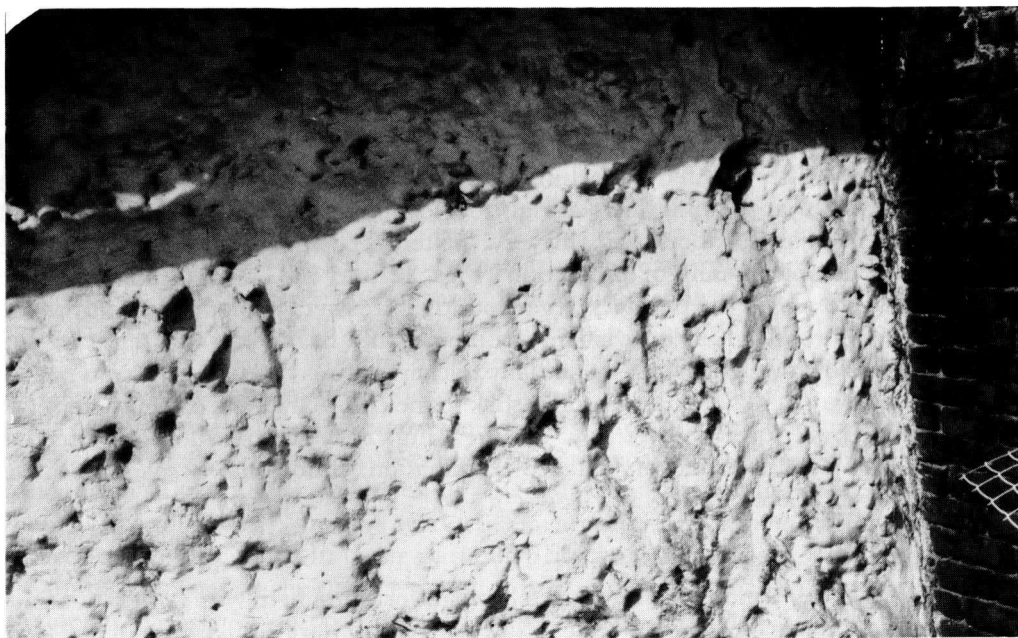
Fig. 23  
(below) Limewash coats over an unregularized  
clay wall on a low, sheltered, easterly elevation  
beneath overhanging thatched eaves

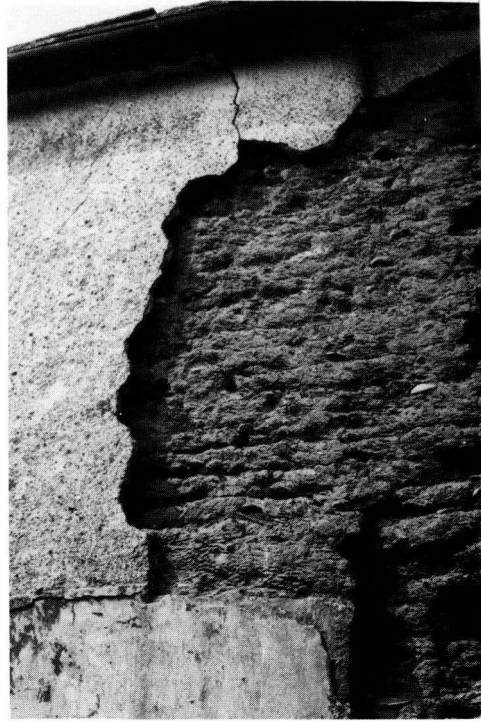
Fig. 24

(right) Very hard (probably) Victorian cement rendering, 'dashed' with gravel and small stones. The material is however so 'strong' that it has bowed off the wall in one piece

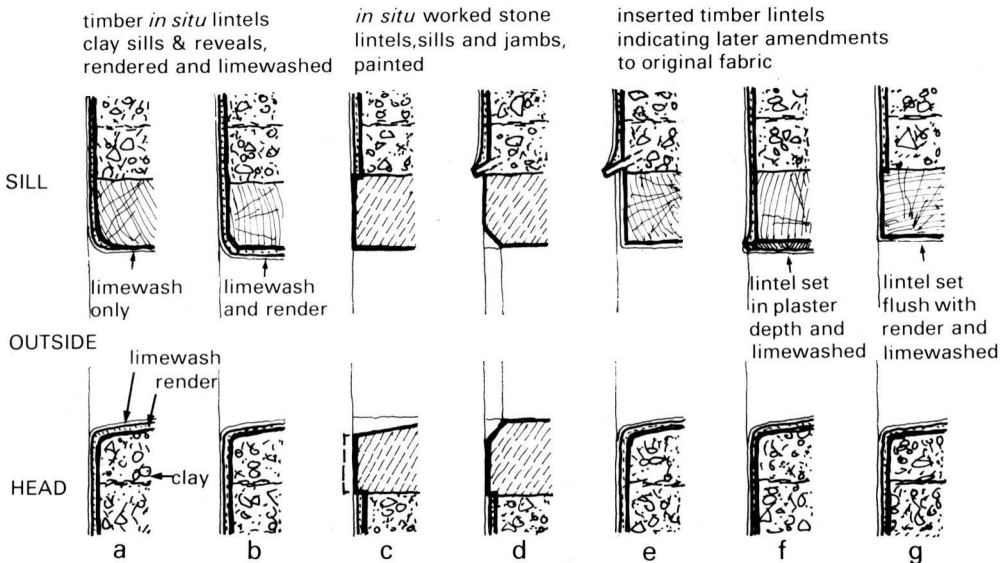
Fig. 25

(below) A variety of openings details in clay walls; vertical sections taken through the outer part of the wall only

The form taken by window sills and lintels can offer some help with general dating. The oldest detail in figure 25 is that at (a). Such sills were quite without the drip

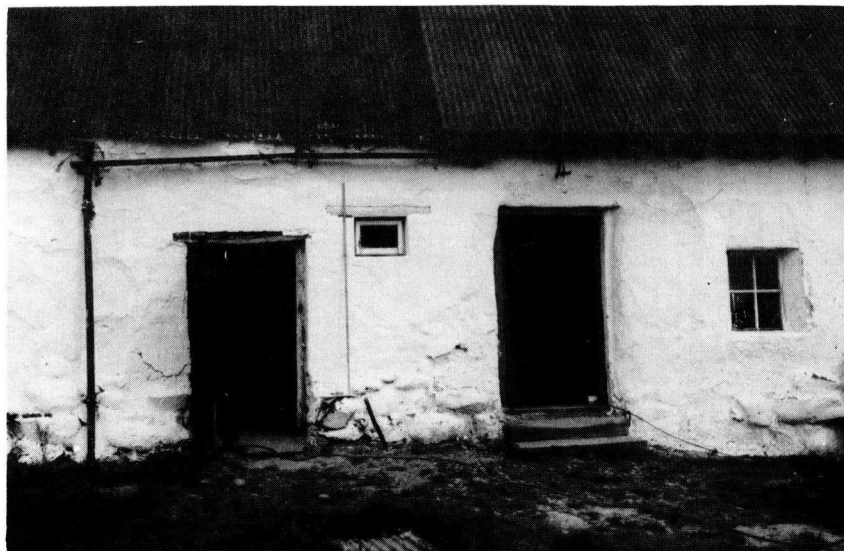
Fig. 26

Openings in the west wall of the house and byre, Lamonby Farm. The steps lead to the cross-passage, the ground falling away from here to left and right, along the face of the building. The door on the left leads into the byre. The 'fire window' is on the right (see Part II (forthcoming) for discussion of these features)

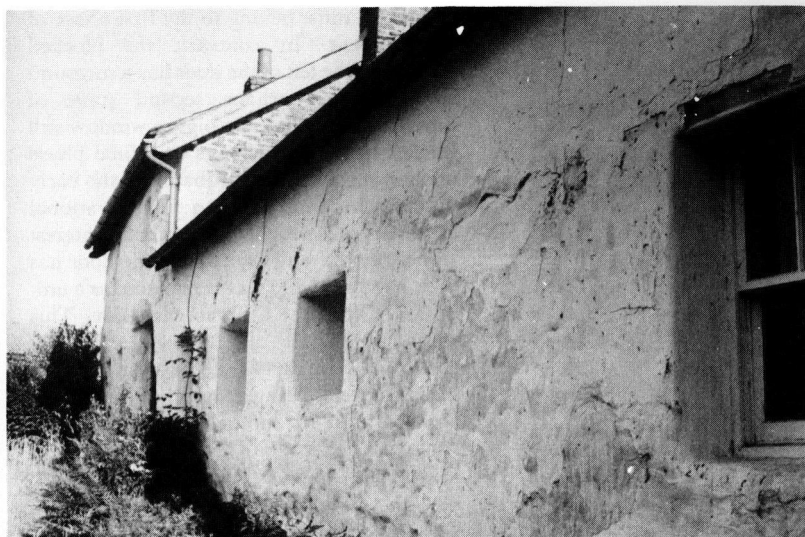
Fig. 27

House at Longburgh, 1979, since re-rendered. Evidence for the 'raising' of the side walls is visible above the windows

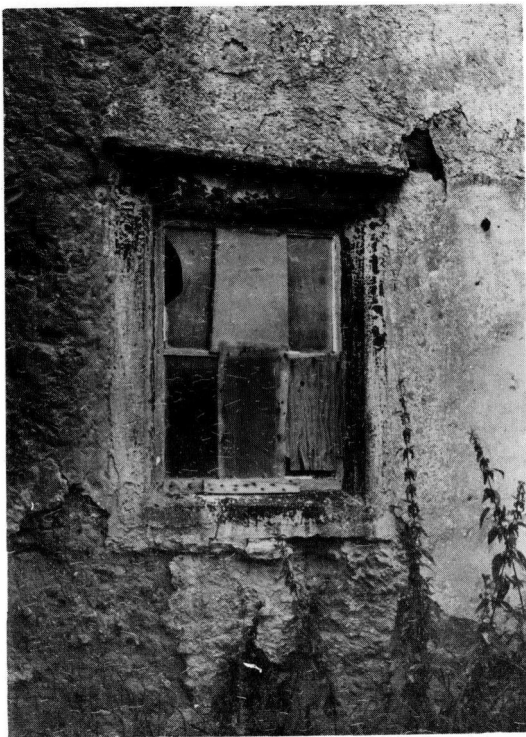
Fig. 29

(left) Chamfered window-surround with simple functional dripstone above. The latter is needed to prevent water running back round the chamfer into the window

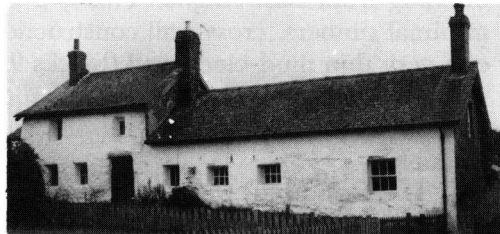
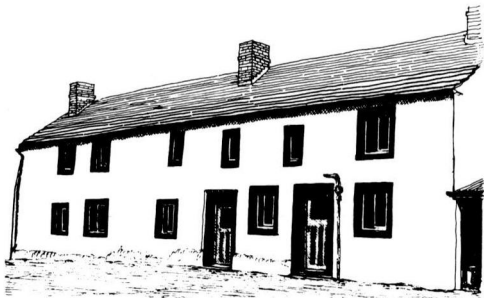
Fig. 31  
Houses with and without window surrounds. Both have had their side walls raised (Moorhouse and Longburgh). The surrounds are in the one case here painted blue, more usually they are black

An illustration of houses at Moorhouse and Longburgh (Fig. 31) shows the strong stylistic difference between those buildings where the window surrounds are highlighted, paint often being applied to the type of stone surround described above,

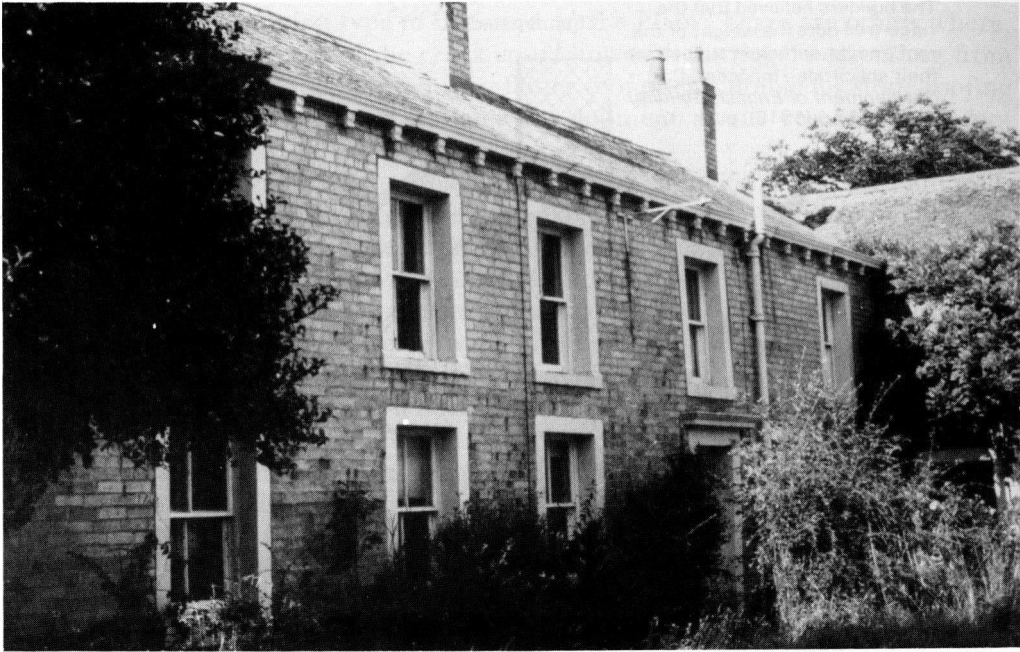
Fig. 32

Victorian yellow brick facings to a house with mud walls, Burgh by Sands

and those where they are not. Both styles co-exist on the Solway Plain; the simpler detail is the earlier. Figure 32 illustrates brick casing, quite another form of external finish. This is found quite often in other mud-building areas but it is not very common in Cumberland. In this example, it has been added to conceal out-of-fashion mudwork and it might be thought to give a better wearing wall-face than render traditionally applied. However, such a skin does not prevent water working in behind, unseen. It was as a consequence of water penetrating at the wall-head, down between the two materials, that a mud wall was discovered here when a gable collapsed.<sup>32</sup>

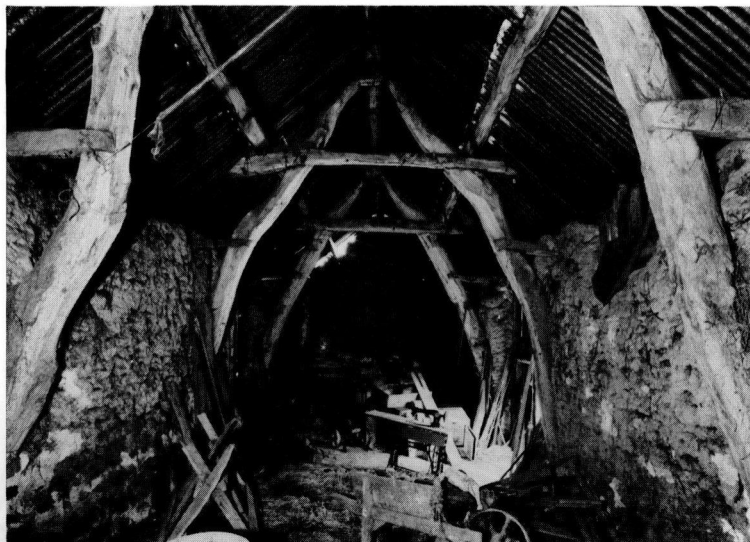
Fig. 37

Interior of attached barn at Lamonby Farm. Workmanship and finish is poor when compared to that of the earlier house. The view is towards the clay north gable, and was taken in the early 1980s  
*Royal Commission on the Historical Monuments of England*

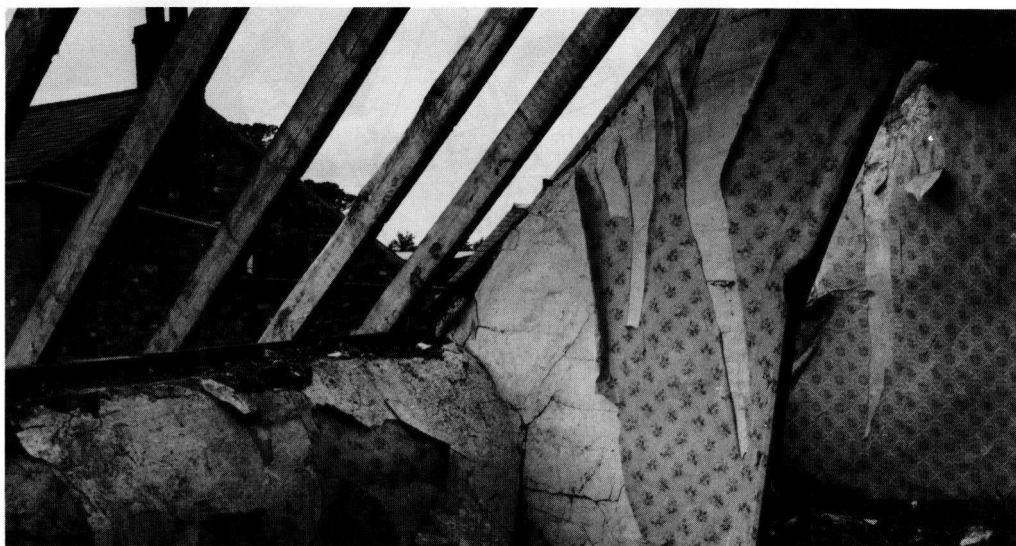
Fig. 38

Round-topped 'beam filling' to the head of a mud side wall, Lamonby Farm. The rafters and wall plate are modern, part of the reconstruction of the early 1980s

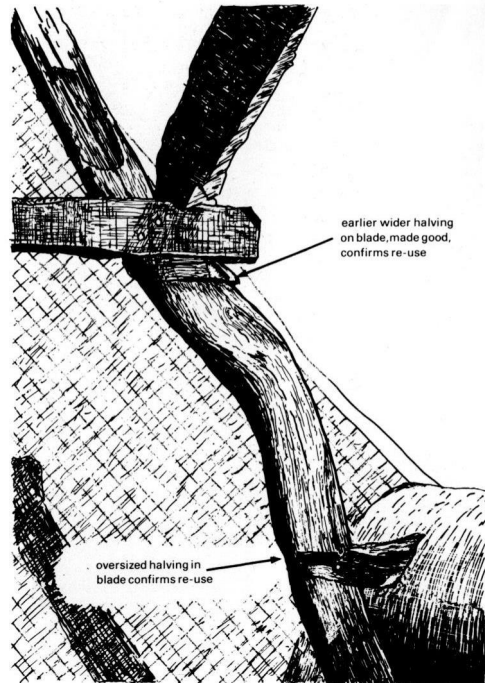
Fig. 39  
Evidence for re-used cruck blade at Lamonby Farm, house section

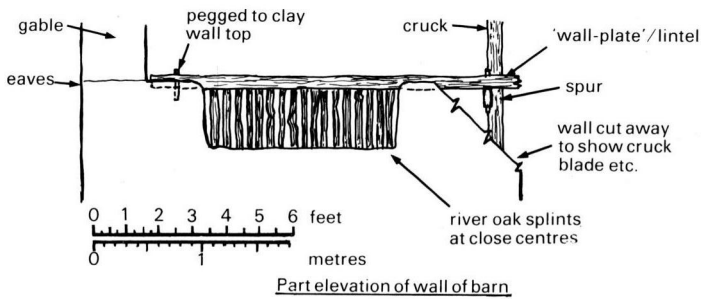
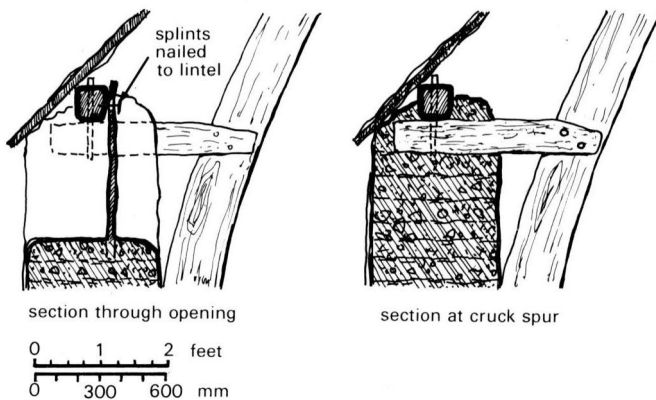
Fig. 40  
A cruck-spur providing a fixing point for a wall-head lintel over a ventilation slot in the attached barn, Lamonby Farm

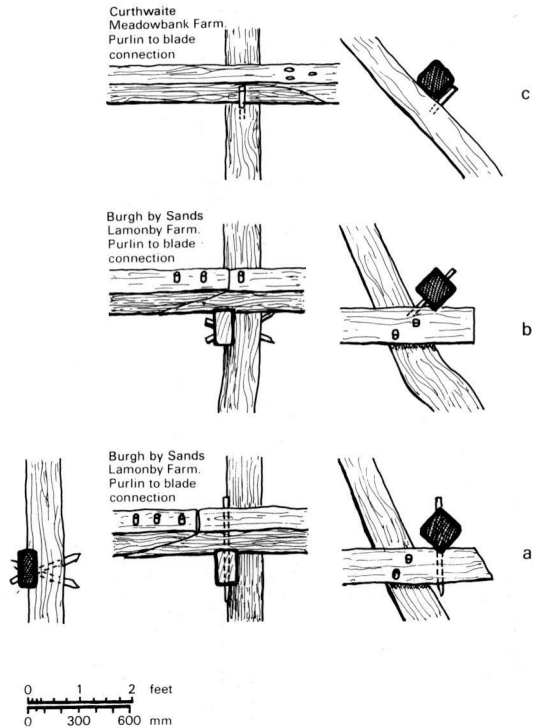
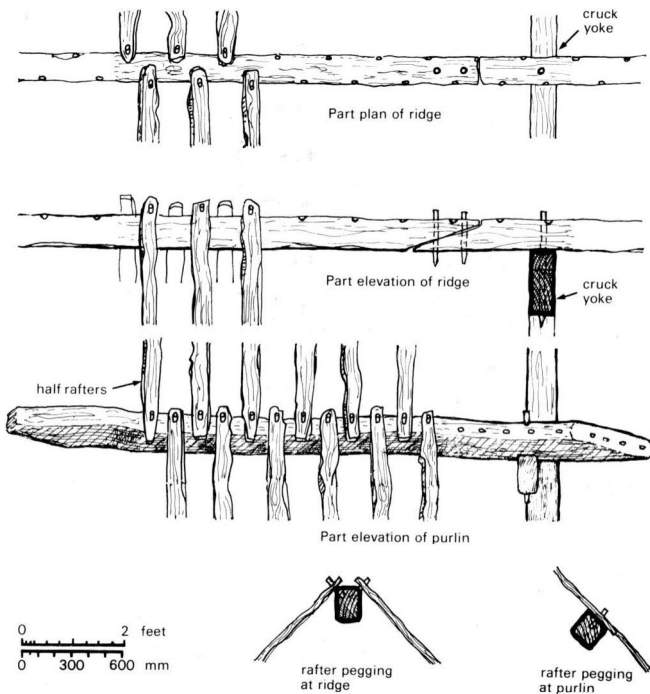
Fig. 43

Ridge form and the relationship of rafters to ridge and purlin (Lamonby Farm). Unlike the purlins, the ridge is invariably set flat side down onto the top of the cruck yoke. A square ridge-setting relates in Devon to earlier cruck-framed houses. Only later were ridges there set up on the diagonal. Information given by John Thorpe, Vernacular Architecture Group Winter Conference 1988

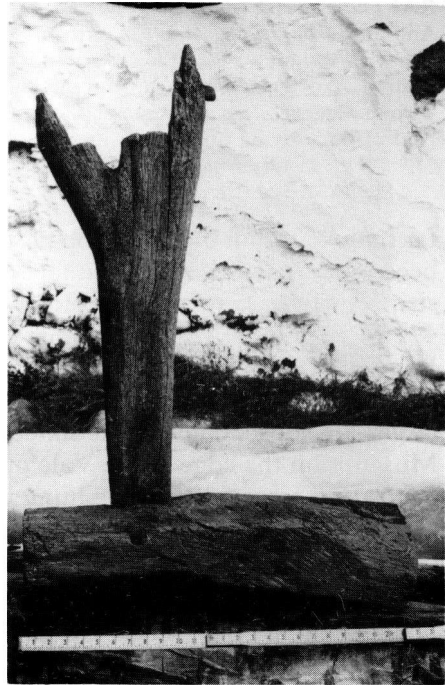
Fig. 45  
Photograph of the 'gable-crutch' at Lamonby Farm,  
lost during reconstruction (Lamonby Farm  
'Cottage')

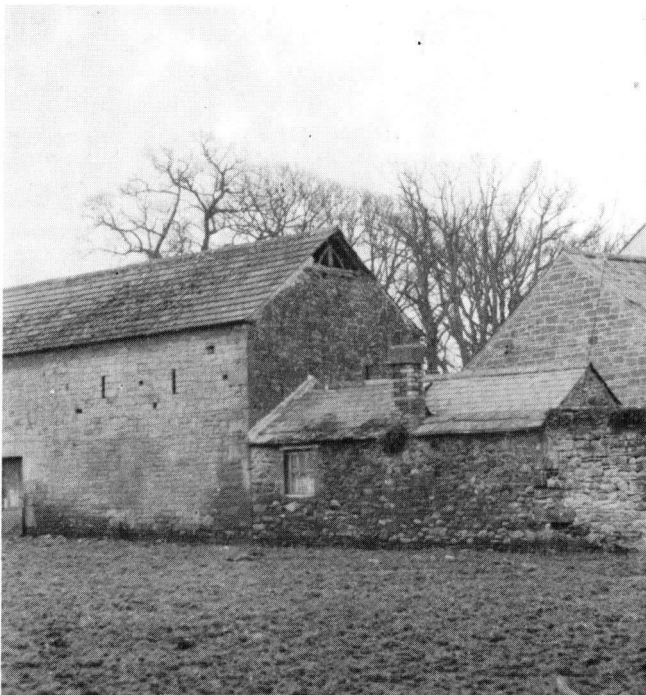
Fig. 46  
Similar ridge-end support in a  
stone-walled barn at Ratten  
Row, Durdar, 1988

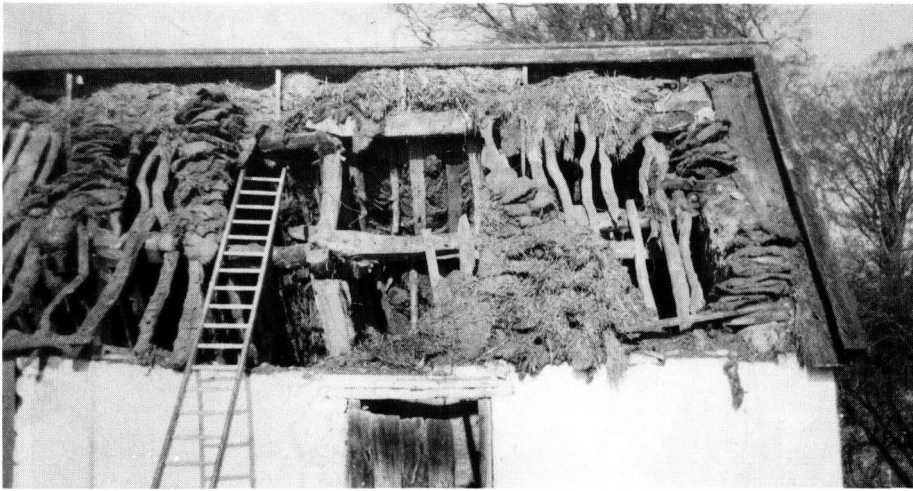
Fig. 47

The roof structure of a 'cottage' at Green Lanes, Dalston, 1981. The roof finish was straw over sods. The sods can be seen heaped-up

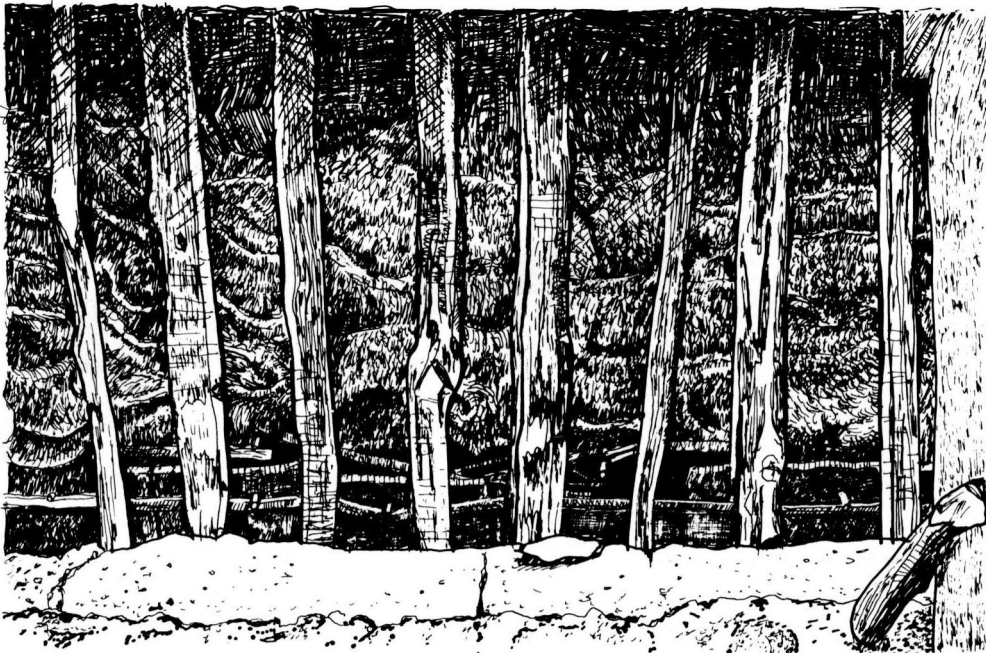
Fig. 48

Detailed sketch of the underside of the house roof at Lamonby Farm showing the wall head, split oak rafters with sods above them, and at low level, split lath (broken) supporting stone slabs at the eaves

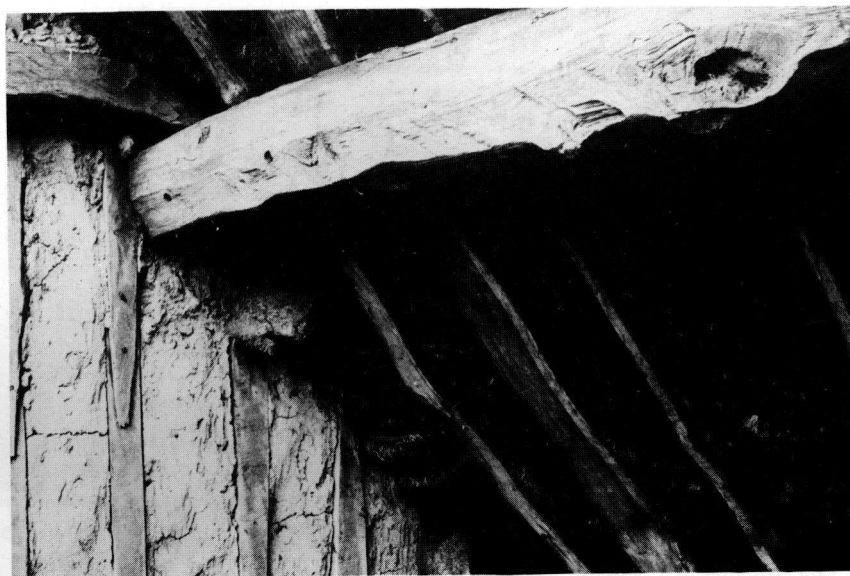
Fig. 49

View of the underside of the roof of the house, Lamonby Farm, exposed by the removal of the ceiling, 1981

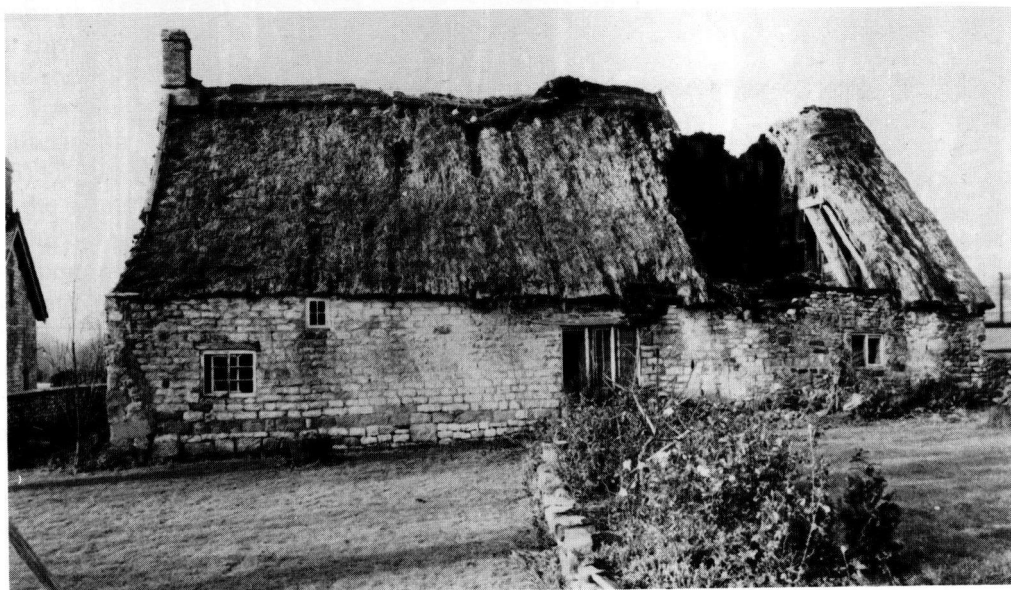
Fig. 50

Harmone Hall, North Yorkshire, in its original location. Note the very heavy timber wall-plates  
*Royal Commission on the Historical Monuments of England*

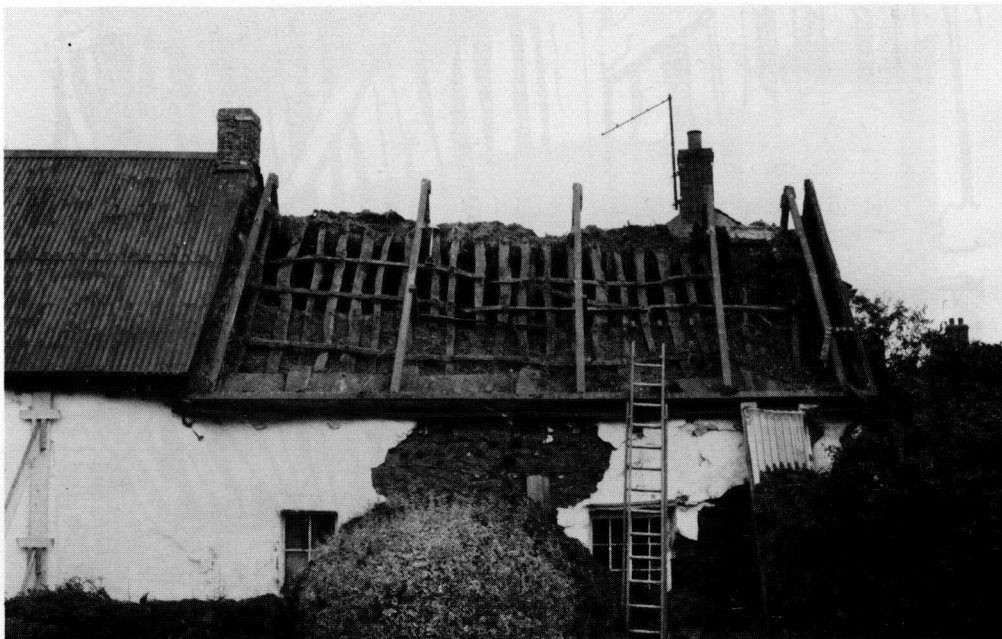
Fig. 52  
Rafters at Lamonby Farm Cottage in long view and close-up, 1981

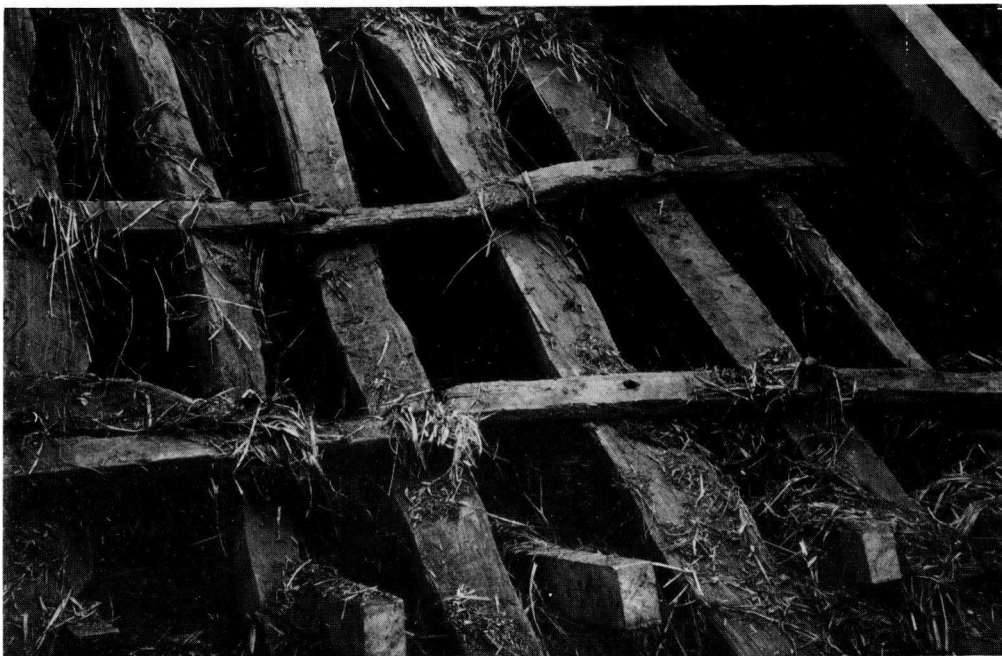
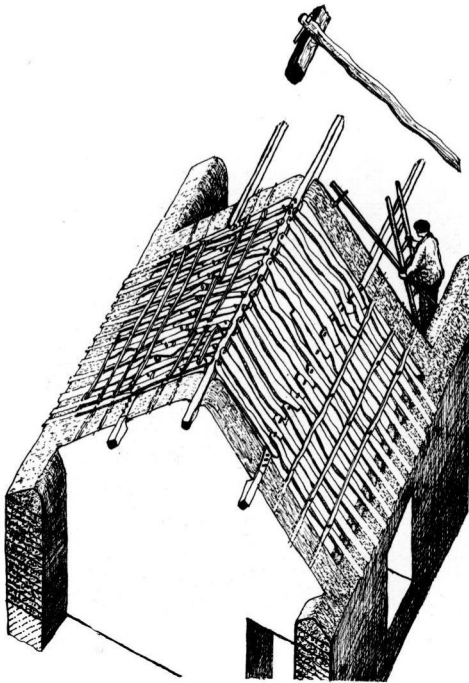
Fig. 53  
The roof structure, Meadowbank Farm,  
Curthwaite, Cumbria
