# Some Clay Dabbins in Cumberland: their Construction and Form Part I

J.R. HARRISON

*This paper, of which Part II is to be published in Transactions, 34 (1990), summarizes the results of field studies of a number of cruck-framed and clay-walled houses on the Solway Plain in Cumbria, carried out between 1979 and 1982. Part I considers the clay wall, the cruck-frame, and the associated rafting and roofing system. New material is presented, confirming the Cumbrian approach to structure and roofing, now uniquely embodied in the buildings of the Plain, as firmly within recent highland tradition, with the possibility of wider connections. The detailed relationship between mass clay wall and cruck frame is explored and the historical and functional primacy of frame over wall demonstrated. Part II will present a number of individual case studies of building plan and section, will consider the way in which these changed with time and will conclude with a brief survey of the wider structural, material and plan-form context of the tradition.*

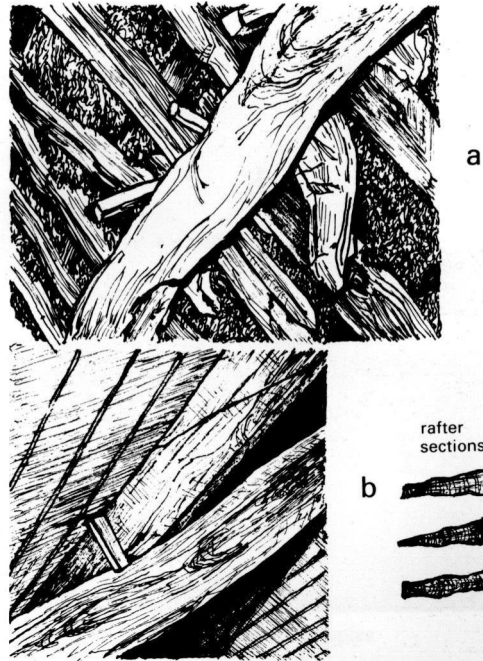
Fig. 54  
Details of the underside of the roof structure at  
Meadowbank Farm. Rafter peg-ends hooked  
over the purlin can be seen at (a), while at (b)  
is a view of the junction shown in figure 42(c)  
*Sketches based on photographs taken by Mr I. Laval,  
owner of Meadowbank Farm*

At Curthwaite, at the landward edge of the Solway Plain south-west of Carlisle, another mud house, Meadowbank, has split flat-raftering with the ends of its fixing pegs hooked loosely over, rather than driven into, the purlins (Fig. 54). The owner—a skilled cabinet-maker—describes these rafters as an economical use of short branch ends where these meet the trunk. Figure 53 gives the general arrangement. The part of the house shown is unusual in that peaked mud compartment-walls alone support the roof, in place of the usual crucks. Their scale is less than that of the mud gables at Lamonby Farm. There are certain to be other examples, but the only similar raftering arrangement known to the author is Danish, from the island of Fünen (Fig. 55). It involves the use of heavier timbers, but the principle of hung construction is the same.<sup>38</sup> In the roof structures at Curthwaite and the more main-stream cruck-framed system of the Solway Plain, as exemplified by Lamonby Farm, we see roof-support methods tailored to bear the economical lightweight, almost lath-like and springy oak rafter with the minimum of complexity. It is tempting to imagine these rafters to be one and the same as those in I.F. Grant's recounting of the Lochaber folk tale, which are described as 'long, smooth and flat', not characteristics of the raftering of immediate pre-improvement Scots peasant houses, to judge by the record of the early nineteenth-century Reporters to the Board of Agriculture.

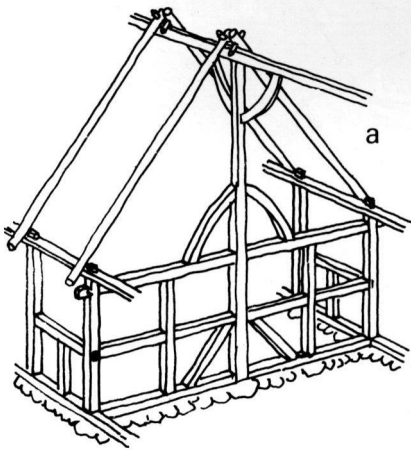
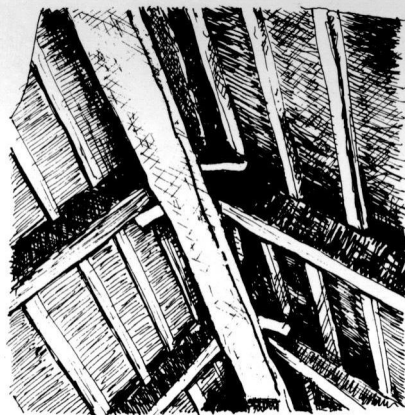
Fig. 55  
(a) Danish loose-hung rafters on a building from Fünen at the Frilandsmuseet Open Air Museum  
*Illustration after material in the 1962 Guide to the Museum*  
(b) Ridge of a Fünen house seen from below. The peg ends at the ridge are clearly visible  
*Drawing after a photograph in the Frilandsmuseet Guide*

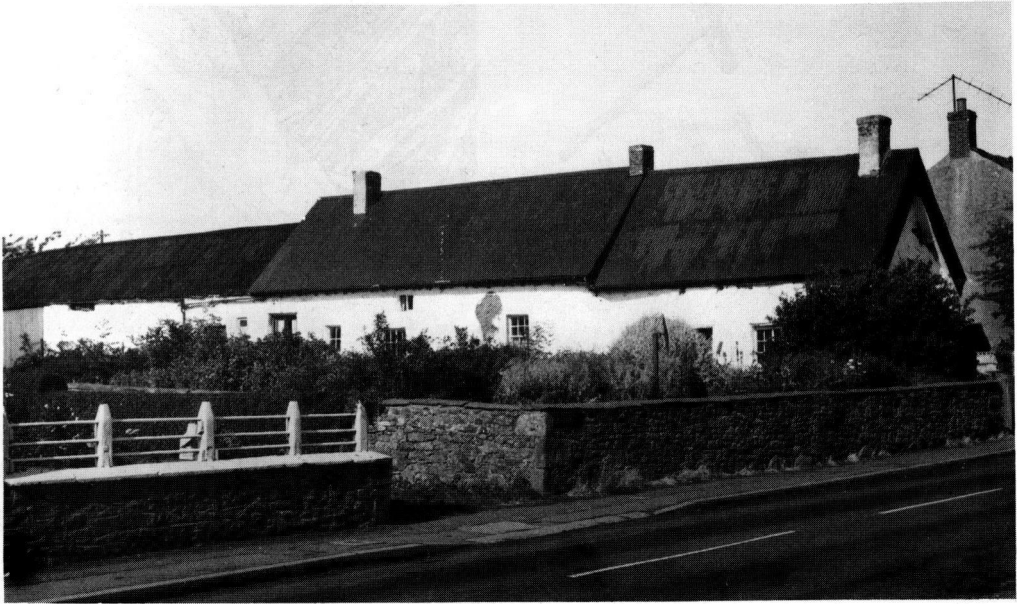
Fig. 56  
Lamony Farm, fully roofed in galvanized iron, prior to rehabilitation in 1979

In 1980, at both Lamonby Farm and Curthwaite, galvanized corrugated iron protected thatched roofing over the house parts at least (Fig. 56). This was subsequently stripped at Lamonby Farm and replaced by an entirely new and different roof. During removal of the galvanized iron and stripping of the original thatch found beneath it, straw and sod under-thatches, overlaid with further wheat straw, were revealed. The principle of the use of an under-thatch is explained in figure 57. The straw version of the under-thatch, attached to the rafters in the traditional way by straw ropes, was almost certainly a relatively recent replacement, one system of thatching coming

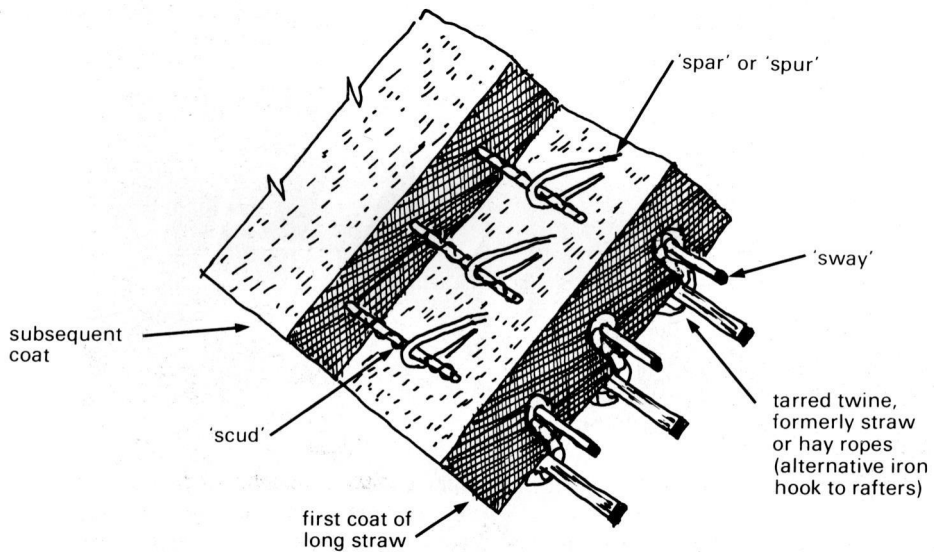
Fig. 57  
The principle of under-thatch, or the first coat of thatch

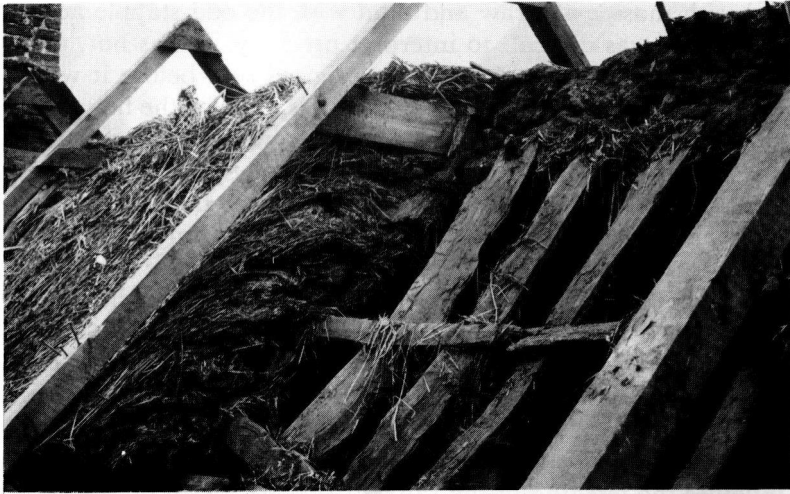
Fig. 58

The roof of the 'cottage', Lamonby Farm, showing rafters partially stripped, battens, ridge and stapple system of thatching. The first coat of stapples, which was thrust between the sods, has been overcoated many times with further stapples

in to oust another. A 'wimble' or 'thraw-crook' for winding the straw ropes still hung in the stable at Lamonby Farm in 1980. Figure 58 shows the original thatching system, which conformed to northern lowland practice. Small bunches or 'stapples' of straw were knotted at one end and thrust between overlapping grass sods, laid grass-side inwards, loose, to the rafters. Three or four horizontal oak laths pegged to the rafters at intervals prevented the sods slipping (Fig. 59). Stapples had also been thrust into that part of the roof carrying a straw under-thatch, to give it too a thick outer coat. A tool for inserting the stapples was found lying among the debris on the floor of Lamonby Farm's attached barn.

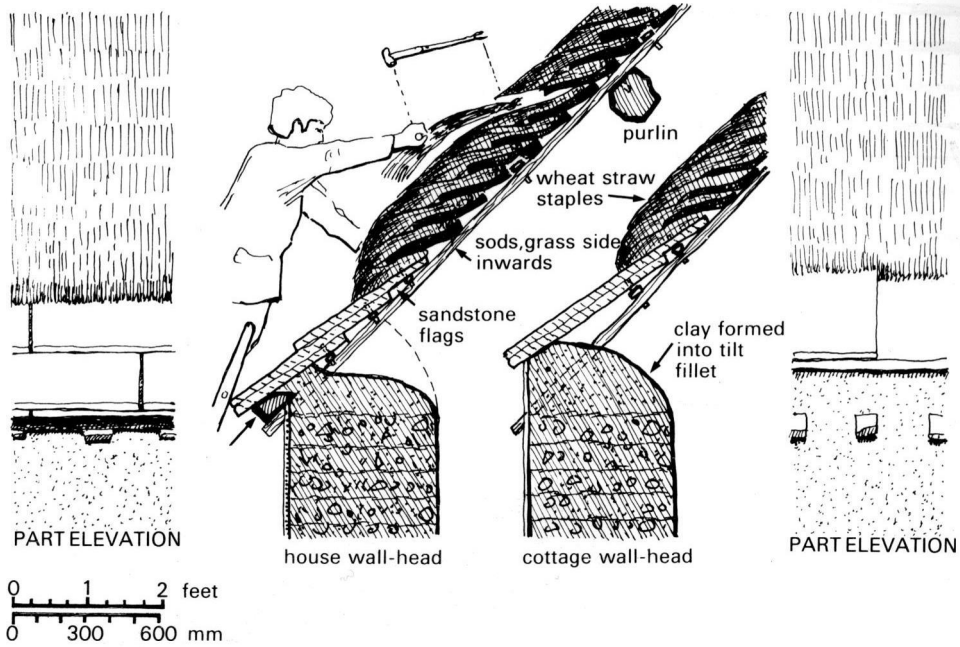
Fig. 60  
Two differing eaves details found at Lamony Farm

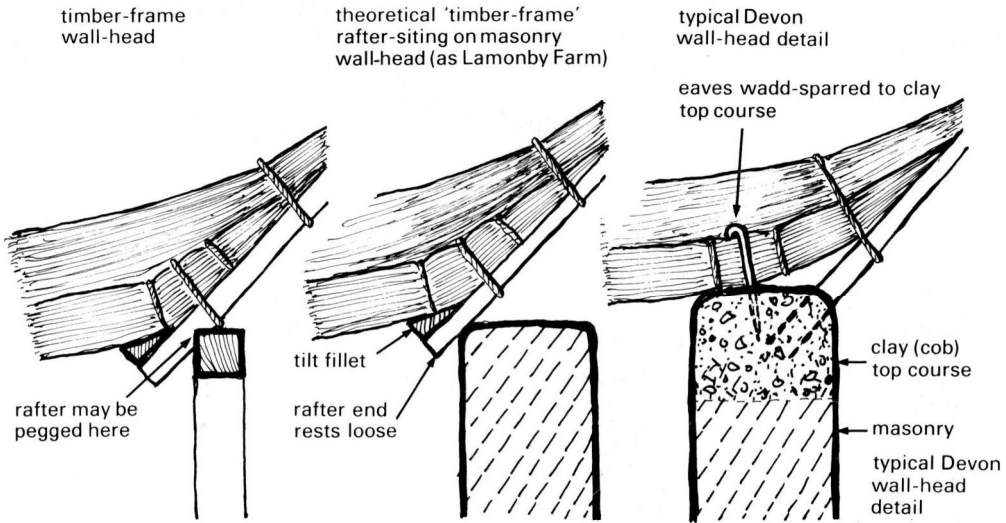
Fig. 61  
Evolution from wall-frame roof support to solid-wall roof support

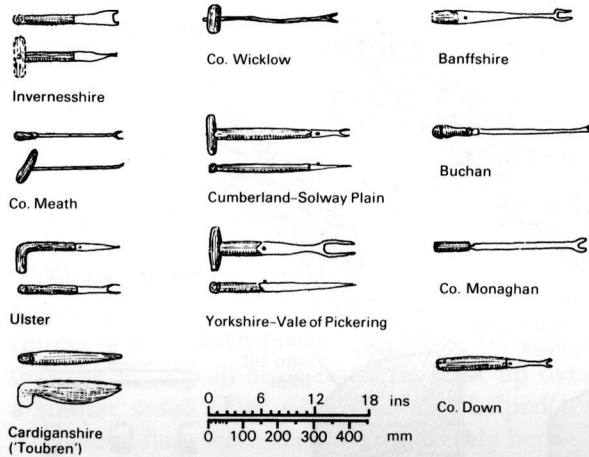
Fig. 62  
A selection of staple thatching tools recorded in the British Isles since the 1940s

Stapple thatch was clearly very much more a handyman's system than English thatching as it is known today (Fig. 62). It was also a suitable method for partial roof repair, or 'patching'. In fact its last use in the Vale of Pickering in east Yorkshire was for just this purpose. The tool used there was called a 'swallowtail' locally.<sup>39</sup> The method was once widespread, as the distribution of tools shown in figure 62 demonstrates. The 'thatching iron', recorded by Innocent in 1916, was in use for patching as far south as Leicestershire and Warwickshire. It was recently known in Cardiganshire and parts of Scotland, as well as in eastern Ireland.

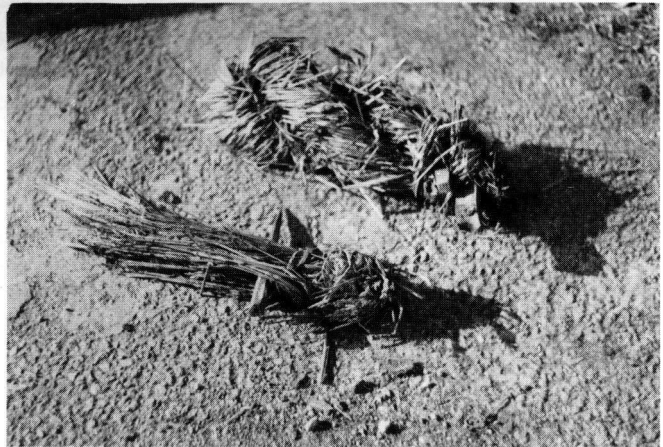
Fig. 63  
Heavily twisted and therefore unusual, pegged, stapples probably from the ridge. Green Lanes Cottage, Dalston, 198

Figure 63 shows an unusual very heavily-knotted handful of straw—a substantial stapple—with a peg through it for further stability, from a roof at Green Lanes, Dalston, on the Solway Plain. This may have come out of a section of ridding. As has previously been noted, stapples could be inserted into different 'backgrounds'. The sod under-thatch 'background' at Lamonby Farm is shown in figure 49. Figure 64 (a) illustrates what could be considered to be one ancestor of the stapple-thatch system, a very simplified French version from the Massif Central region. A stapple-end typical of the kind found at Lamonby Farm is shown in sketch form in figure 64 (b). Three other systems of thatching in use very recently in Britain—there were yet others but these are the principal ones employing straw—are shown in figure 65. Figure 65 (a) shows the present southern English form. Here, long straw and Devon Reed (combed wheat reed) and water reed, are fixed by horizontal 'sways' which are pinned or sewn to the rafters. Overcoating old with new straw effectively turns the former into an under-thatch, and this has been common practice. Ideally all these forms require roof pitches from fifty degrees and upward for maximum efficiency,
