# Evidence for an Intermediate Stage between Earth-fast and Sill-mounted Posts

C.A. HEWETT

*This paper draws attention to recent evidence for both earth-based and earth-fast posts in standing buildings. Using Essex examples, the author argues a development from the earth-fast post, through an earth-based sequence to the sill-mounted structures that were universal by the end of the Middle Ages. Field evidence is supported by documentary references and absolute (14C) dating.*

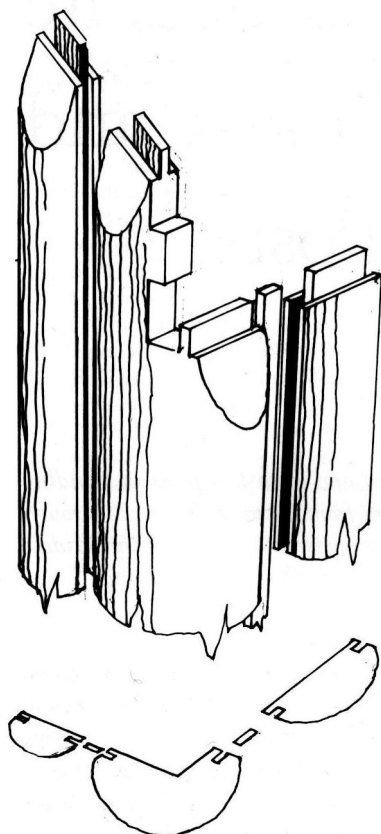
Excavations at Greensted in 1960 proved the original existence of an earth-fast north wall to the chancel and it is therefore reasonable to assume an earth-fast construction throughout.<sup>4</sup> Figure 1 shows perspective sections of three posts at the south-west corner. This corner-post was cut internally to the right-angled wall-junction and provided with grooves for draught-excluding fillets; the top was worked obliquely to meet the pitch of the roof, with tenons cut at angles, on two different planes, to receive wall-plate and gable rafter. Had this been simply an excavated site the circular post-holes would have told us nothing of the superstructure. Here is a wholesome

Fig. 1  
South-west angle-post of the log-walled church  
at Greensted, Essex

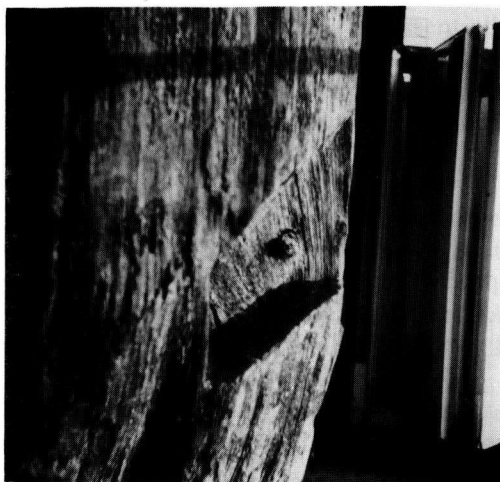
An arguable exception, where something of the superstructure at least remains, is the problematic fragment, probably of the late eleventh century, from Rayleigh castle.<sup>5</sup> This early fortress is one of the few strongholds mentioned in Domesday. It therefore follows that the castle must have been built some time between 1066 and 1087.<sup>6</sup> The flat-bottomed post had been earth-based, and must date from before the universal use of lap-joints and the appearance of open-notched lap joints (Fig. 2).

Fig. 2  
An earth-fast post at Rayleigh Castle, Essex  
P. Richards

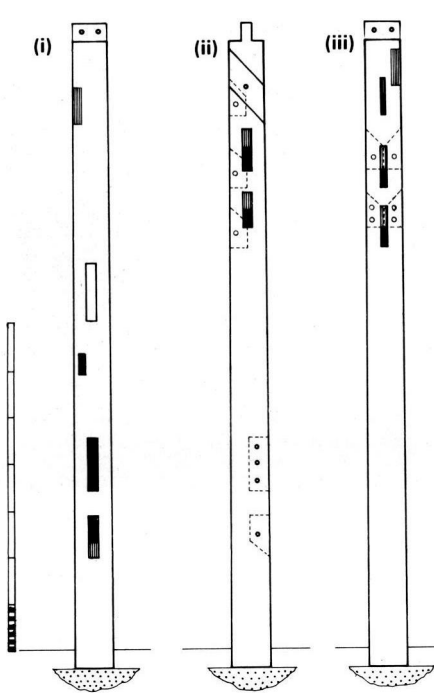
Fig. 3

one of which, at the east end, is complete showing the cut from which a sample was taken for dating; it has earth-fast shores illustrated in figures 3 and 4. Figure 3 shows the back, side and front of the post to scale, figure 4 illustrates the chained raking-shore.

(Above) A post of the barn at Paul's Hall,  
Belchamp St Paul, Essex, showing the back  
(i), side (ii) and front (iii)

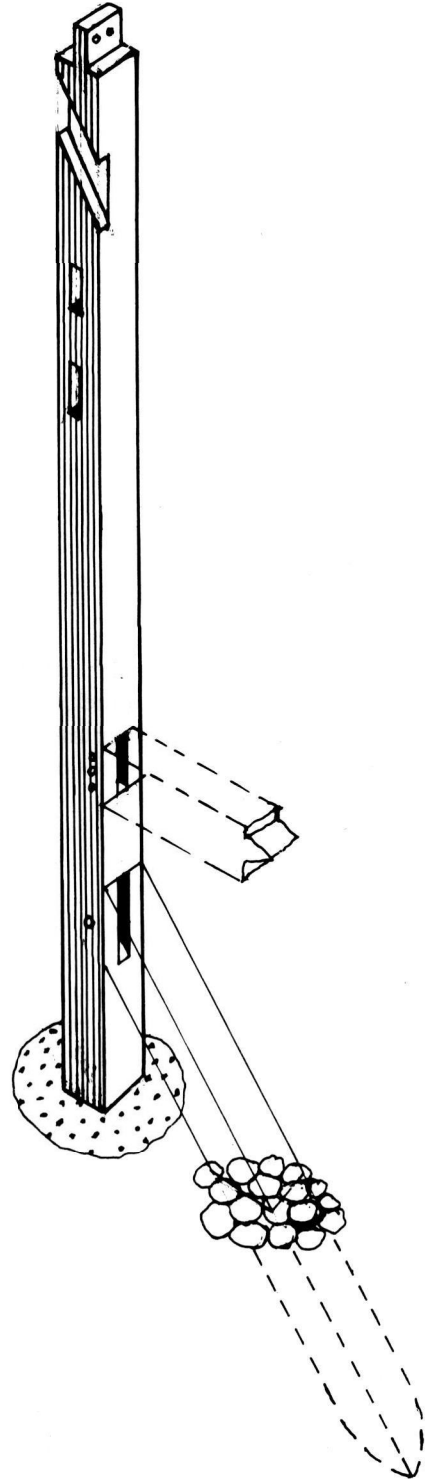
Fig. 4

Figure 4 illustrates the floor beneath the post: a light covering of earth separated from the natural clay by a layer of chaff. The arcade post rests on mortar about four inches below the present surface. The floor level between the arcade post and the aisle wall forms a hollow, dipping into the natural clay. This hollow was found to be surrounded and lined by a cluster of cobbles, its angular shape suggesting that it may originally have received the truncated lower end of a shoring-brace rising to the arcade-post. If so, such an insecure construction would have needed cobble packing to tighten it. Although the cutting was taken to the aisle wall and considerably deepened, no further early features were recognized. When the loose, dry, friable material from the north face of the base of the post was removed by hand, a distinct ‘tide-mark’ on the vertical surface was revealed, indicating prolonged burial of the foot, and noticeable erosion and decay below the mark. The base of the post was both perfectly flat and horizontal, as though pared or ‘shot’ with a plane; immediately beneath lay the mortar surface, cracked by prolonged compression.

(Right) The chained raking-shore in the barn  
at Paul's Hall, Belchamp St Paul, Essex

Having then established, by following the downward angle of the departure of the rising shore—which was probably as massive as the post itself—that none of its timber remained, a further test was made by continuing the excavation outside the lateral wall to a depth of three feet, in case the inclined and cobble-packed depression had been no more than a temporary footing at the time of the rebuilding of the wall. No trace of any lower and earlier penetration of the ground was found.

Beside the seating for the raking-shore, a long mortise, 6 ft. 1 in. above the mortar floor, and suitable for timber of about the same scantling as the post, seems to indicate an outshot tie or strainer. The posts themselves are cut from young oak $\text{s}$ , slightly tapered, as grown, and used the natural way up. The sole connection with the ground was evidently by means of the rising-shore. This, it is proposed, was earth-fast, driven as far as the resistance of the clay would permit. It was then cut to an upper chase-tenon, on to, and against which, the post could be reared, earth-based, on a thin artificial pad. It would have remained adequately stable for the remainder of the prefabricated frame to be added, the ultimate stability, of course, being concentrated about the level of the top-plates.

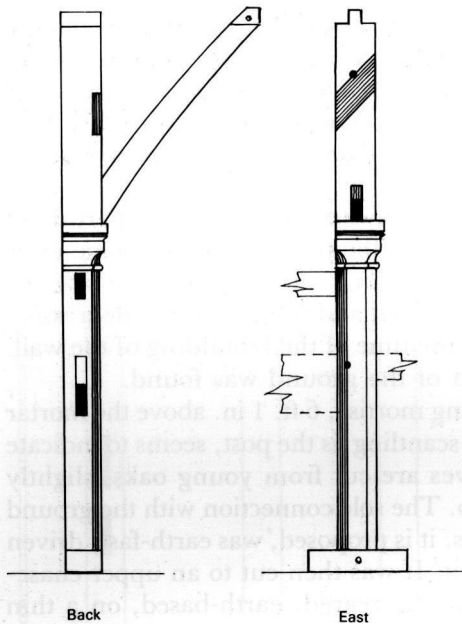
Fig. 5

A post in Faulkner's Hall, Essex, showing the wooden pad

The post stands on an oak pad some nine inches by five inches.

Although the building had been known to him for many years, the writer had no opportunity to inspect the Maltings in detail before the late 1960s, when its complexity and interest were at once apparent.<sup>15</sup> The structure appears to comprise the main posts of a three-bay hall, which carry capitals of evidently Romanesque form. The building was certainly aisled on both sides but not heated by any known method (unless by a wall fireplace) since all original timbers are of naturally-coloured clean oak, without any traces of sooting. The main span between the capitals is 17 ft. 5½ in., but the original widths of the aisles are unknown. The curvature of the arcade braces is slight (only ¼ in. in an overall length of 8 ft.). A typical capital is illustrated in figure 5. Although formed mainly by slightly hollow chamfers, the accurate carinate fillet, immediately beneath the abacus, has affinities to that widespread and persistent Romanesque feature in stonework seen, for example, in a series in Winchester Cathedral. There, in the south transept triforium, the feature may be as late as in the present choir vestry of the 1170s. The actual form of the capital, however, seems to be a purely timber idiom, not exactly paralleled in any known early hall. Its chronological significance at Faulkner's Hall has yet to be determined, but it is not inconsistent with a date somewhere near the reorganization of the prebends in *c.* 1158.

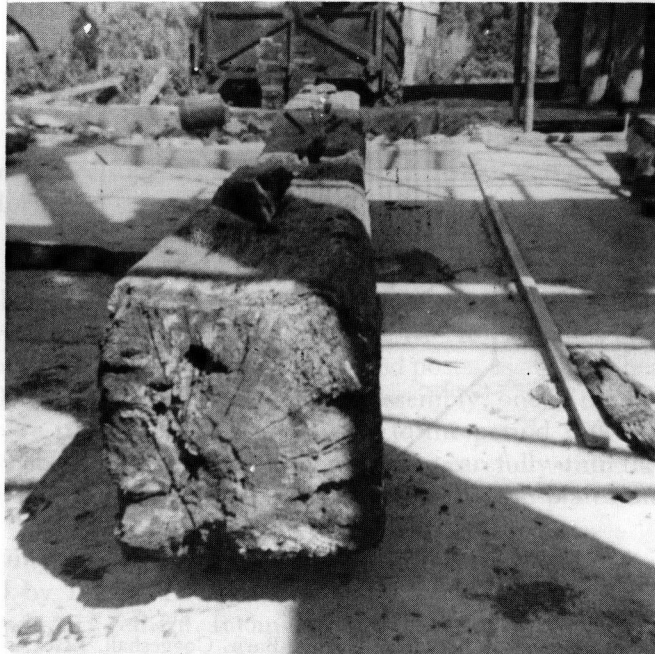
This is a large, but considerably altered, barn situated under a mile from the Savignac abbey of Coggeshall on which it was dependent, a royal foundation of 1140,<sup>18</sup> taken into the Cistercian connexion in 1147. The proximity suggests a slightly remote *curia* of the main settlement rather than a typical detached Cistercian grange and 1140 is a valid *terminus ante quem* for its building. That it must have been constructed within a few decades of this date is evident from the archaic features, such as the refined angle of the notched lap-joints<sup>19</sup> that occur in the main range of arcade-posts, most of which survive from the primary build. One post was dated by 14C to  $1130 \pm 60$ .<sup>20</sup> In 1985 the barn—by then collapsed—was restored. Most of the great posts, on average sixteen inches square at the base, stood on great stone stylobates only one of which was not removed when the top-plates were reused after *c.* 1375.<sup>21</sup> The bases of prostrated posts were observed to be either 'pared' or 'shot' with a plane to a perfect surface at right angles to the taper of the post, which was that of the tree as grown,

Fig. 6  
The base of the post, and  
stylobates, Grange Barn,  
Coggeshall, Essex

with no trace of any form of jointing into the standing (Fig. 6).

Mr Martyn Owen of the Geological Museum, London, reports on the stone stylobates: 'The specimen . . . is a rather brownish, crystalline shelly limestone and matches well with the specimens in our collections from the Middle Purbeck of Dorset. It is not of Purbeck Marble, which is Upper Purbeck, but from the underlying strata which have been extensively used in building stone'.<sup>22</sup> By the 1170s diffusion of stone from the Purbeck quarries was widespread, facilitated perhaps by royal interest. Figure 7 shows a post with a stylobate, an outshot tie-beam and the 'refined' form of the open notched lap-joint.

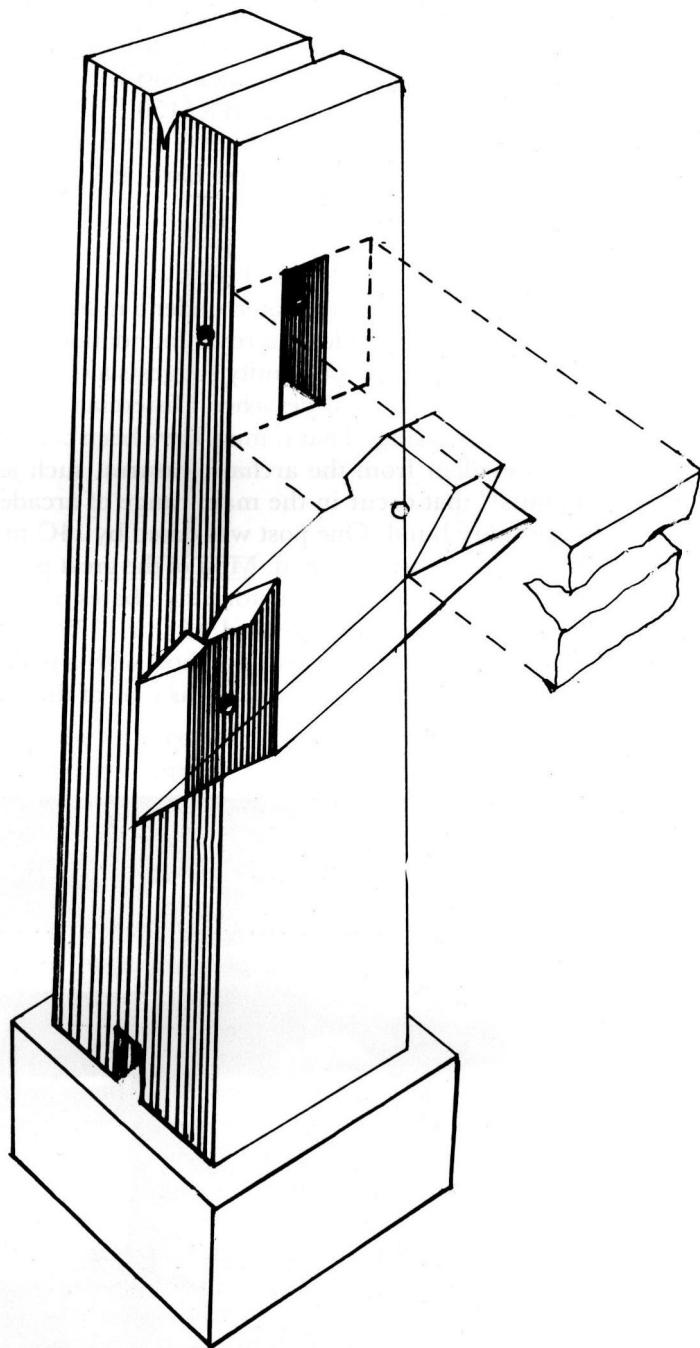
Fig. 7

A post from Grange Barn, Coggeshall, Essex, showing stylobates

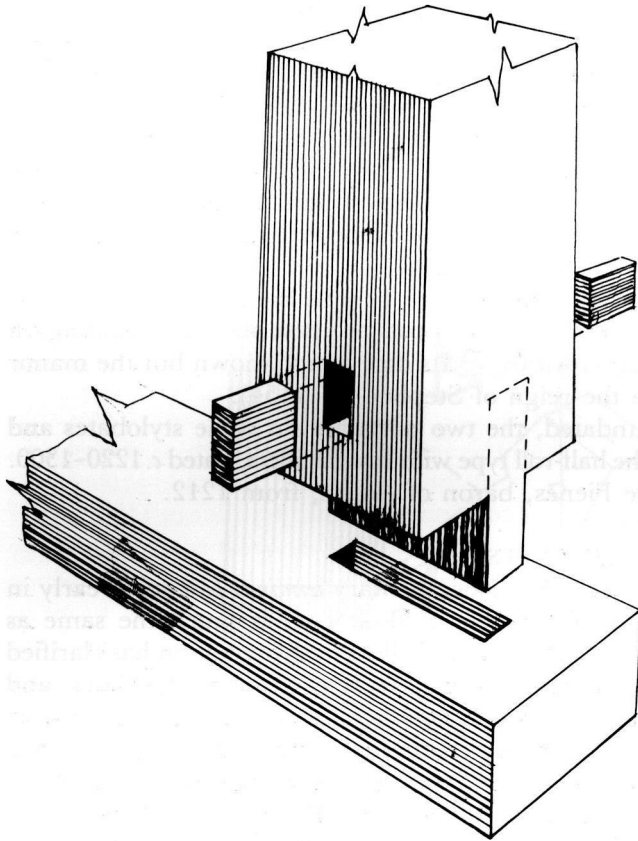
This most impressive barn, at a site whose documentary *terminus post quem*, early in the reign of Stephen and the gift of Matilde of Boulogne, is much the same as Coggeshall and has often been described in print.<sup>24</sup> Recent examination has clarified details of the standing of the posts on the post-plates, or transverse sole-plates, and established that the post at the northern corner, although the most depleted in respect of its complementary bracing, is that which occupies its original standing. The foot of the post (Fig. 8) is shown with basal tenon and complementary mortise, and carefully plugged side sockets. The purpose of the latter was probably to take the 'trunnions' used to steady the feet of the posts during rearing, thus ensuring that the tenon entered the mortise accurately.<sup>25</sup>

Fig. 8  
A post from Barley Barn, Cressing,  
Essex, showing the sill

At the Barley Barn, Cressing, Essex, oak sills are mortised to the ground-sill, one of the first such known to be used in England and dated by 14C to  $c. 1200 \pm 60$  AD.<sup>29</sup> The rearing of posts was difficult as they were both high and heavy, almost twenty-five feet long, fifteen and a half inches square at the bottom and ten inches square at the top. The present outside wall is not original. The early wall was probably under the top-plate. As reversed assembly is used, the posts would be held in place as soon as the top-plate was fixed. The first to be erected and stabilized were the four middle posts, followed by the two straining beams, free tenoned to the posts. The two top-plates were mortised by holding the already tenoned braces by rope passing through holes in their sides. This is the first recorded use of this method. The tie-beam could then be offered and pegged. All arch braces had notched laps and were offered by sidewise jointing as in Temple Balsall.
