The Spire of All Saints' Church Maldon, Essex

The Romanesque timber-frame spire of Maldon church is unique in England. Not studied in detail until 1992, this hexagonal shingled spire with its three spirelets, set on the triangular plan of the tower walls, has proved to be unequalled in quality of design, constructional detail, lasting quality of form, and technical excellence. Other, comparable, Essex spires are also considered and a typological and chronological sequence suggested on the basis of stylistic dating and the study of the evolution of timber joints.

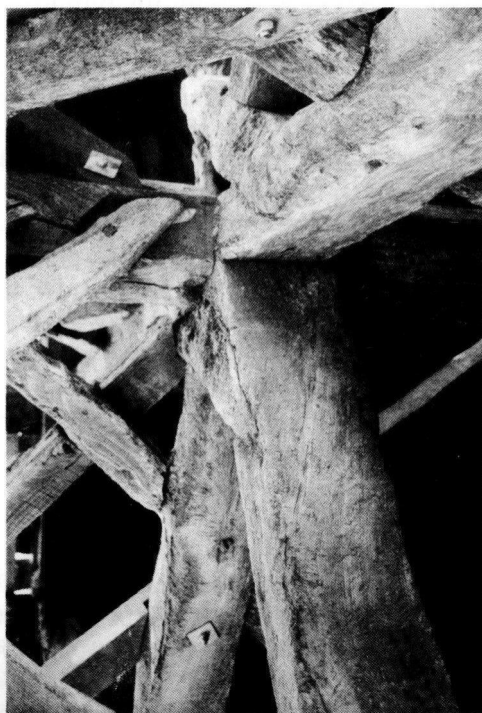
Fig. 10

Spire frame to the north-east showing the mast, one vertical post, rafters and braces, with windlass and shoring

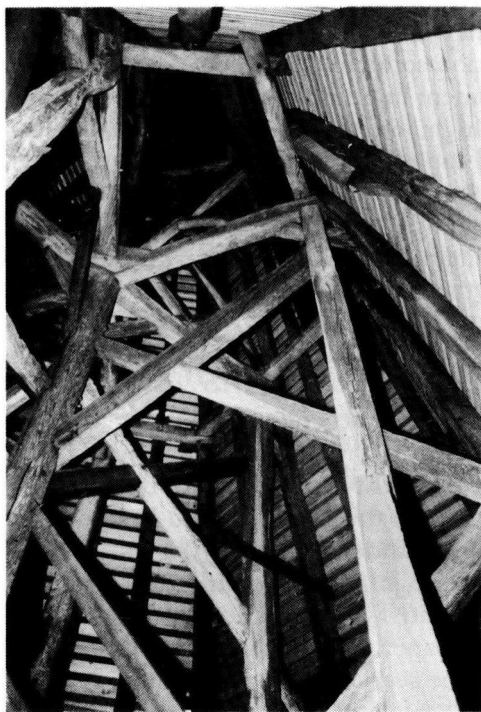
Fig. 11

View up the spire to the first lift, showing the halved-over joints of the wheel-rim and the cross-bracing up the spire

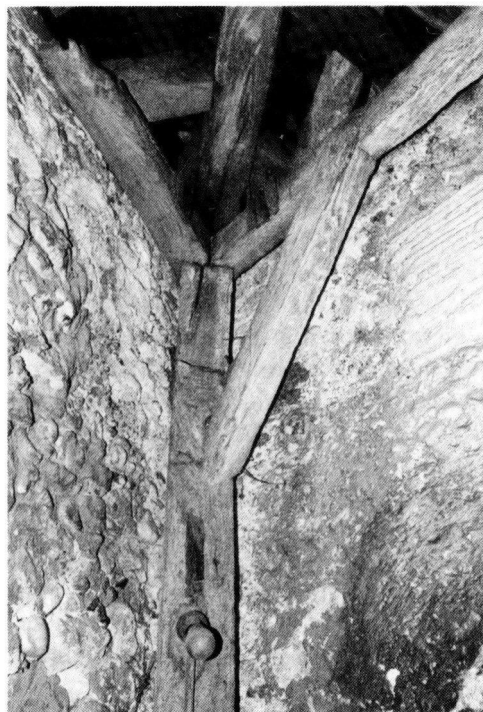
Fig. 12

Upper portion of the east post showing original brace, the other empty brace mortise and top-beams tenoned into the post. The fish-plates must date from the cutting away of most of this under frame

The whole of this construction was anchored into the tower on a triangular underframe set within the walls (Figs 5 and 12). This appears to have been a heavily-braced triangular box-frame, with further vertical posts within the centre of each wall, running in line with the centre of the double lancet windows. The corner posts were tenoned into the floor-frame and the top beam was pegged to the spire floor at each crossing point (Fig. 13). The triangular underframe has mostly been destroyed, first in the nineteenth century, when the bells were rehung, and subsequently in 1922 when the number of bells was raised to the present eight.

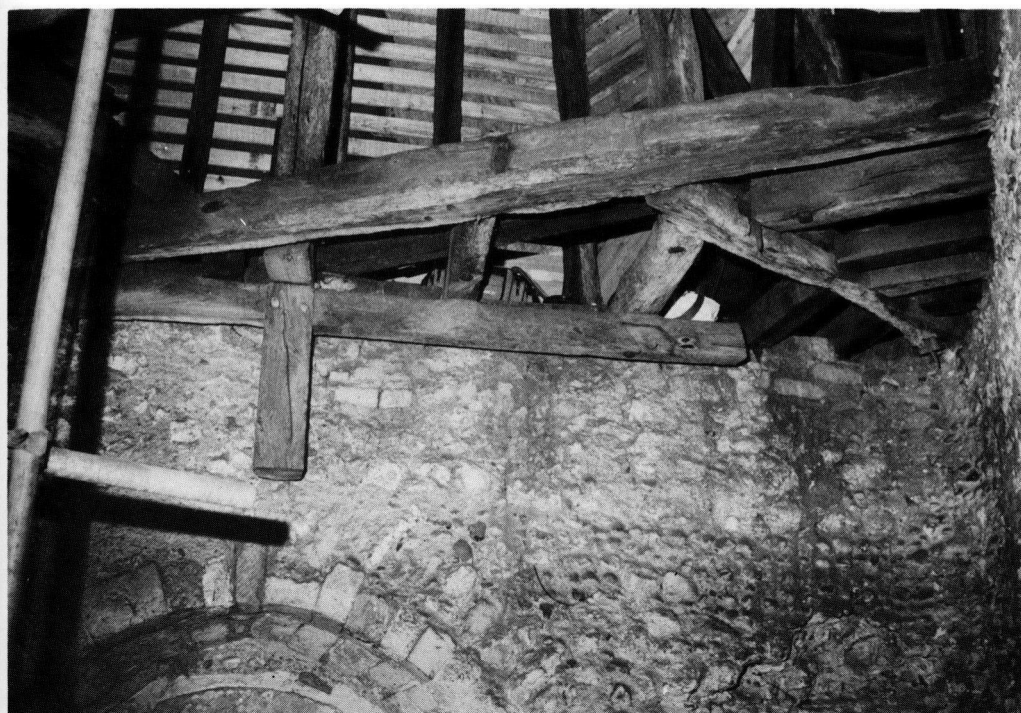
Fig. 13 (*above*)

The north-west tower wall showing top of window with cut-off centre-post above, rafter beams into floor-frame side-spine and angular side-spine to the north spirelet. The cut-off under-frame beam is jointed to the cut-off centre-post and the secret notched-lap joint for the brace to the missing corner-post

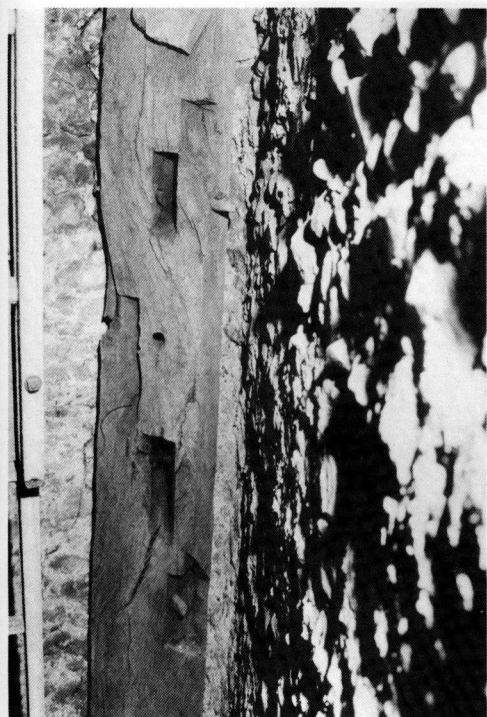
Fig. 14

The west post with square and angle mortises, and a secret notched lap-joint for the up-brace to the centre of the main spine

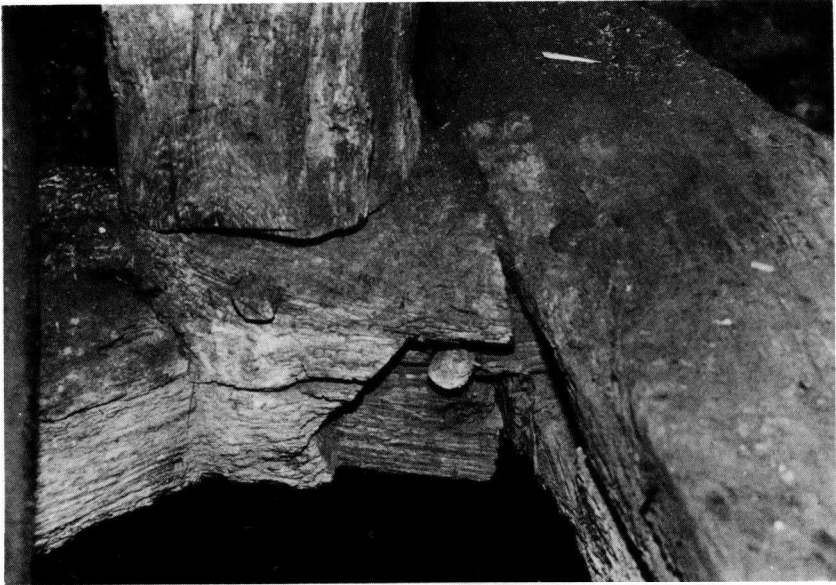
Fig. 16

The junction of the north angular side-spine to the floor-frame side-spine, showing an over-size mortise joint, the base of the vertical frame-post on the angular spine, and an empty secret notched lap-joint for a rising-brace from the corner-post

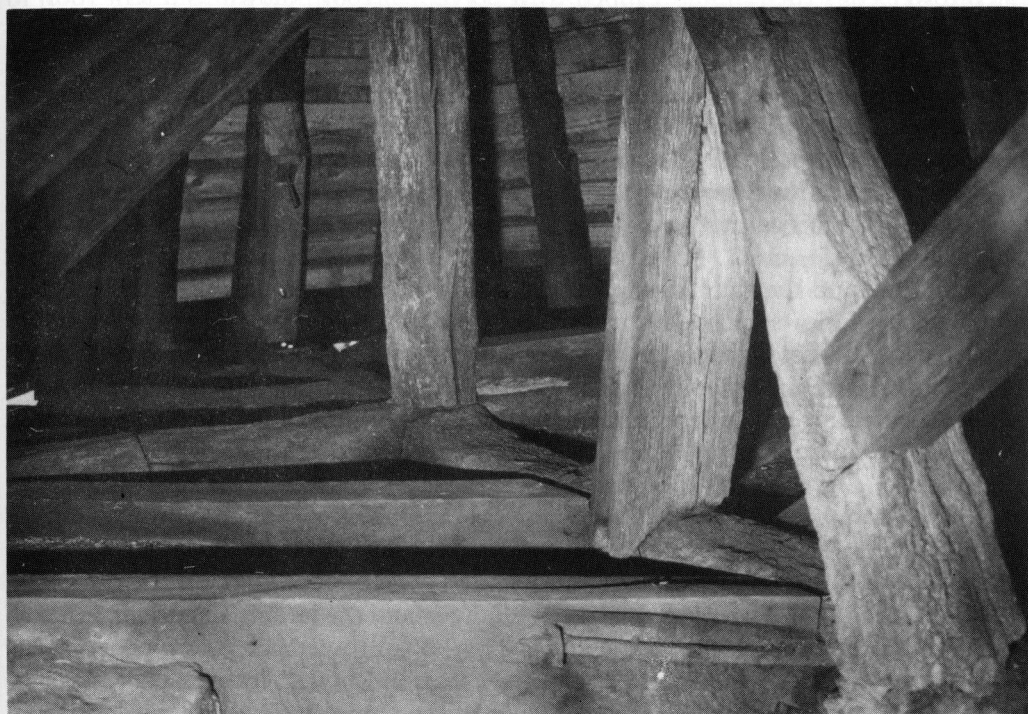
Fig. 17 (*above*)

The north spirelet base-frame showing both the original and the replacement timber, the end of the scarf-joint on a cruciform base, the spirelet mast, spirelet, and main spire-rafters

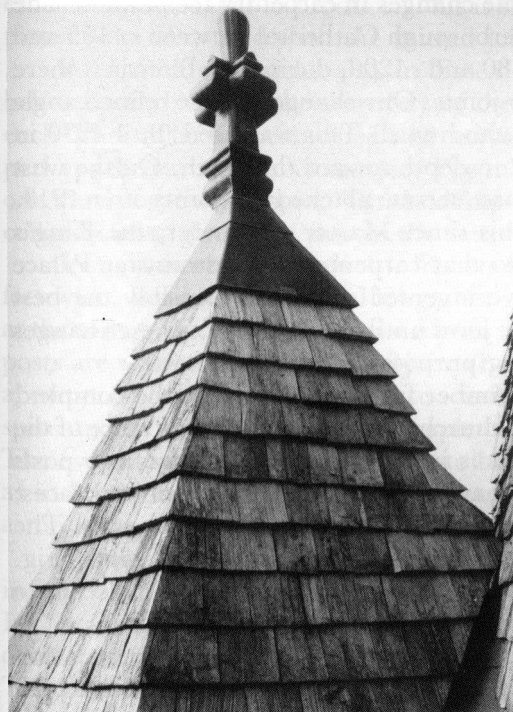
Fig. 18

The spirelet, after renovation, showing the junction with the spire, the start of the lead valley, and the new lead finial to the spirelet

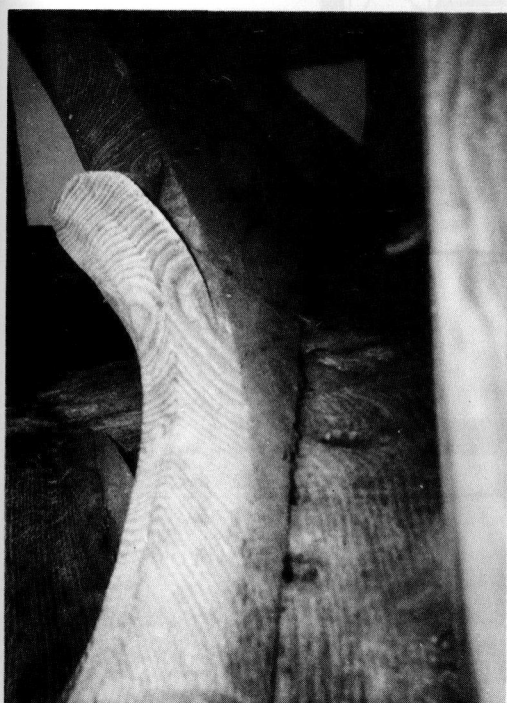
Fig. 28
Stock belfry, Essex: a cusped, foliated, arch-brace

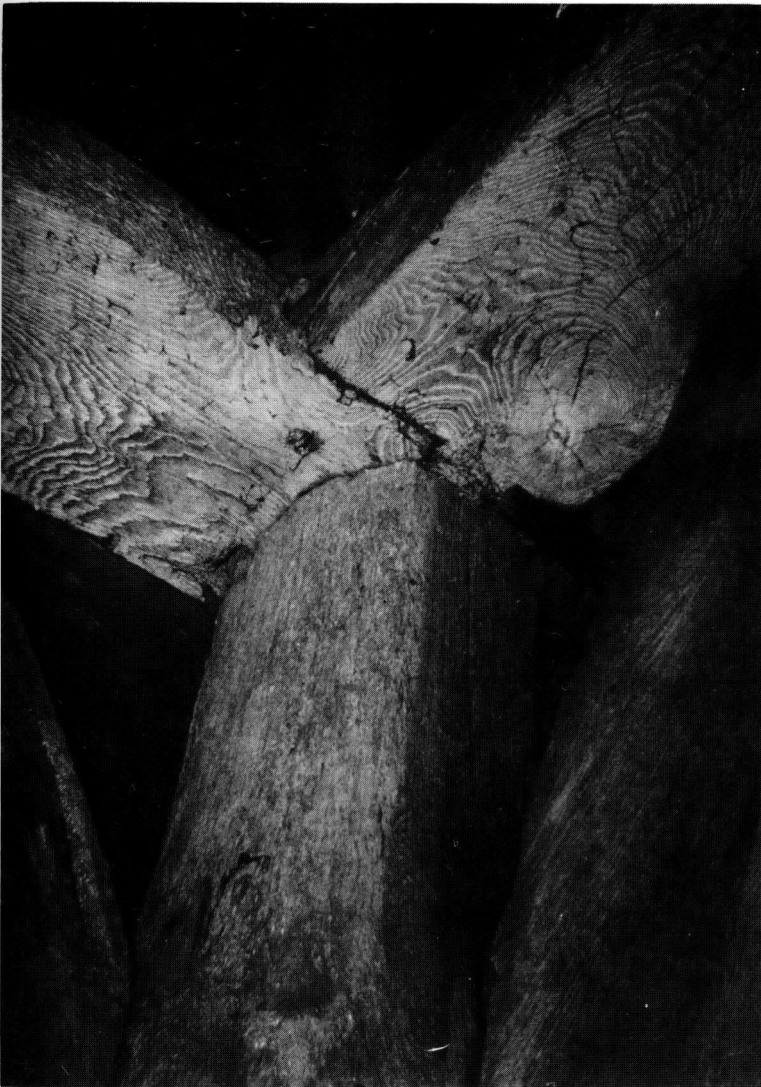
Fig. 36
Stock belfry, Essex,
showing a late top-
plate before the
mitred joint
