Early Malt Kilns in England

AMBER PATRICK

This paper summarises the results of the author's study of malt kilns in England from the 18th century to the second half of the 19th century. The paper will look at twenty-three examples across fourteen counties, from Yorkshire in the north to Devon in the south, and from Shropshire in the west to Norfolk in the east. The findings will then be used to assess whether there are any similarities in design, and if so, whether they are specific to a geographical area. The reasons for the better survival of early kilns in some areas than others will be considered. Finally the issue of whether there is any chronological development of these early malt kilns will be discussed. A catalogue of all the sites recorded follows at the end of the paper.

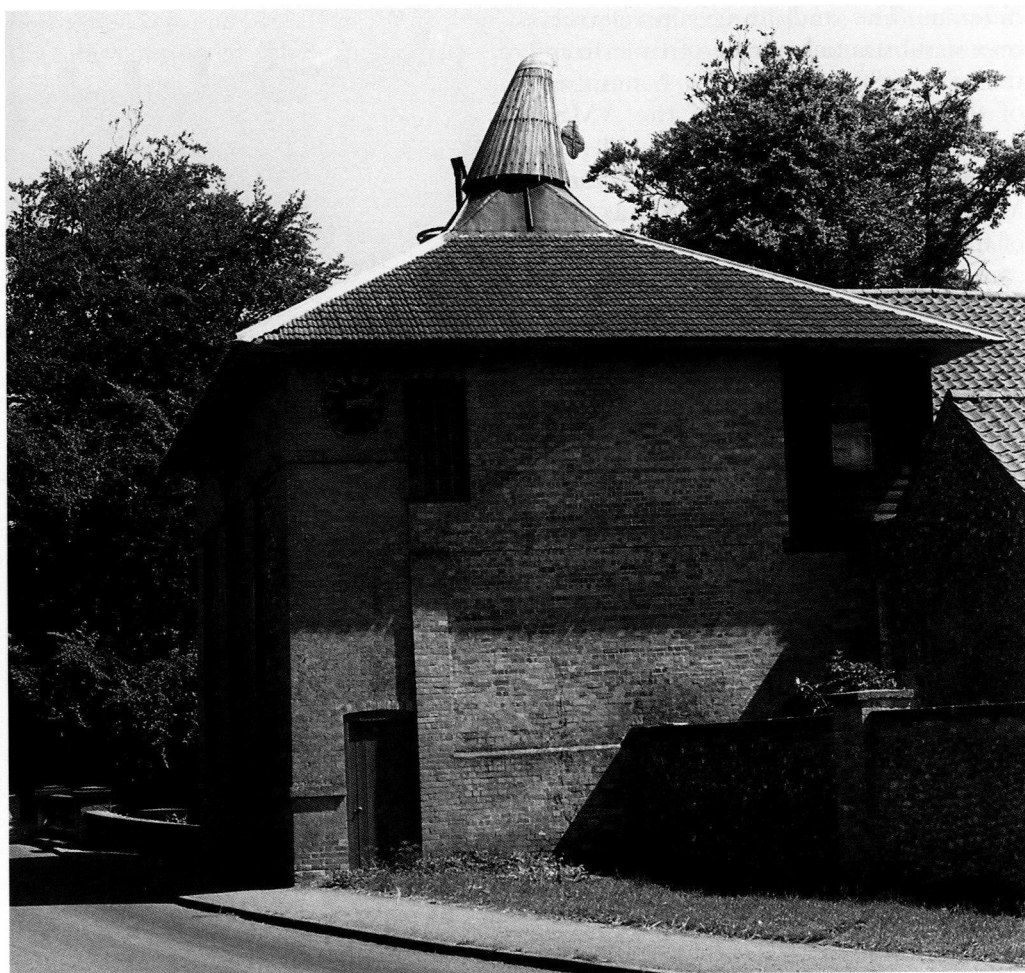
Fig. 1

Letheringsett (Norf.), exterior of the malt kiln facing onto the road; note the cowl and the clock.

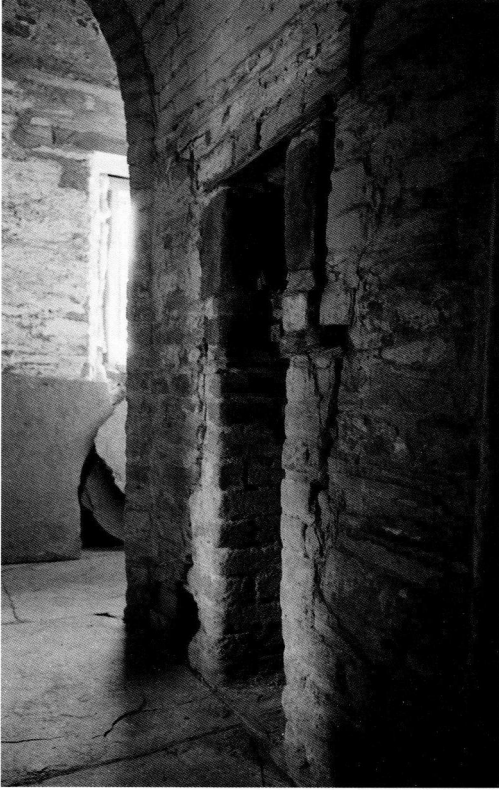
Fig. 7

Coryton (Devon), the kiln furnace with high fire bars set in a brick-lined furnace mouth, and showing the brick corners of the furnace on the left hand side of the furnace shaft.

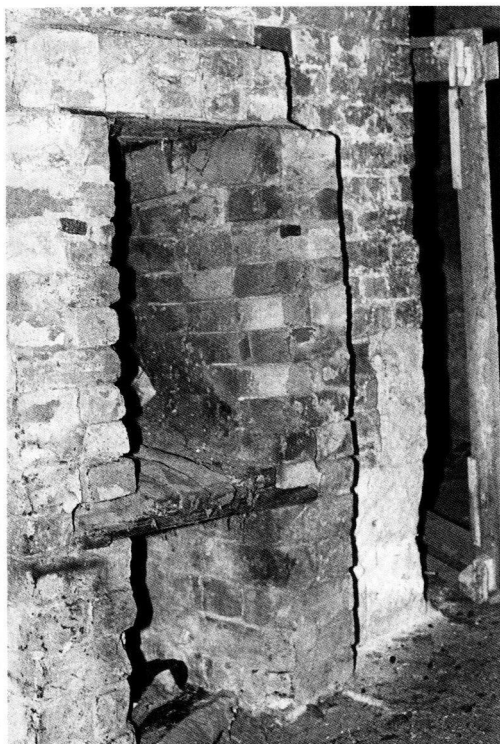
Fig. 10 (top left)
Brockhampton (Glos.), The Old Brewery,
the kiln furnace mouth with fire bars in a
position slightly below midway.
Photograph, author 1995

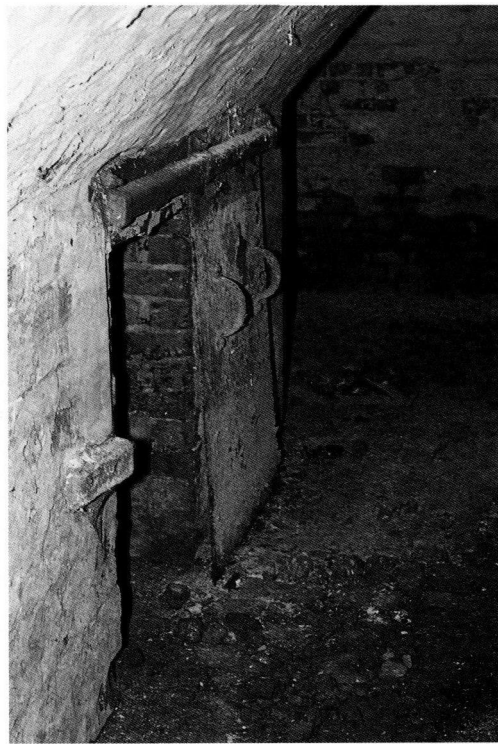
Fig. 11 (top right)
Alne (N. Yorks.), sliding door to the kiln
furnace.
Photograph, author 1995

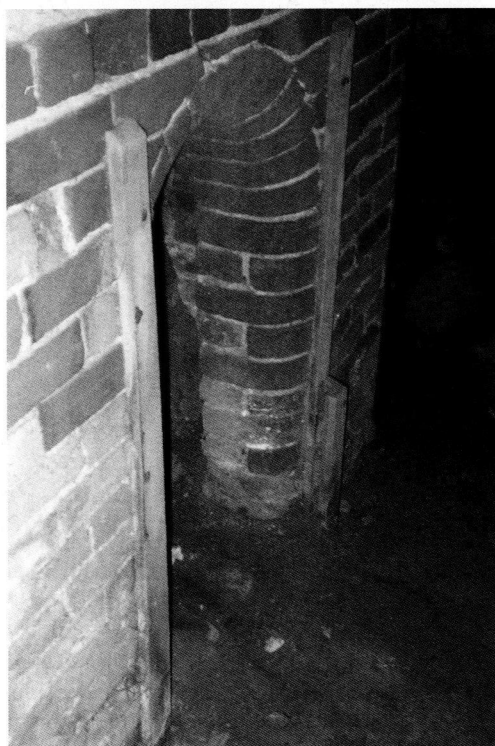
Fig. 12 (right)
Harvington Hall (Worcs.), exterior of the
kiln furnace, showing the furnace mouth.
Photograph, author 2008

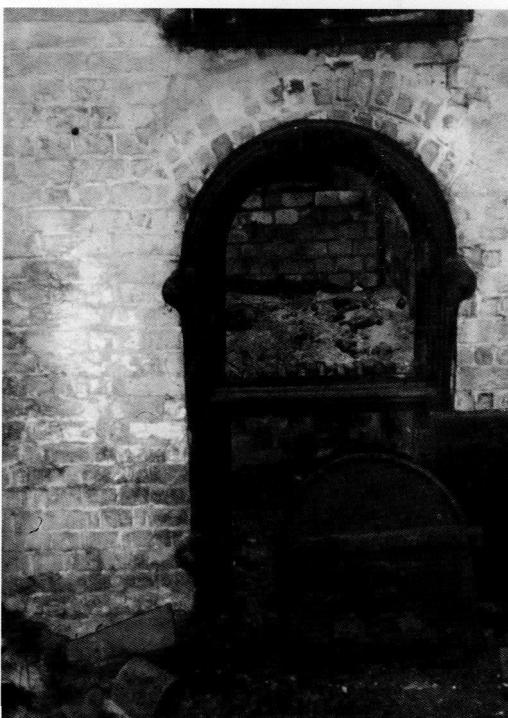
Fig. 14

Mistley (Essex), Malthouse No. 4 (spare kiln), Brooks Site, the kiln furnace upper door removed and on the floor; bottom door open. The last firing on the fire bars.

In twelve cases the kilns appear never to have had doors. Only two malthouses, Deerhurst and Mistley (Fig. 14), originally had both upper and lower ones, although in both cases one set was missing. In another two cases, at Chipping Campden (Fig. 15) and at Snape (malthouse No. 3), there were doors to the bottom part of the furnace only, whereas top doors survived only at Chetnole and Alberbury (Figs 4, 13). However, there is evidence that originally there had been upper doors

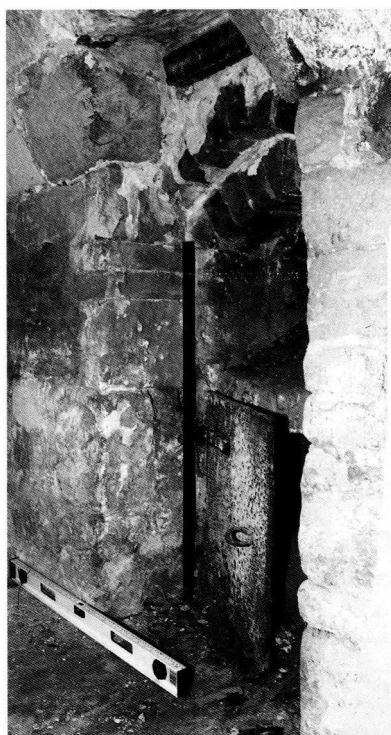
Fig. 15

Chipping Campden (Glos.), The Malthouse, High Street, the kiln furnace with the bottom door in a nearly closed position; note stone is used for the furnace base.

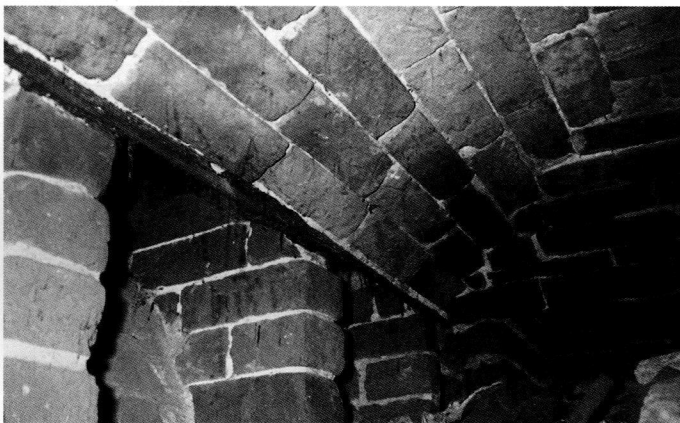
Fig. 17

Mansfield Woodhouse (Notts.), interior of the furnace showing the brick spark plate with brick piers and iron bar support on the left hand side.

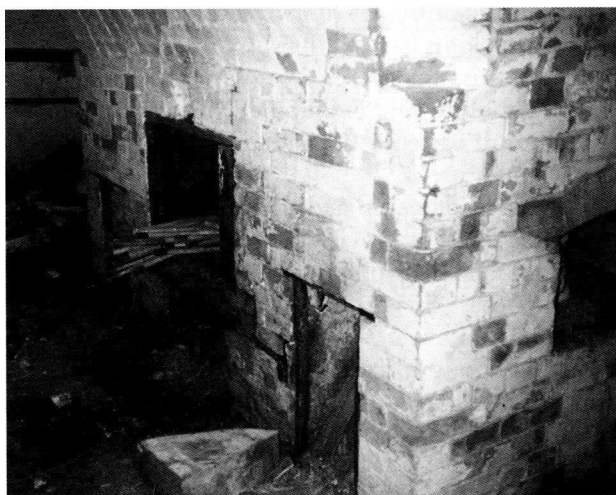
Fig. 18

Charlton Musgrove (Som.), the kiln furnace mouth (with chimney brush) and ventilation slips on either side of the furnace; part of the bread oven on the extreme right hand side.

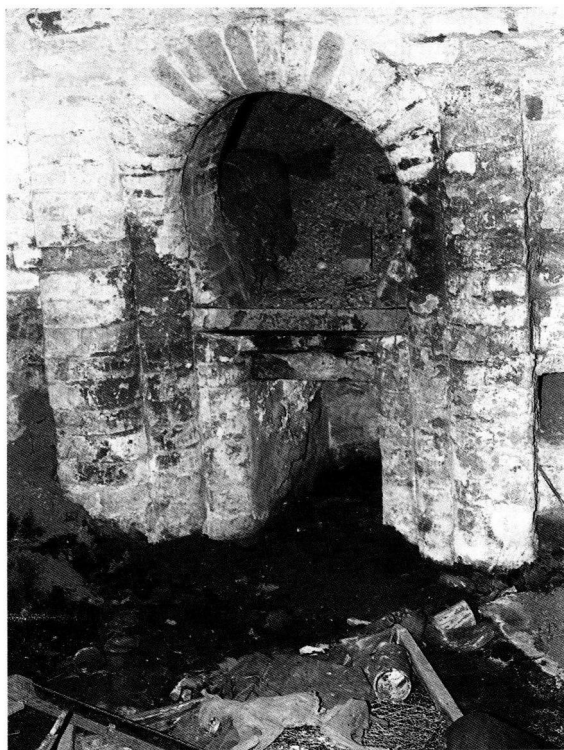
Fig. 19

Burghley Park (Cambs.), the kiln furnace mouth showing its horseshoe shape.

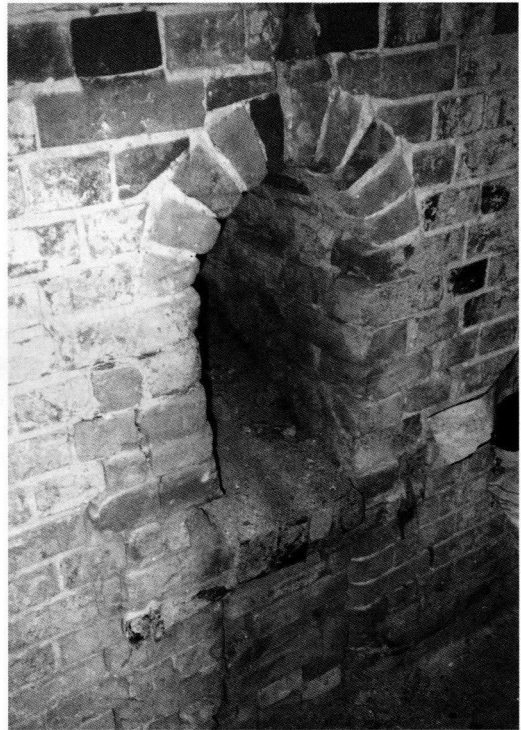
Fig. 20

Old Basing (Hants.), the kiln furnace front with a narrow aperture; note only four fire bars.

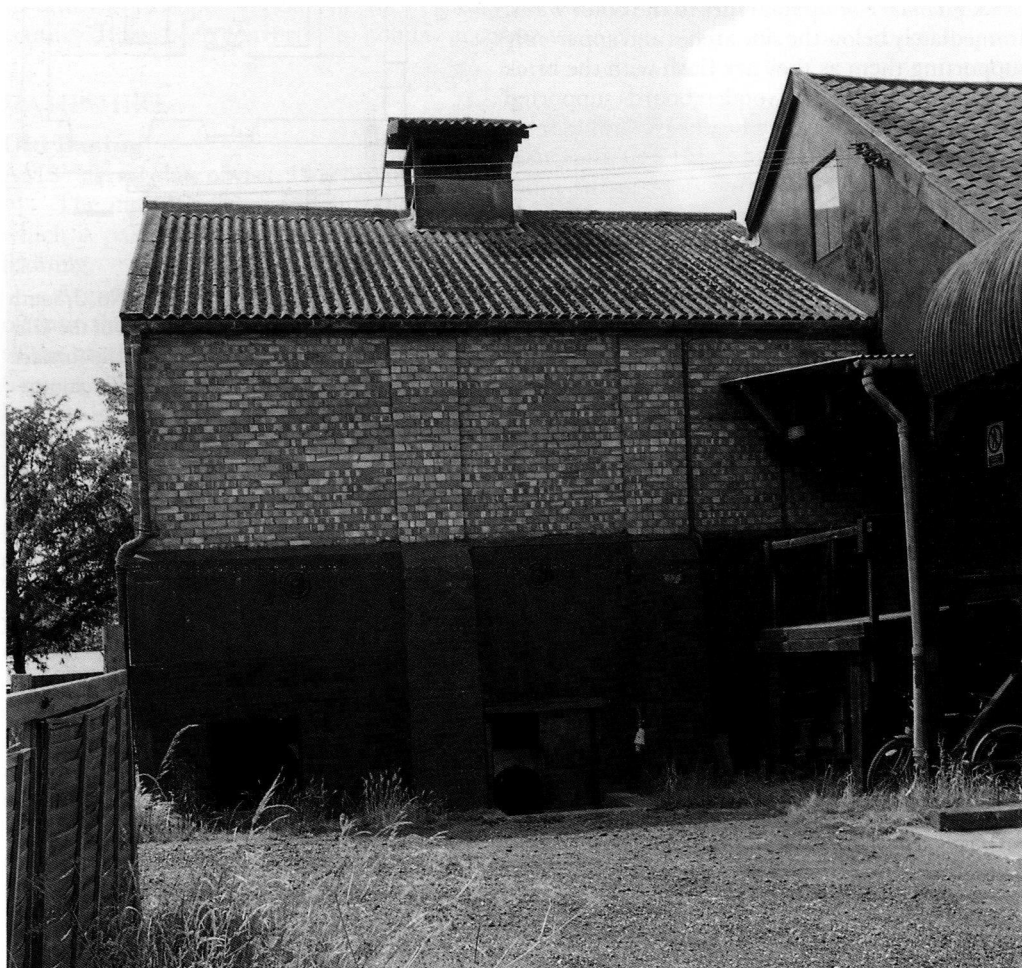
Fig. 23

Diss (Norf.), Cuthbert's Malthouse No. 4, north side of Victoria Road, exterior of the malt kiln with square hat cowl. Note the change in building material, probably at kiln drying floor level, from clay lump to brick.

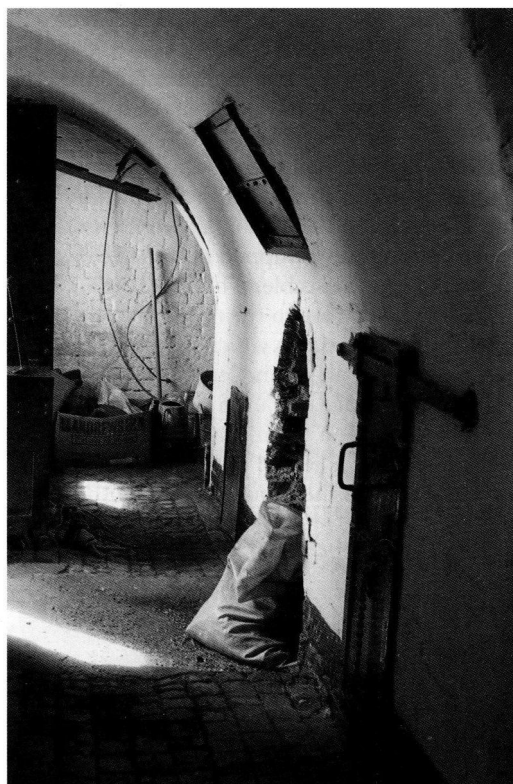
Diss (Norf.), Cuthbert's Malthouse No. 4, north side of Victoria Road, interior of the malt kiln showing the furnace front removed. Note the two different ventilation slips.

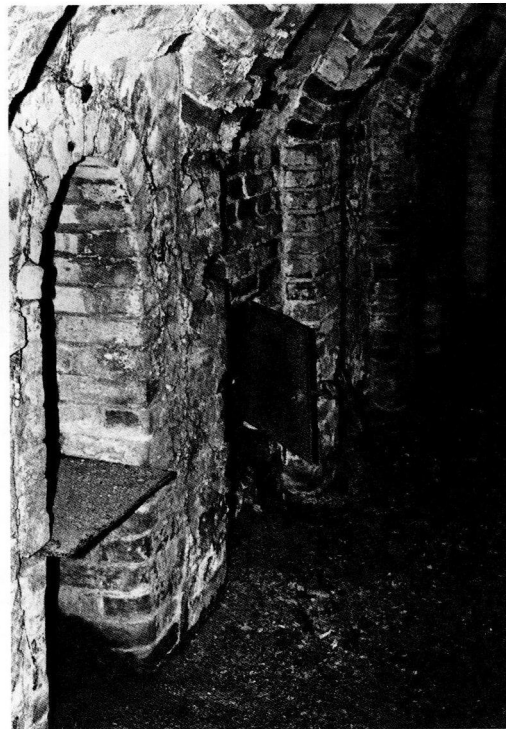
Fig. 26

Letheringsett (Norf.), interior showing the kiln furnace block. Note the shelf in front of the fire bars of the left hand furnace; also the brick ribs.
