# How medieval is a medieval house?: Whitestaunton Manor, Somerset

*This essay presents speculative interpretations of archaeological observations made by the author during the structural and decorative refurbishment of Whitestaunton Manor House near Chard in Somerset between 2004 and 2011. The bulk of the data recorded during the intermittent 'watching brief' operation conforms to received models of historical building development and would be of little interest to readers of this journal, but three ensembles of archaeological details challenge conventional explanation, whilst a fourth is of methodological significance for others engaged in this sort of work. The author suggests, tentatively, that Whitestaunton Manor House displays, inter alia, evidence of non-economic re-use of salvaged fabric and structures in the 17th and 18th centuries for polemical purposes, comparable to the use of spolia in continental Europe.*

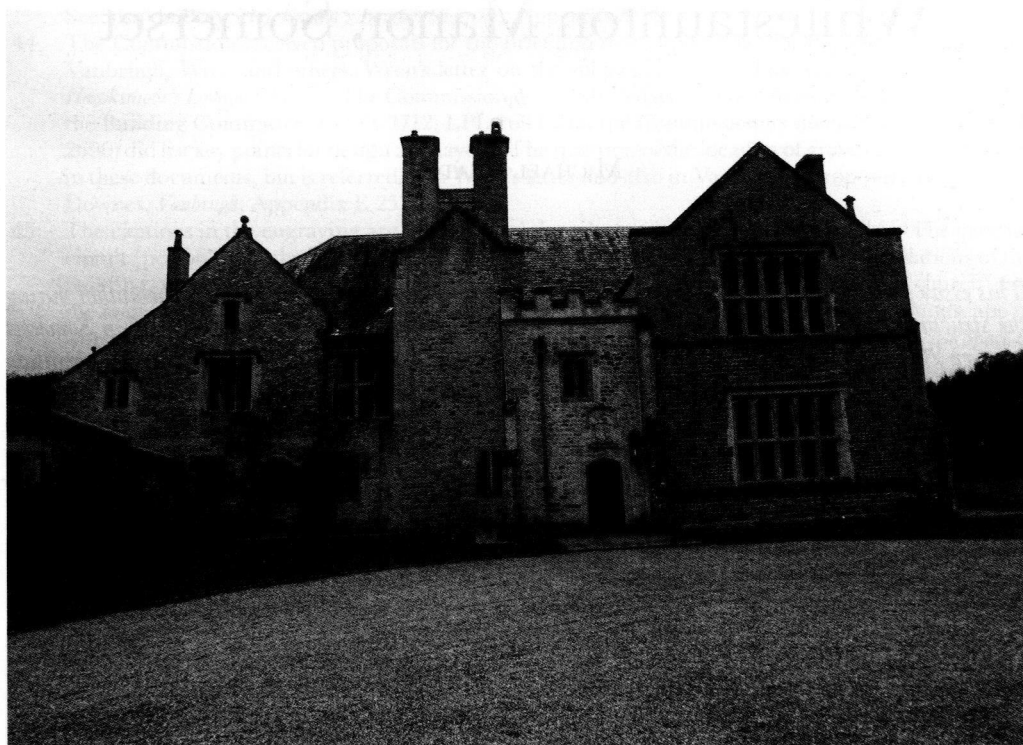
Fig. 1

Whitestaunton Manor House, Somerset, north elevation (September 2017).

The house (Fig. 1) stands next to the parish church of its eponymous village, at the source of the River Yarty in the south-facing slopes of the Blackdown Hills near Chard in southern Somerset, within landscaped gardens. The geological base is extremely complex

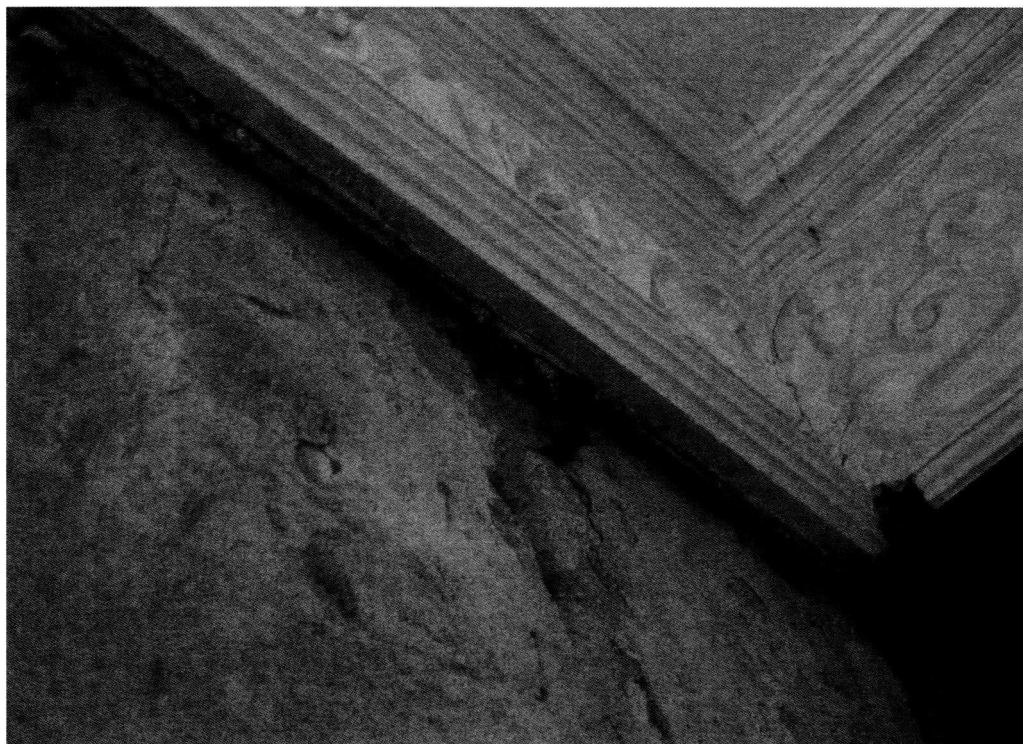
Fig. 5

The plaster frieze in the Frieze Room, showing it clearly separated from the rendered wall face by sawn, softwood roofing battens. The thin grey layer within it (not clear here) is expanded metal lath (EML).

Firstly, the decorative plasterwork friezes in the Dining Room and the Frieze Room one of which is described, presciently, by Jane Penoyre as 'extraordinary' and dated to *c.*1630 on the basis of its physical association with a datable heraldic device over the fireplace, are composites of broken pieces held together on a substrata of expanded steel mesh and machine-sawn softwood battens fixed to fully rendered wall surfaces (Fig. 5), in places retaining fragments of flock wallpaper. They were well-executed: the joins between the short, repeated lengths of the patterns are discernible only at close quarters, whilst the substrata became visible only during dismantling of the panelling below it. Neither Penoyre nor anybody else could have seen it. Penoyre's study of the plasterwork of Somerset, in which the Whitestaunton examples feature, is one of several important typological studies that use 'dated' examples such as this to establish a chronological and stylistic sequence against which less-securely dated examples can be compared. The Whitestaunton example may well have been created, first, in 1630 and possibly for this house, but that cannot be proved. There is no evidence that either of the two rooms ever had friezes or any other type of decorative fixture fixed to their walls prior to the 20th century. In contrast to the highly decorated interiors acquired by the Moores, Whitestaunton Manor appears to have been brutally austere. In all likelihood the friezes were acquired from elsewhere and installed *c.*1925 by Lieutenant Colonel Reynolds-Mitchell, following the fashion of nearby Barrington Court. Whilst this reveals the hitherto unrecognised interior character of the house prior to the early 20th century, its significance relates primarily to the art-historical typological study that informs architectural history generally, for the purposes of which it is of fundamental importance that the provenance of a dated piece be established. The provenance of the Whitestaunton friezes is unknown and, as Harris and others demonstrate, it is unlikely that they are unique instances.

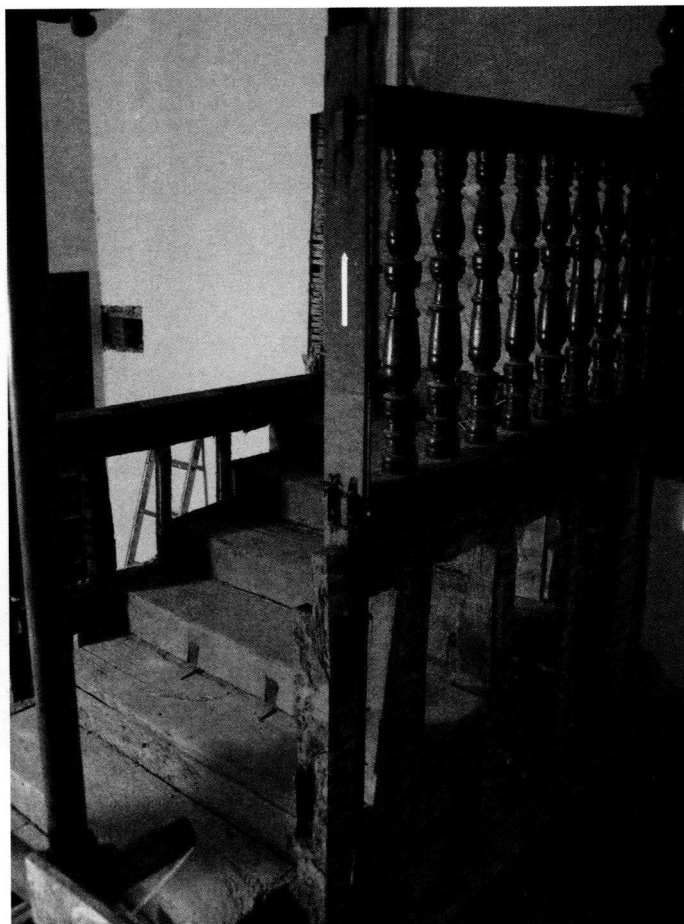
Fig.6

The main staircase during investigative dismantling. Note that the newel post (marked by white label) is merely cosmetic.

Secondly, the ‘good 17th C stair’ is – or was – a composite of re-positioned 16th, 17th and 18th century components within a collapsing framework of late 19th and 20th century construction (Fig. 6). It was neither ‘good’ nor ‘17th century’ but appears to have been re-configured, first in the 18th century when access to the newly converted roof spaces was created for the new owners, the Elton family. Leaving aside the inaccuracy of the List description and the problems which that caused Mr and Mrs Moore, the staircase is interesting for two reasons. Archaeological and metric analysis of the re-used 17th century components allied with chronological plan-form analysis of the rest of the house, undertaken to support the Moores’ case for re-modelling the stair, revealed the original form of the Jacobean staircase and the layout of the stair turret that accommodated it. Rather than the claustrophobic and poorly-lit Escheresque winder stair inherited by the Moores, the Jacobean stair had been an elegant, well-lit open-well structure that ascended three sides of the stair turret to alight on a balustraded internal balcony landing that ran the full length of its west side and opened into the principal first floor reception room of the Jacobean west range. It was extended to the roof space, probably by the Eltons in the 18th century, and then the balcony closed-off and its balustrading re-used serially throughout the later 18th and 19th centuries to form the inelegant and

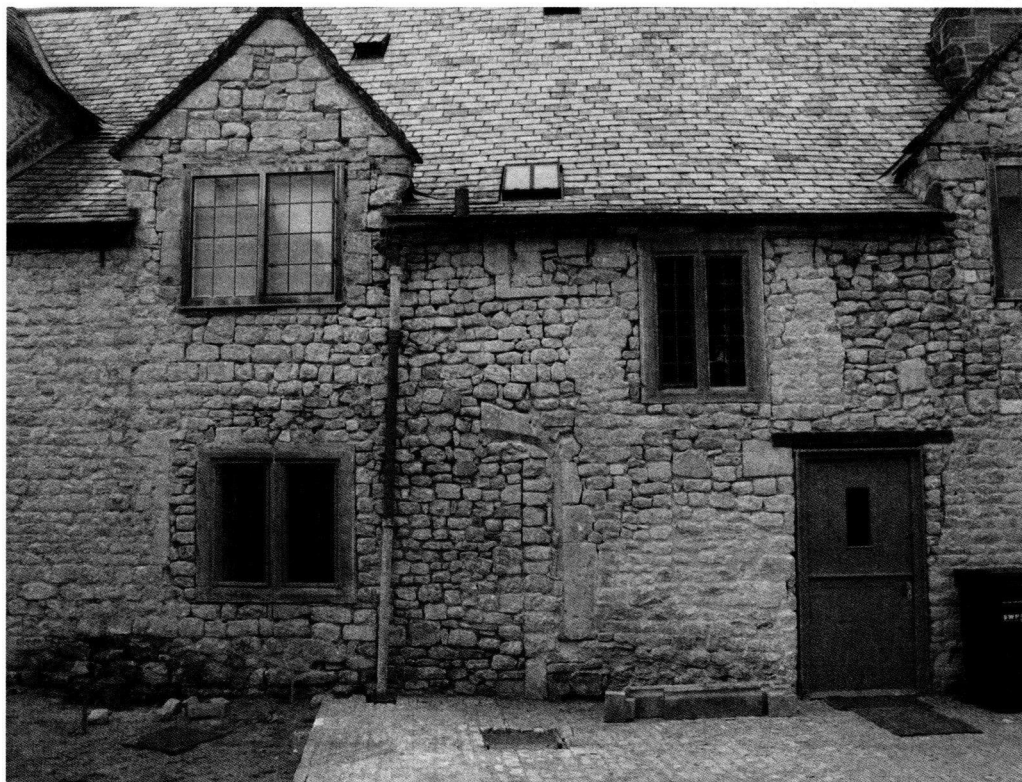
Fig. 7

Part of the east elevation of the east range, showing the *faux* archaeological details. The Hamstone windows were probably installed under Sedding's direction in 1875.

kitchen now at the southeast corner of the house. The Victoria County History ascribed to the east range a late 16th century date; the Somerset Vernacular Buildings Research Group places it in the late 18th – early 19th century. It was added before the tithes survey of 1840; clear structural joints demonstrate that it post-dates the 15th century Hall; its mono-pitch roof structure is of simple principal rafter form; and its functional window and door surrounds, which are replacements of earlier assemblies, are of exactly the same stone, weathering and detailing as those installed in the 17th – 18th century stables by John Dando Sedding in 1875. The author concludes that the east range was probably added by Isaac Elton shortly after 1718. Removal of the external render of its eastern elevation (Fig. 7) facing onto the stable yard, revealed a number of ‘archaeological’ details that do not relate to present or past layouts and, more definitely, do not penetrate the full thickness of the wall. They are integral – exactly contemporaneous – to the masonry fabric enclosing them, but they could never have been functional doors or windows. They are unlikely to be incidental inclusions within the rubble because any mason would have hidden them or at least laid them horizontally, and they are self-evidently not antiquarian architectural embellishments. They must therefore have been incorporated for visual effect, but to what end? This, also, is addressed in the Discussion.

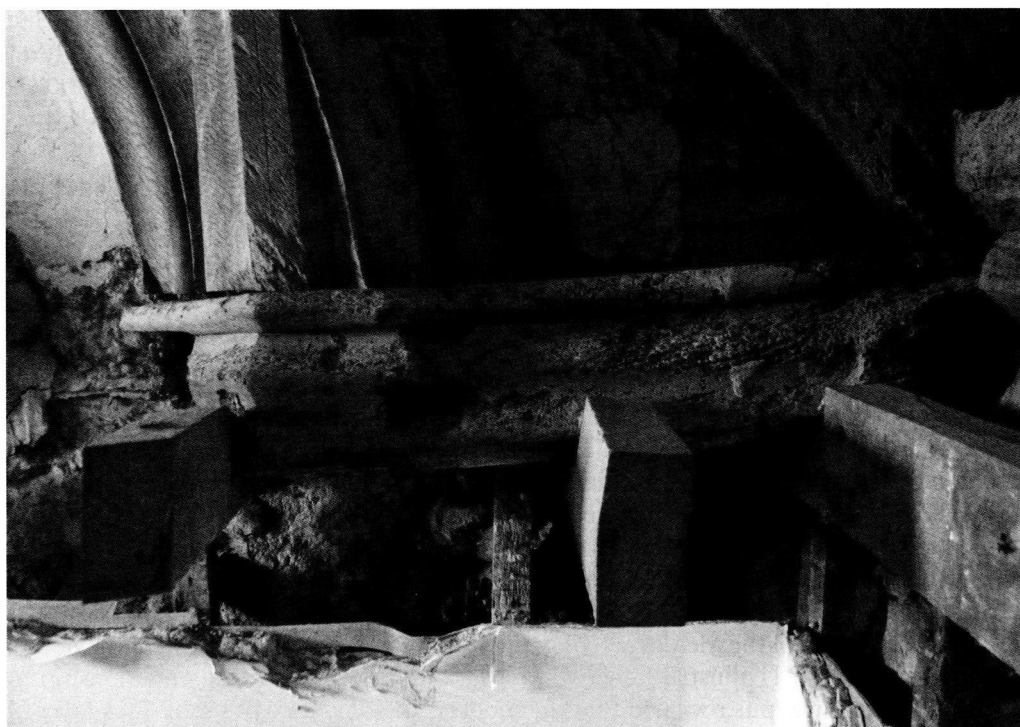
Fig. 9

The roof space over the first floor Hall showing one of the hammer beams with later ceiling joists let into its soffit. Note the missing knee brace.

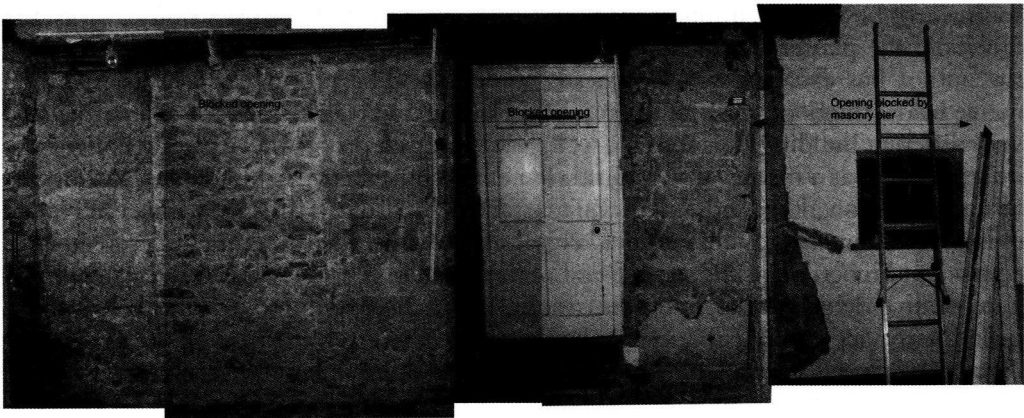
Fig. 11

Composite photograph of the west elevation of the east wall of the kitchen, taken in a dusty atmosphere, showing two of the three openings, one filled with rubble, the other partially filled with rubble and an inserted door opening.

Figures 10 and 11 illustrate the west elevation of the wall and its relationship to the floor levels. Trial pits revealed that the modern floor lay on a 500mm thick layer of compacted rubble of chalk and painted plaster that extended southwards beyond the house and into the inner courtyard. At the base of the rubble is a compact, 200mm thick, pale brown mortar surface that runs contiguously into a pitched slate hearth between massive limestone block abutments, also c.500mm below the current fireplace hearth level and nearly one metre below the floor level of the rest of the house. Though not established conclusively in the small exposures possible, the mortar surface appears to be structurally associated with the east wall of the kitchen. The wall face is formed of punch-finished rectangular ashlar blocks of cretaceous limestone on a rubble base; its north end stops cleanly 800mm short of the north wall of the kitchen and its elevation is pierced by three identical tall blocked openings, of which the northernmost has survived unscathed. Each is 1.34m wide x >2.0m high and has chamfered reveals with plain run-out stops at the bases and tops. If these are doors, they relate to none of the existing or known former floor levels or room configurations; if they are windows, they conform to no known medieval or post-medieval type. At first floor level, this wall also incorporates a projecting hollow masonry moulding (Figs. 8, 10 and 12) in its west face that runs across the full width of the room, partially obscured by the existing ceiling/floor structure and carrying a slight offset of the wall face. It is not a string course or drip moulding of medieval type, it is on an internal wall and it does not relate to the floor configuration of the two storey medieval hall – it pre-dates the upper floor.

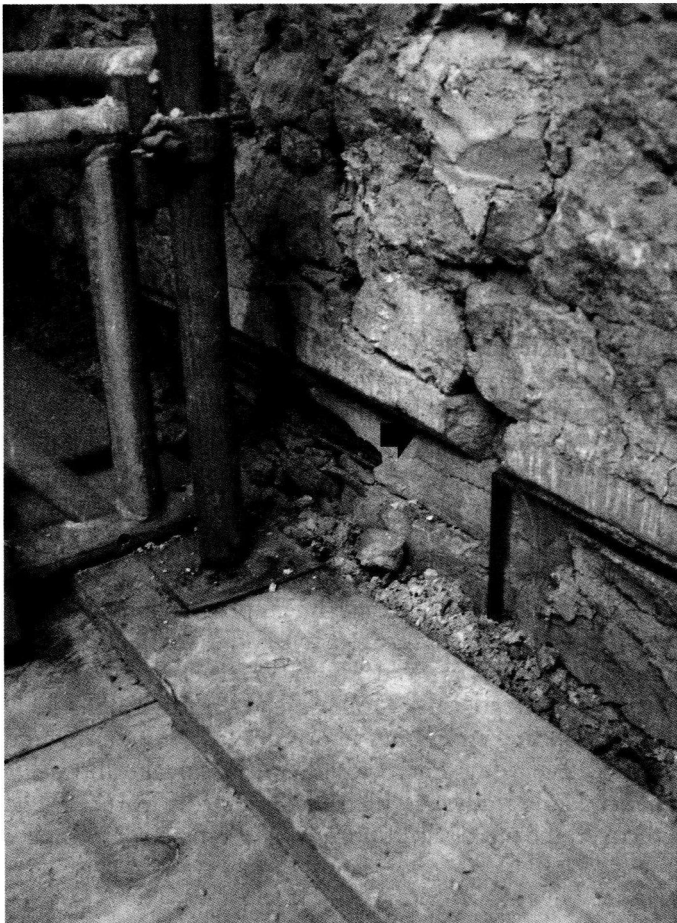
Fig. 12

The hollow moulding integral to the east wall of the kitchen and first floor hall. The scaffold boards are resting on the 15th century upper floor structure.
