Protecting the Fabric and Content of Historic Cathedrals against Fire

VINCENT SHACKLOCK and ALEXANDER COPPING

This article looks at the causes and effects of fire and at systems and procedures which will minimise risk, using information drawn from various cathedrals and agencies. Experiences at York Minster and Norwich Anglican Cathedral, both leaders in certain respects in the adoption of fire safety measures, is given special attention. The aesthetic impact of physical interventions is also considered.

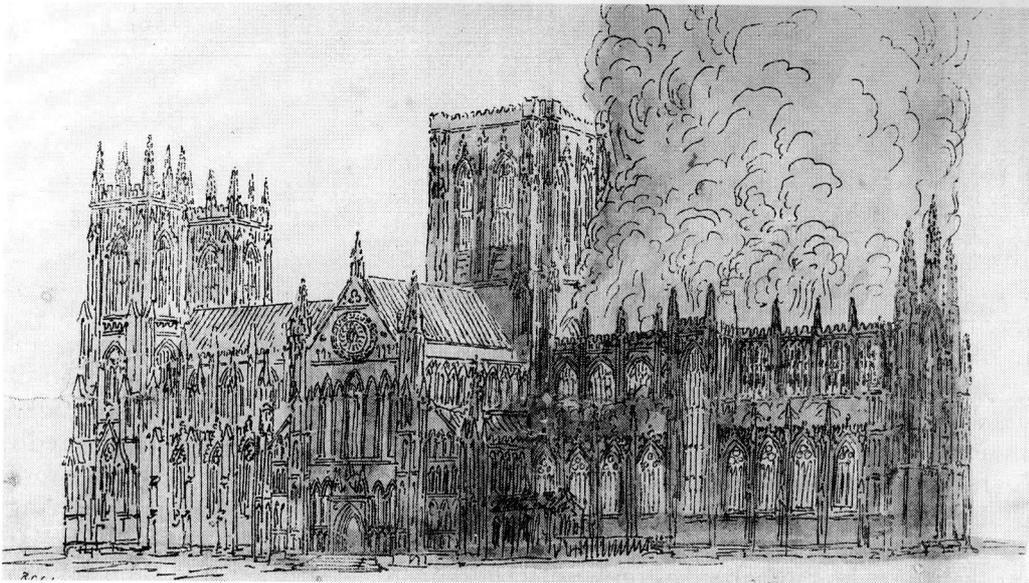
Fig. 1

Sketch by T. Inchbold of the 1829 York Minster fire
York Minster Library

1. On 1st February 1829 an act of arson by Jonathan Martin destroyed the choir roof, the organ, the medieval stalls and all the furnishings of the eastern section of the building (Figs. 1 & 2). Born in 1782, Martin served in the Royal Navy for

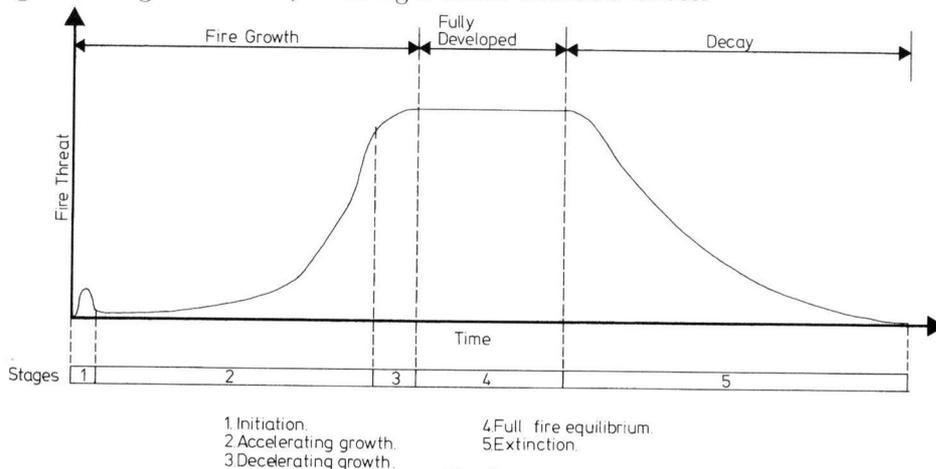
Fig. 6
Stages of fire development

Before considering how fire may behave in cathedrals it is useful to clarify the physics of fire. Fuel, oxygen and heat are needed to initiate and sustain a fire but two further elements must be understood. First, the buoyancy of hot air carries the exhaust products away from the fire. Without such movement all the combustible gases would remain in the heart of the fire and there would be no spread. Second, it is the flammable gases given off from the heated-up solid material that burns rather than the solid material itself. These gases produce more heat which feeds back to the fuel, causing greater intensity and leading to the production of more flammable gas.⁷ All fires, regardless of their severity, undergo the following five stages (Fig. 6):

1. *Initiation*. Heat is brought in contact with flammable material which acts as kindling.
2. *Accelerating growth*. Flames raise any potential fuel in the vicinity to the point at which it starts to release combustible gases (pyrolysis) which feed the flames, generating more heat, creating a chain-reaction effect.

3. *Decelerating growth.* The rate of growth declines as the concentration of oxygen in the air becomes depleted and the supply of fresh air to the fire zone is constrained by the capacity of the ventilation system. As the temperature rises, the rate at which heat is lost from the fire zone by convection and radiation increases sharply, limiting the rate of pyrolysis. Although the pyrolysis-effect reduces temperatures, extremes of heat may be transferred to adjoining areas and structures by convection and radiation.

4. *Full fire equilibrium.* The fire atmosphere reaches an equilibrium temperature that fluctuates about a mean of 1000°C as a result of the processes described in the third stage. The energy output of the fire remains relatively constant so long as fuel and air supplies to the fire zone are maintained.

5. *Extinction.* This will be caused by the action of fire suppression systems or exhaustion of available fuel.⁸

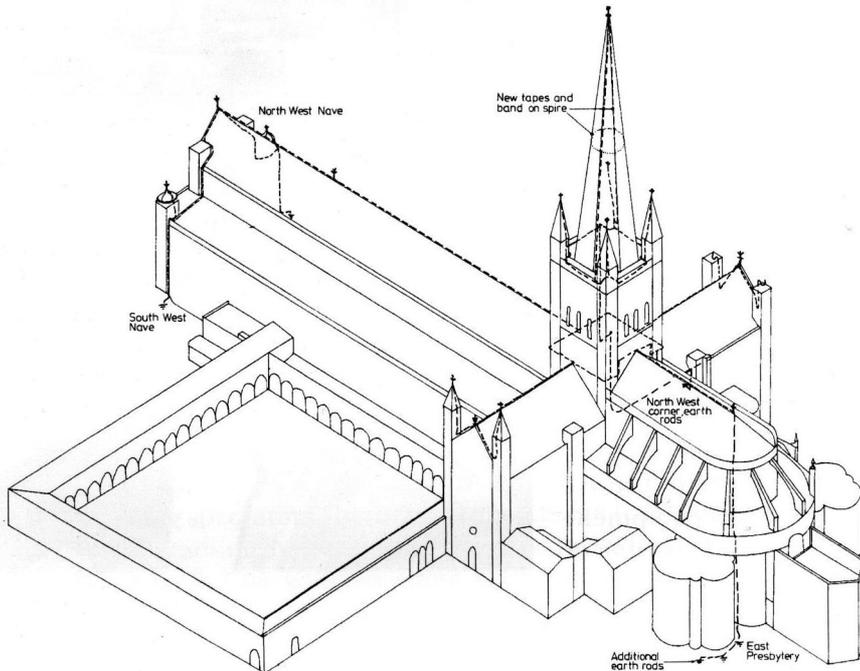
Fig. 8

Norwich Anglican Cathedral lightning protection system. All the pinnacles and other high points are protected

of 1992 is a recent reminder of this danger, but all cathedrals now have stringent work specifications to ensure precautions are in place when blowlamps, flame cutting and welding equipment or flammable liquids are being used. Lightning remains a threat to any church although techniques for bonding electrical and structural elements and catering for side-flash are now better understood and applied. A full protection system involves a number of circuits and earthing points and most casual observers would be surprised to discover the length of conductor cable and the number of lightning rods employed (Fig. 8).

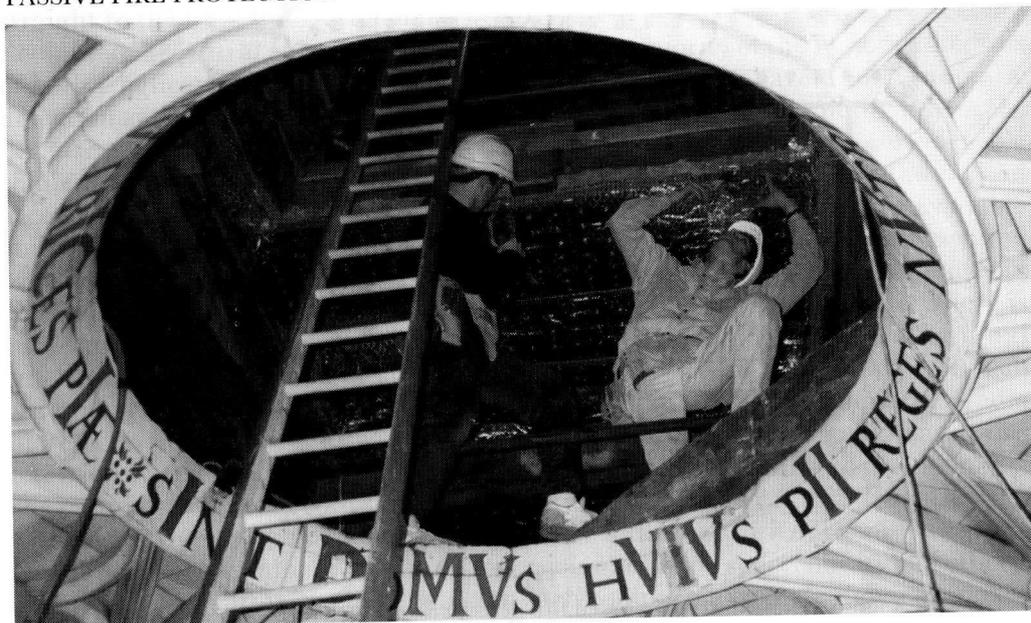
Fig. 10

Insulation being installed under the bell tower floor at Winchester Cathedral

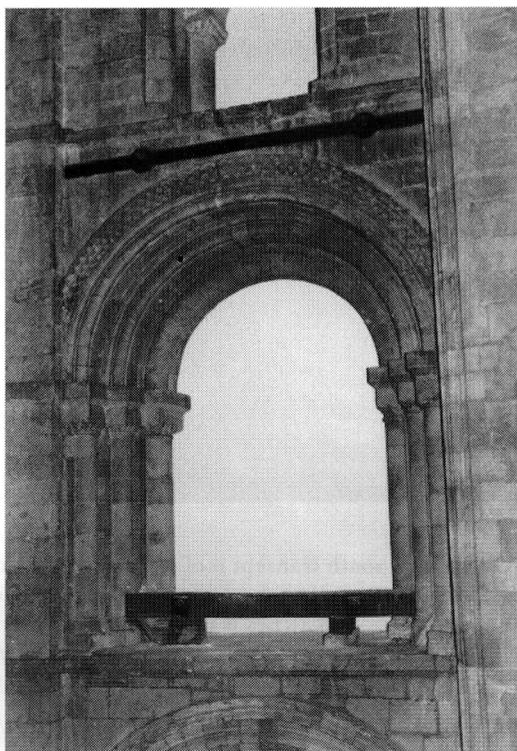
Fig. 11

On the advice of the local fire service, the triforium and clerestory arches open to the west towers at Southwell Minster have been infilled with one-hour fire-resisting board

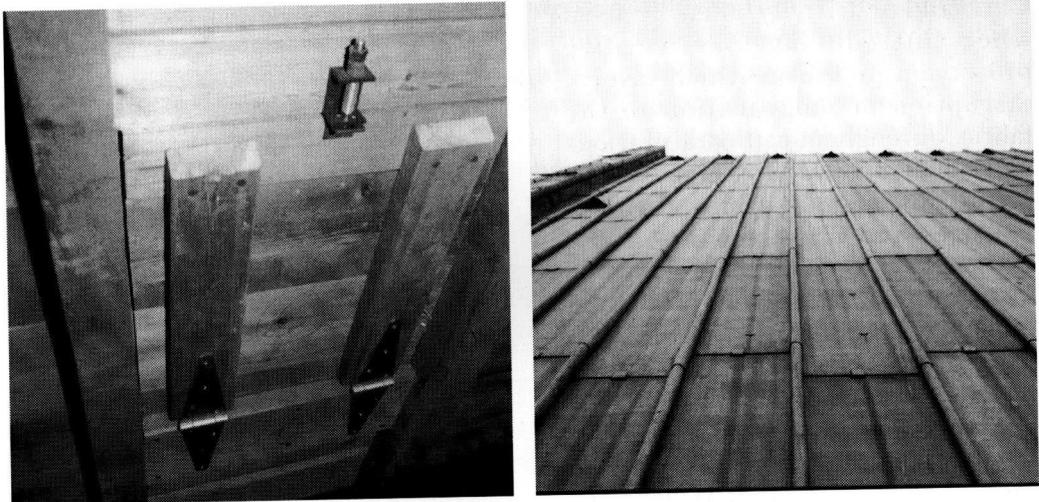
Figs. 12 a & b

On the new south transept roof of York Minster, cleverly disguised bottom-hung trapdoors have been installed to allow the escape of smoke and heat in the event of fire. The location of the fire hatches is identified on the outside of the roof by lead dots.

Air-venting to allow the escape of smoke also helps to control fires. On the new south transept roof at York Minster, cleverly disguised bottom-hung trapdoors have been installed. In the event of fire the fusible-link catches are designed to give way and the trap to fall open, allowing the lead roof at this point to melt and the smoke and heat to escape. The hatches are identified on the outside of the roof by lead dots, allowing fire-fighters to locate them (Figs. 12a & b).

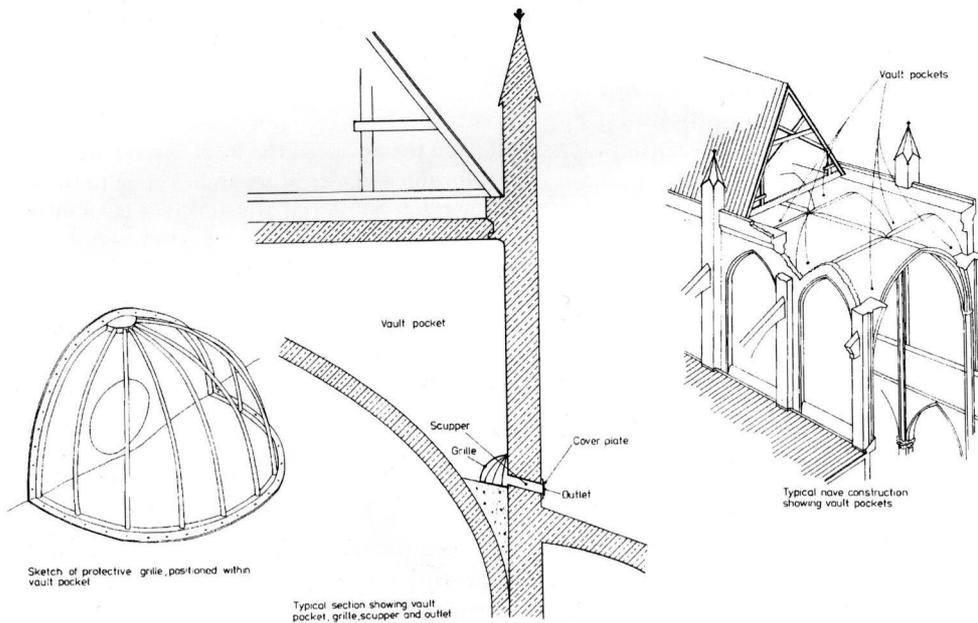
Fig. 13

Removal of water from vault pockets. Scuppers allow drainage to ensure that vaults are not threatened by a water load in the event of a roof fire.

In response to concern at the potential for the collapse of vaults owing to water retention in the pockets, some cathedral authorities have installed scuppers which

will allow water to drain away. These are holes drilled from the bottom of vault pockets to the exterior of the building or into an interior drainage facility, covered with grilles to prevent blockage by debris. Scupper outlets may be disguised by a variety of means including top-hinged plates, loose-fitting stone blocks which are pushed out through pressure of water or new gargoyles (Fig. 13). St Paul's has a similar potential for large amounts of water to be caught at high level because of its complex construction, consisting of an inner dome, a brick cone which supports the lantern and an outer dome, which is really a trussed roof, covered in lead. Subdivision of the outer space into eight compartments has been completed to slow the progress of any fire in this dry and frequently very hot space. Difficulties of access have been addressed in part by the insertion of an elevator in the south-west corner to enable four firemen, in full equipment, to be taken up the first thirty metres; a second elevator to the base of the dome remains to be completed.¹⁹ The problem of retention of water used to fight a fire in the dome remains to be addressed. Two substantial reservoirs exist which, if filled might prove heavy enough to bring about a collapse (Fig. 14).

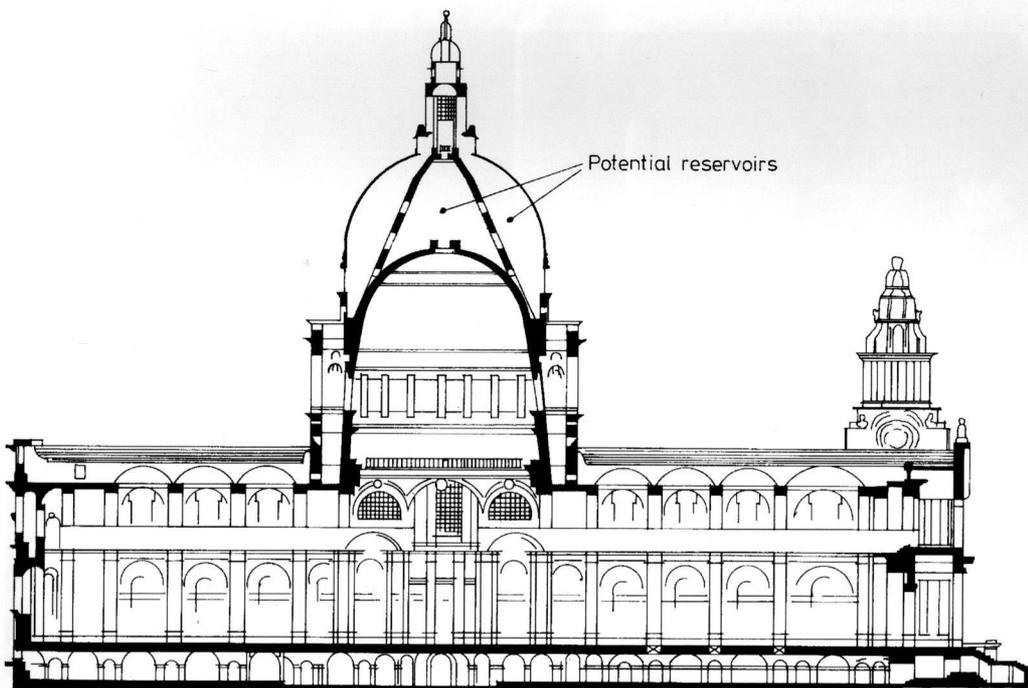
Fig. 14

St Paul's Cathedral. The dome's construction has created spaces with the potential to hold dangerously large quantities of water.

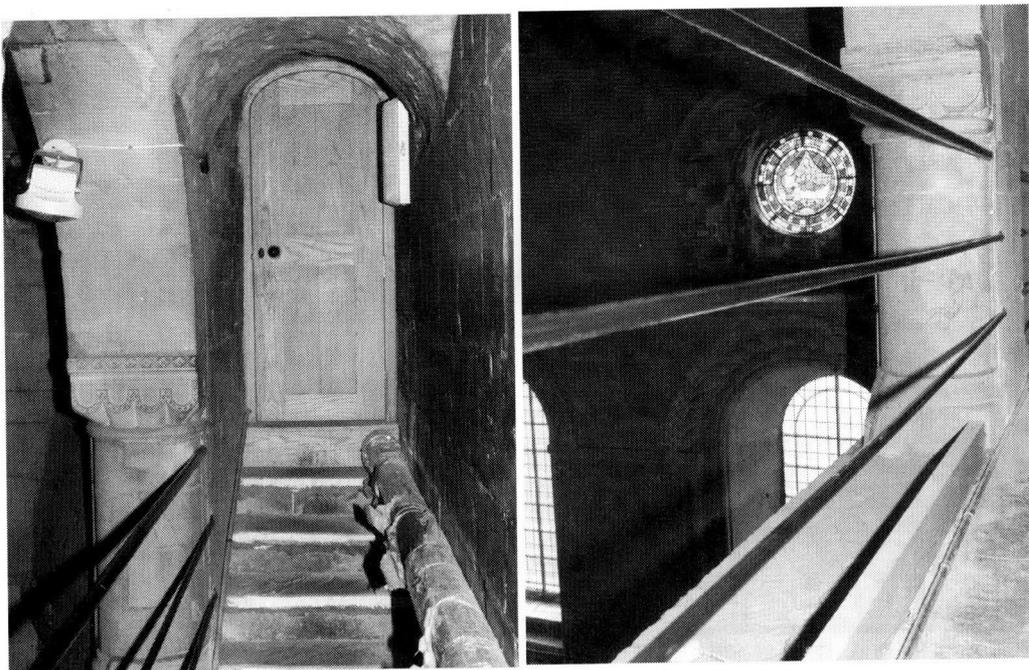
Figs. 15 a & b

Recently installed solid oak fire doors at Southwell Minster provide additional safety for tour parties, while emergency lighting, white-lined stair-treads, toeboards and handrails improve ease of escape in the event of fire.

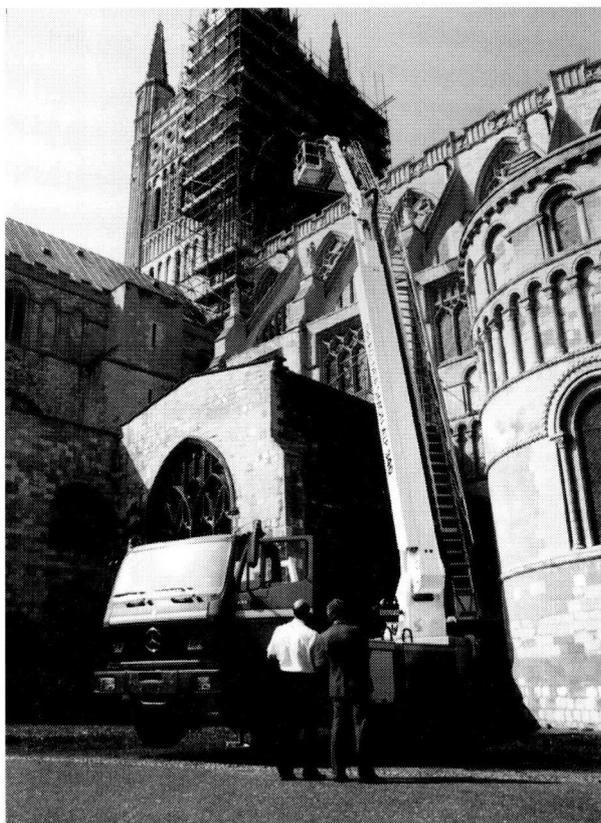
Fig. 16

At Norwich Anglican Cathedral the fire brigade practise regularly, so that each fireman is familiar with the cathedral layout and the procedures to be followed in an emergency.

Fire services will frequently regard a cathedral as the single most important structure in the area, carrying out training exercises as frequently as every two months, but this is not always the case (Fig. 16). In the event of a fire, it is vital that there is suitable access for fire appliances and equipment but many cathedrals present problems. Access to Wells, for example, requires appliances to have tyres part-deflated to get through a medieval gate to the precinct, while at Canterbury the Christchurch Gate, the single access for the brigade, allows only 75mm clearance to either side of the vehicle which has to be very carefully aligned before entry is attempted (Fig. 17). Elsewhere, there are various examples of graveyards and monuments, burial voids and unconsolidated ground presenting obvious problems

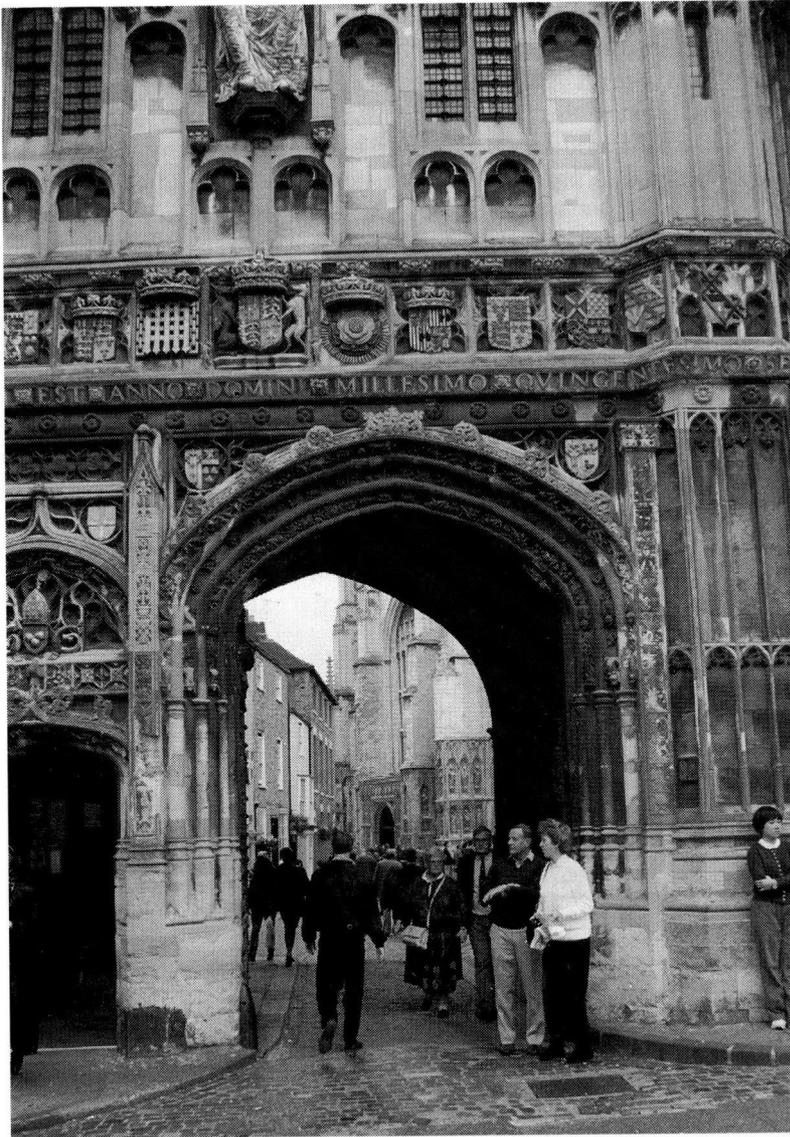
Fig. 17
 The Christchurch Gate at Canterbury Cathedral provides the only vehicle access. Clearance on either side of the fire appliance is less than 75mm.
A. Copping

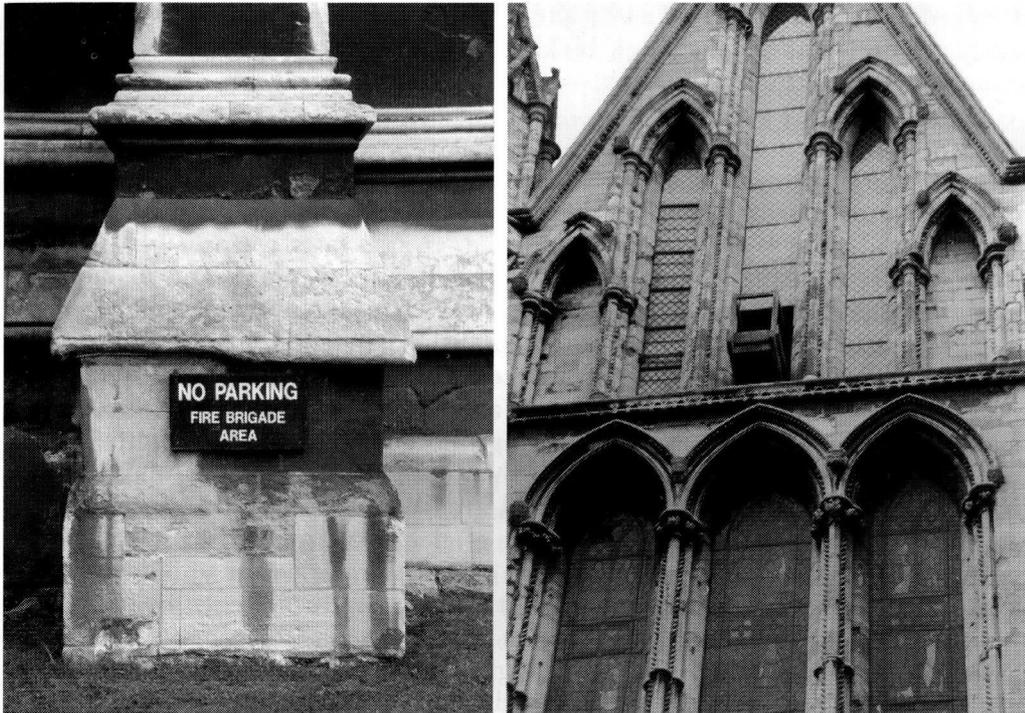
Figs. 18 a & b

Lincoln Cathedral. A grass covered concrete hardstanding for a brigade vehicle with an access walkway above leading directly into a roof space in the south transept.

for large heavy machinery. A hardstanding capable of carrying 12.5 tonnes is required for the engines and one of 16.25 tonnes needed for high-reach equipment²⁰ (Figs. 18a & b). Wet and dry risers are a vital tool in enabling water to be pumped rapidly into the building. Most systems are interconnected and provide internal outlets at ground level, within roof spaces and at other high-risk areas within the cathedrals. In addition, foam inlets to protect the boilers and oil tanks are used. Although risers are a visual scar on the exterior, their importance in ensuring fire safety seems to be recognised by all parties.
