DOVECOTS OF EAST LoTHIAN

By D. C. Bailey and M. C. Tindall

SURVEY

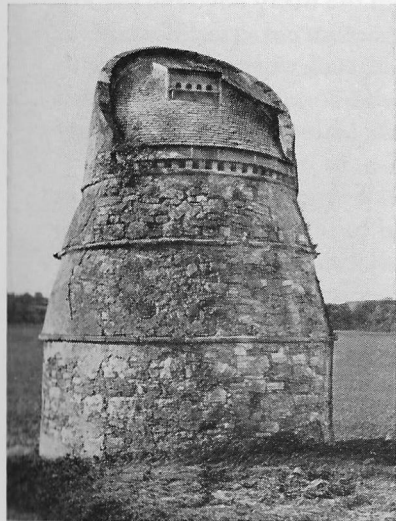
FIG. 4. Phantassie.

⊙ **Phantassie** 598774 (fig. 4). Near East Linton there is a *beehive* 9 feet 11 inches internal diameter with one-way slate roof bounded by a horseshoe-shaped parapet; random rubble wall 4 feet 3 inches thick; recently harled and colourwashed; three stringcourses; door 5 feet 2 inches by 2 feet 6 inches; sunk floor; sixteen entry holes in a row on the south side below the eaves, also four in a dormer; 544 stone nests of widely varying sizes, starting about 4 feet from the floor, and without ledges; lower nests 6 by 6 inches; upper nests 7 inches high by 10 inches wide by 12 inches deep; fixed ladders; good repair; no pigeons.

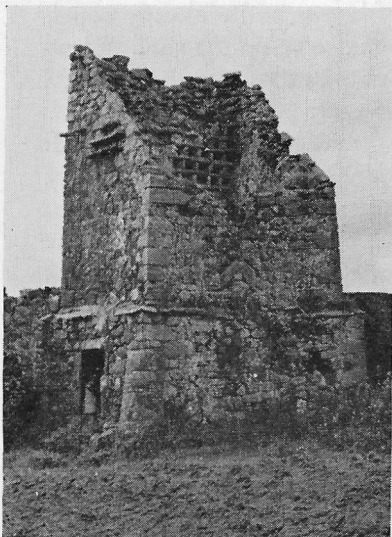
FIG. 8. Saltcoats.

□ **Saltcoats** 485819 (fig. 8). In the boundary wall of the ruined Castle there is an almost square *lectern* 15 by 17 feet, now roofless, once with one-way roof sloping in an easterly direction; crowstepped gables; random rubble walls, partly buttressed, with dressings and one setback course; doorway 4 feet 10 inches by 2 feet 6 inches; raised floor; no windows; six entry holes in a stone grid in the south gable; about 200 stone nests, once more, 8 by 8 by 12 inches deep; ruined; no pigeons.

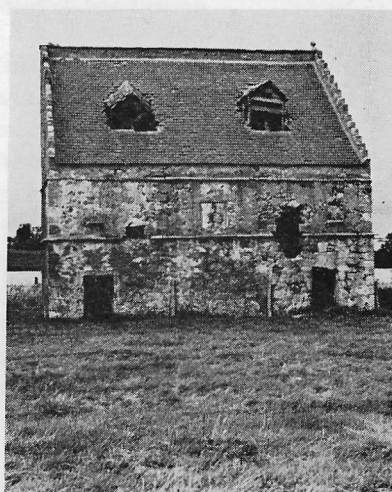
FIG. 11. Herdmanston.

◻◻ **Herdmanston** 471699 (fig. 11). Beside the River Tyne, on the opposite side to the mansion, there is a double *lectern* 35 feet by 18 feet 9 inches with one-way slate roof, two dormers and crow-stepped gables; remains of stone ball ornaments on the rear parapet; random rubble walls 3 feet thick with dressings and two stringcourses; coat of arms on the south wall with remains of date 1669; dividing wall not carried above roof; two doorways each 5 feet by 2 feet 9 inches; one window about 24 by 12 inches, possibly once a window in other chamber also; formerly twelve or seventeen entry holes in each dormer, now ruined, also an entry hole and ledge in the wall of the left-hand chamber; large numbers of stone nests, once about 2,000, 9 inches high by 8 inches wide by 14 inches deep; remains of revolving ladders in both chambers; ruined; pigeons.

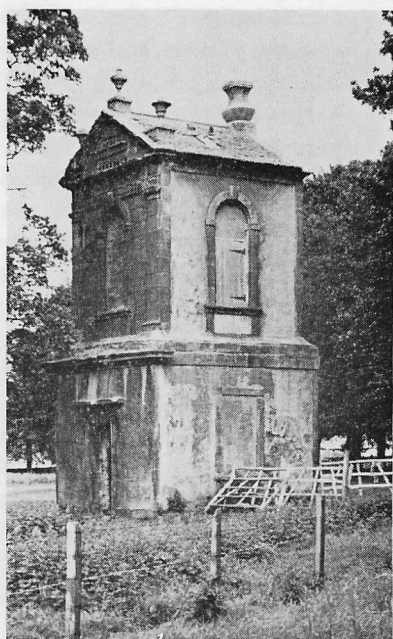
FIG. 13. Huntington.

□ **Huntington** 485749 (fig. 13). In the park, near the mansion, there is a dovecot in the upper part of a square pavilion with pedimented roof and stone ornaments; dressed stone and rendered brick walls 2 feet thick with stringcourse between lower and upper parts; floor covered with 4 feet of droppings, said to have accumulated in seven years since last cleared out; blind arched recesses, no windows; thirteen entry holes in one of the pediments; 151 nests now visible, out of a reported original total of 262, made of bricks and tiles, 10 inches high by 9 inches wide by 10 inches deep with 3 inch ledges; fair repair; pigeons.

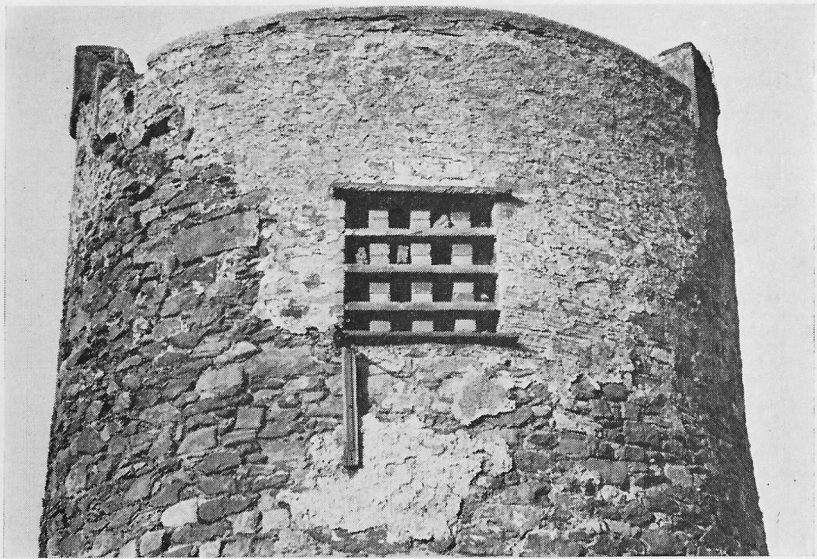
FIG. 15. Heugh.

○ **Heugh** 562842 (fig. 15). On the east side of North Berwick Law, now surrounded by poultry runs, there is a cylindrical dovecot 48 feet 6 inches outside circumference; random rubble wall 3 feet thick, partly harled and once whitewashed, carried above the roof and finished with a stepped parapet descending from north to

south; original roof replaced by flat concrete; door 4 feet 1 inch by 2 feet 5 inches; no windows; sixteen entry holes in a stone and brick grid on the south side; 587 nests, made of stone and brick, 10½ inches high by 7 inches wide by 13 inches deep; one string-course; fair repair; pigeons.

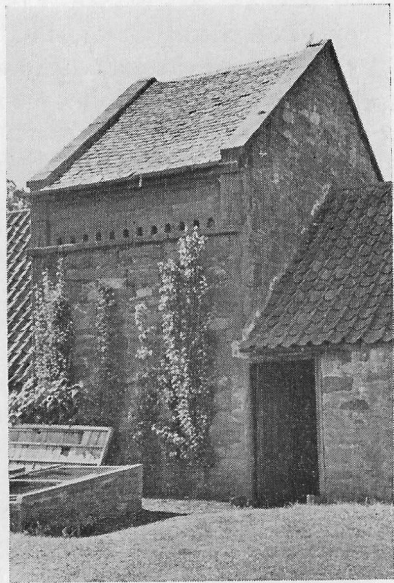
FIG. 16. Tynninghame.

T **Tynninghame** 611792 (fig. 16). In the upper storey of out-buildings behind the *factor's* house there is a dovecot with two-way slate roof and plain gables; random rubble walls with one stringcourse; twelve entry holes in a row in the south wall above the stringcourse; nests not inspected; good repair; pigeons.

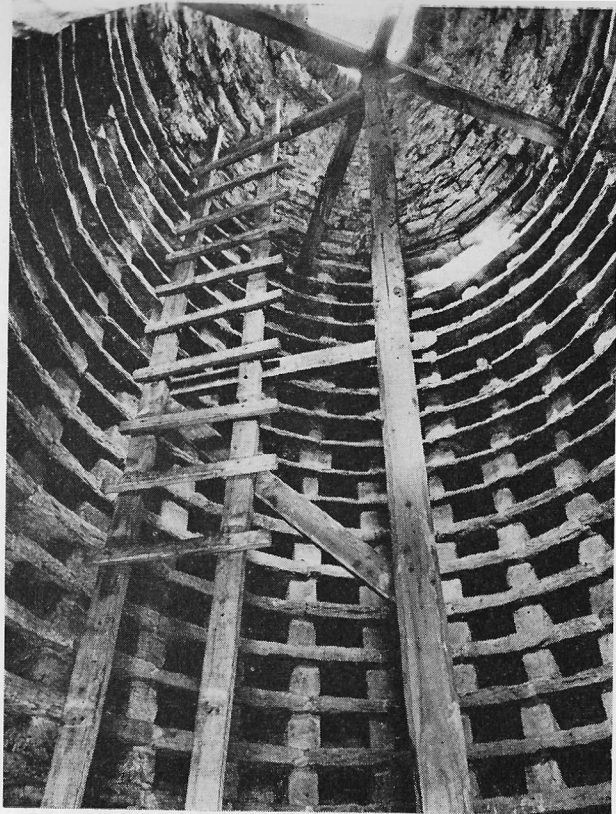
FIG. 21.

○ **St. Germain's** 426746 (figs. 21, 22). In a field at some distance from the mansion there is a cylindrical dovecot 50 feet 10 inches outside circumference with a battlemented parapet; flattish domed roof hidden by the parapet and until recently surmounted by a wooden Glover; random rubble wall 3 feet thick with one stringcourse; door 4 feet 7 inches by 2 feet 10 inches; sunk floor; three window slits, two projecting 6 inches from the

wall, splayed inwards and once barred; entry for pigeons through an opening in the centre of the roof; 501 stone nests $7\frac{1}{2}$ inches high by 10 inches wide by $15\frac{1}{2}$ inches deep, with ledges, starting at 2 feet 6 inches from the floor; potence ladder; good repair; pigeons.

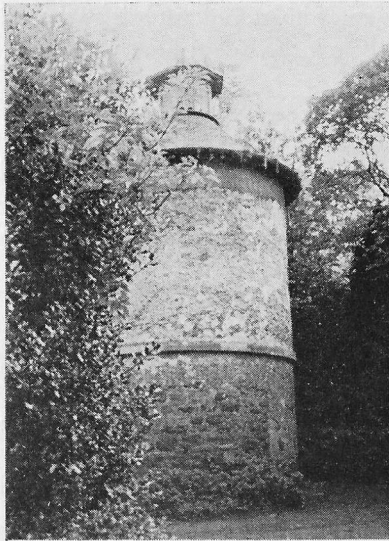
FIG. 26. Colstoun.

○ **Coulstoun** 513710 (fig. 26). Attached to buildings near the mansion there is a cylindrical dovecot with conical roof surmounted by a Glover; dressed stone wall 2 feet 4 inches thick partly harled; door 4 feet 11 inches by 2 feet 10 inches with wooden lock; no windows; 5 entry holes in an opening in the wall above the stringcourse, and 16 in the Glover; 468 nests $8\frac{1}{2}$ by $8\frac{1}{2}$ inches by 11 inches deep; well preserved potence ladder; good repair; pigeons.
