# THE TITHE BARN, ARRETON, ISLE OF WIGHT.

By J. E. C. Peters

THE purpose of this paper is to comment on the roof structure of the tithe barn at Arreton, which is of a number of periods, the earliest appearing to show evidences of the Highland cruck technique, although, according to Professor R. A. Cordingley's map the Isle of Wight is just inside the border of the Lowland box-frame zone.<sup>1</sup> The barn was examined and drawings made in 1960, certain details being checked the following year.

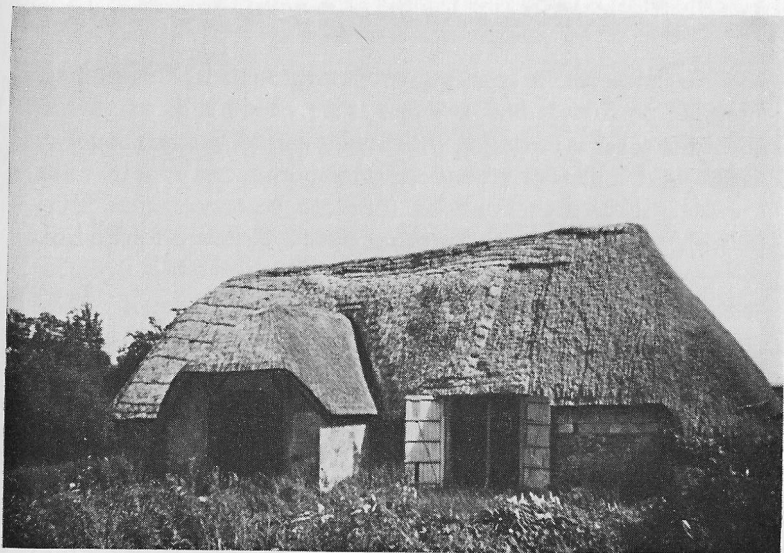
FIG. 1. Barn from north-west.

The farmyard is on a south facing slope with the barn on its southern side, a lower fold-yard lying beyond and a pond to the east. The main approach is from the north, where there are two entrances, the elder being an aisled porch with the sole southern entry opposite, 2 feet up from the yard, to provide a winnowing draught. The barn is built from the local chalky stone, is of six bays, thatched throughout with partly hipped ends; the valleys are tiled. It has been variously dated to seventeenth century<sup>13</sup> but is much older. The oldest trusses are of the base-cruck form, with a ridge purlin, the latest aisled in the box-frame tradition

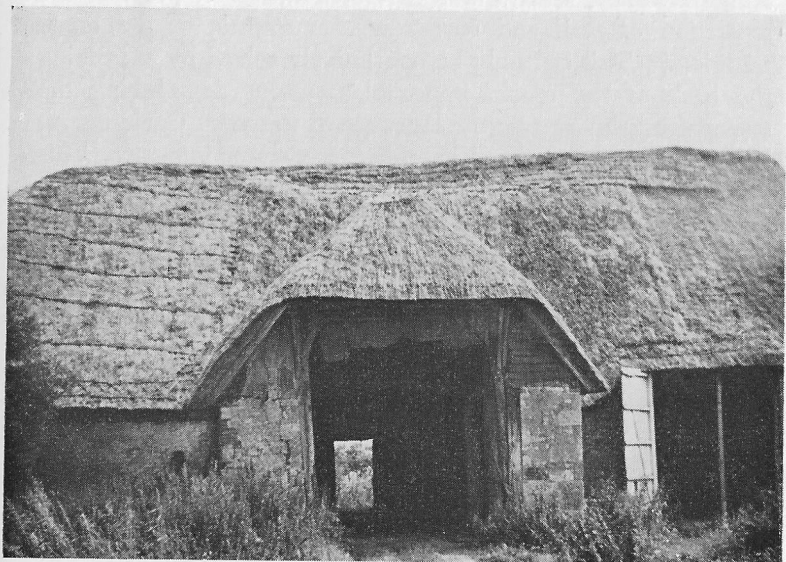
FIG. 2. Entrance porch.

The aisled porch was probably added after the cruck barn had been rebuilt and enlarged. Its trusses bear a close resemblance to what is left of Truss 6, allowing for the difference in span. The aisle-plate rests on top of the tie-beam, so no shoulder is needed to the principal post. This seems to indicate surviving cruck influence. Arch-braces rise to both but are so arranged that they enter the aisle-post at different levels, and so not weakening it. Both the purlins and the ridge piece run from the main roof to Truss 7 where they stop with two angle-struts; reinforcing to the roof beyond is provided by two rafter-collars. (The ridge-purlin beyond Truss 7 is a later insertion). The aisle-purlin seems to have begun against the crucks, and projects beyond the doors to form a hood, which has a floor of  $\frac{1}{2}$ -inch boarding on light poles. As the aisle-purlin is higher than the walls a triangle was left which was filled with vertical boarding, but this only survives on the eastern side. The original doors were probably harr-hung, the present ones still pivot in a hole in the stone plinth. The hip is larger than that at the east end, suggesting that it may be later, taking into account the same sized and later one at the west end.

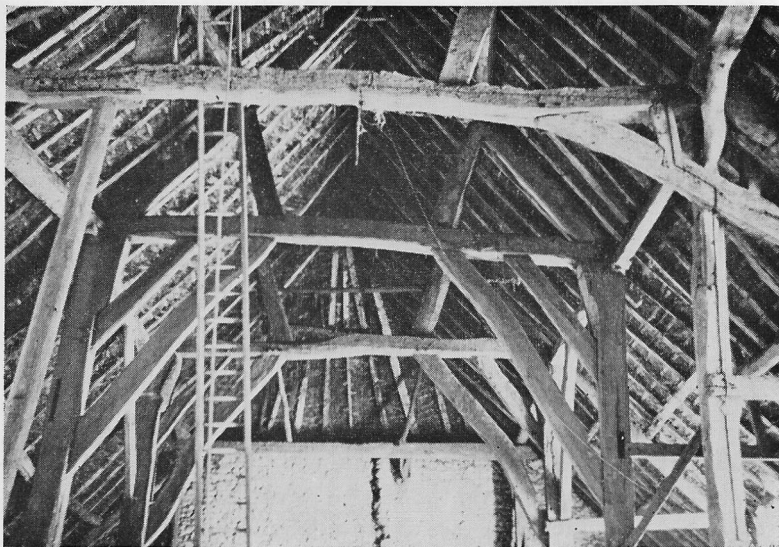
FIG. 3. Interior looking west, trusses 4, 5 and 6.

Truss 6 has also been heavily altered, now standing from seven to fourteen inches from the west wall. At Chale the end trusses are separated from the gables by a quarter bay, but as will be shown later the Arreton truss is not in its original position, otherwise it would suggest a date at the end of the timber-framing period. The tie-beam is a replacement (late nineteenth century?), having no provision for the arch-braces the posts undoubtedly originally carried, the mortices and dowel-holes being extant. The fact that it is underneath the aisle-purlin, in view of its being a replacement, only becomes significant when the porch is examined. The re-roofing of the north aisle leaves the interpretation of the mortices in the post on this side in doubt, but the original system survives on the south, where a cambered tie-beam sits on the wall-plate and penetrates the aisle-post.

Trusses 4 and 5 represent the last major alteration, and are in good condition. The bases to the principal posts do not project above the modern bituminous floor. Their timber has been inverted from its original growth, so that a shoulder is provided to provide an adequate surface for the joints with the trapped aisle-plate and tie beam. C. A. Hewitt<sup>31</sup> has shown that this is a later method than that seen in Trusses 6, 7 and 8.

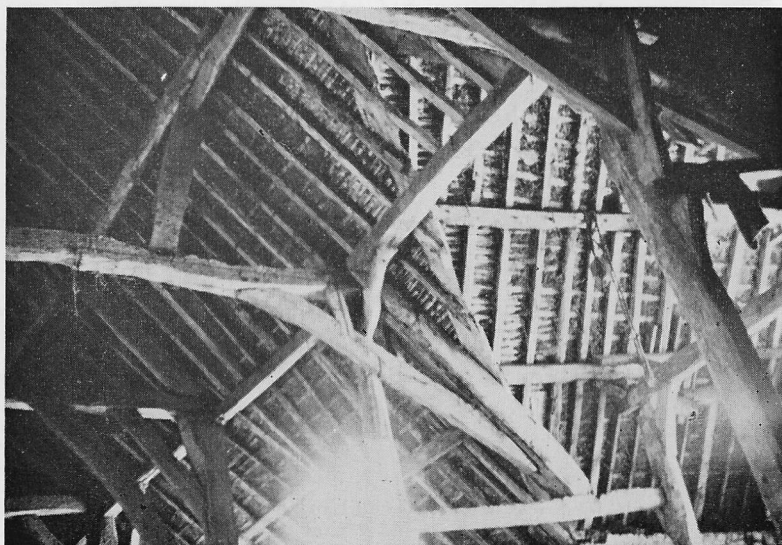
FIG. 4. Interior, truss 3, junction of porch and barn.

It would perhaps be advisable to begin with the oldest part of the building, the two trusses flanking the threshing floor, onto which the porch aisle-purlins appear to have run. They are curtailed—or base-cruck trusses, in a poor state of preservation, in 2 the northern cruck has completely gone, in 3 nearly so, the remains being supported by rather rough timber, approximating it to an aisled truss. Sufficient remains for the original form to be established, however.

preserved, the blade is 13 inches on the face, and has a vertical mortice in the side just appearing above the stonework of the wall. Does this indicate that the barn was originally timber-framed and that the cruck doubled as a wall-post? or was it merely a slot cut to take a temporary support whilst the truss was reared? If the former there should be a housing for the wall-plate—but as only 1 inch of the vertical back of the cruck is visible (Truss 3) it may be hidden by the stonework, the removal of which would reveal any other joints, there might be. In a cruck barn at Ty Mawr, Dingestow,<sup>17</sup> the vertical cruck fort has a clasping pier outside it, but the size of the crucks at Arreton should have rendered this unnecessary.
