A CRUCK BARN AT HENDRE WEN, LLANRWST, DENBIGHSHIRE

By Eurwyn Wiliam

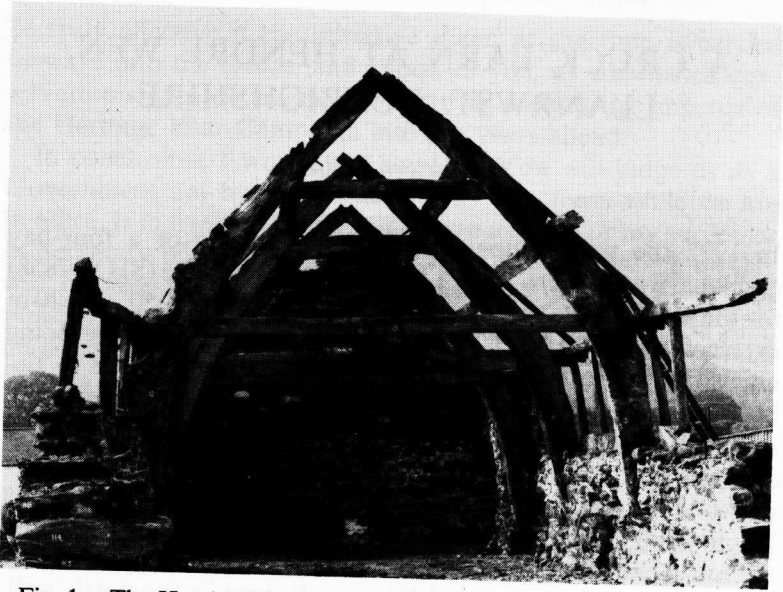
Fig. 1. The Hendre Wen barn before removal: view from the south

In 1972 the writer supervised the dismantling of a four-bay cruck barn at Hendre Wen, Llanrwst, Denbighshire (SH 807858) for the Welsh Folk Museum. The barn measured 15.50 × 6.20 m externally and was 5.50 m high, with the western gable being carried in stone to its full height, and the eastern one to tie-beam level, at 2.80 m. Two large facing doors divided the building, with the single bay to the west of the threshing floor having its walls all of stone. The remainder of the two side walls were of stone only up to *c.* 1.50 m from the ground, the remaining height being carried up in timber-framing covered with planking. Such a technique is not usual in the region.¹ The single bay at the western end was entered by a small door in the north wall.

The barn gave the appearance of having been constructed of massive dry-walling. The footing course consisted of stones of up to 1.30 m by 0.60 m and weighing up to a ton. It is clear, however, that the barn was originally rendered externally with the same greyish-yellow mud that was used to bind the stones together. The eastern gable included a fair amount of cow-hair plaster in its make-up. The roof was originally covered with small rough slates of varying quality and size, held in place by wooden pegs.

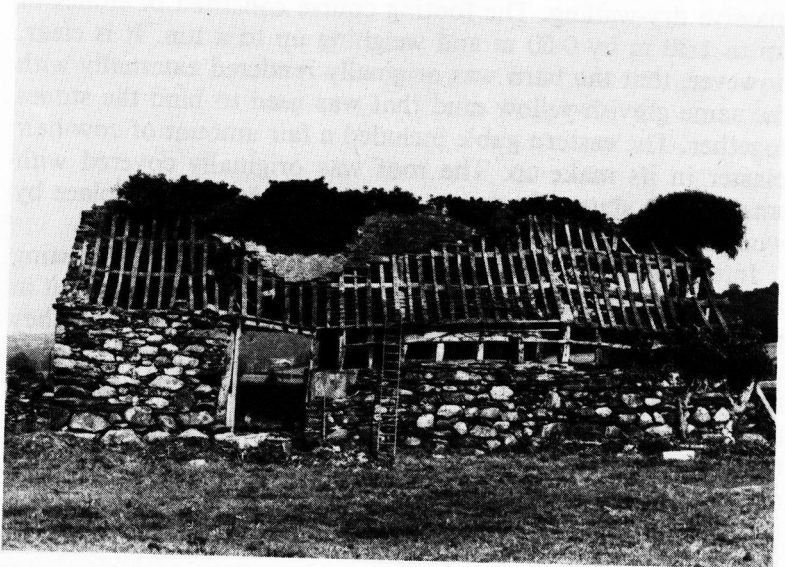
Fig. 2. The barn in process of dismantling: view of the crucks from the east

Internally, the barn was divided into four bays (one being taken up by the threshing floor) and demarcated by the three cruck trusses, slightly askew to the building. The four bays were approximately 3.65 m, 3.68 m, 3.70 m and 2.70 m wide. The three cruck trusses were c. 4.80 m wide at the base and 5.50–5.60 m high at the apex, and were of similar construction. Cruck I, easternmost, is inferior to the other two trusses, but all three have a "good" and a "bad" side, carefully worked and un-trimmed respectively, the "good" sides in all cases facing the threshing-floor. This is also the side on which the tie-beams and collars are placed. The tie-beams project to hold the wall-plate. The

bases of all the crucks rested on padstones built into the wall, these normally going right through to the outside, with the wall above the padstones carried up around the bases of the cruck blades. Cruck I had its blades set at 0.85 m and 1.00 m above the ground. The tie-beam was 2.80 m from the ground, and the collar, a re-used piece of timber, 4.20 m. The blades were halved at the apex. The southerly blade had been cut into to provide a 0.20×0.10 m seating for the bressumer. Cruck II had its blades 0.60 m off the ground, the tie-beam at 2.60 m, and the collar at 4.10 m. Here again the blades were halved together. Cruck III was set against the ends of the walls of the fourth bay, and thus was held in place only by the purlins and its own weight. Its blades were 0.40 m and 0.60 m off the ground, with the tie-beam at 2.70 m and the collar at 4.30 m. The blades at the apex were butted against each other, and pegged through from edge to edge. In all three crucks, the ridge purlin *c.* 0.15×0.15 m rested in a V notch and was secured by pegs.
