CHORLEY HALL, CHESHIRE

By R. A. Cordingley and R. B. Wood-Jones

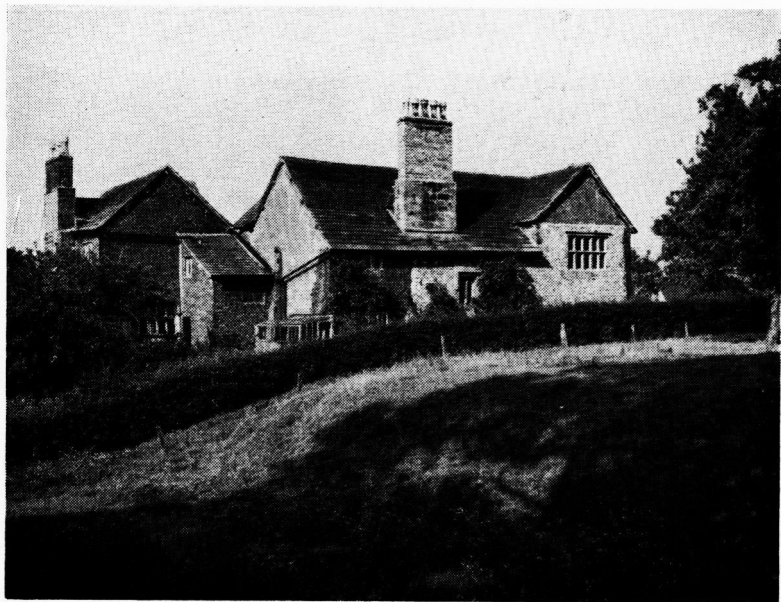
FIG. 1. The North Front.

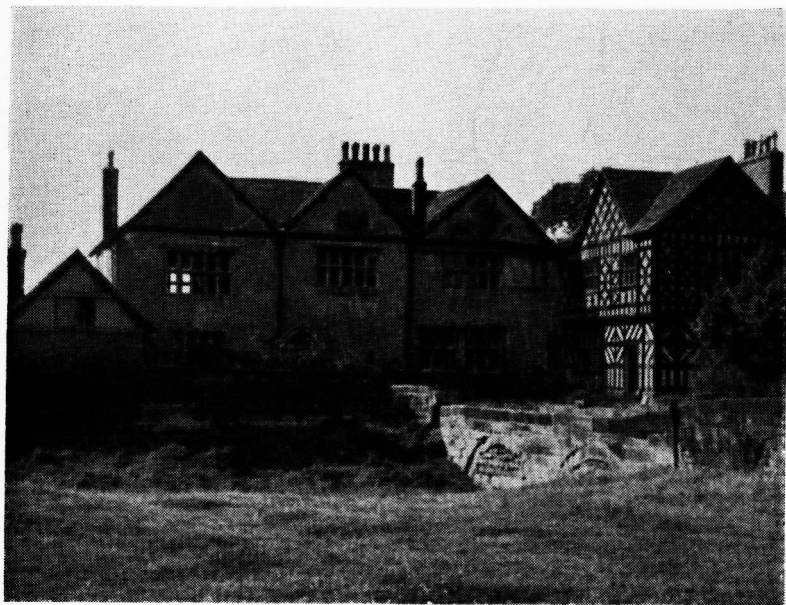
FIG. 2. The Hall from the South.
CHORLEY HALL, CHESHIRE.

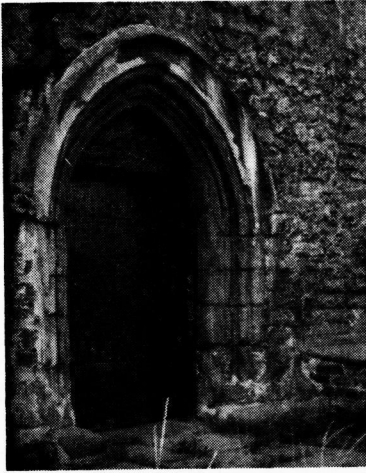
FIG. 3. North Doorway.

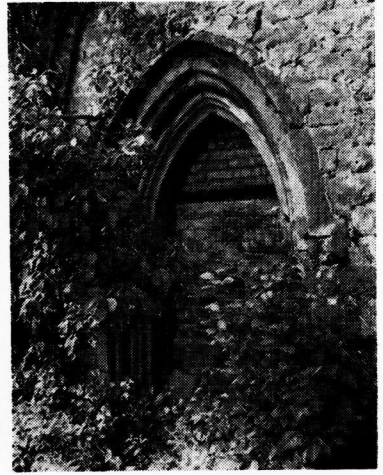
FIG. 4. South Doorway.

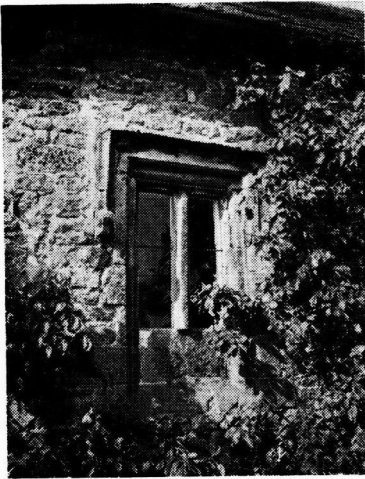
FIG. 5. Hall window on South Front.

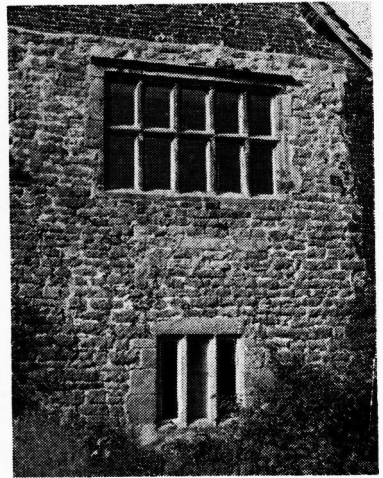
FIG. 6. The South Wall of the solar block showing original window to buttery.

Of the former fenestration, only two windows now remain. One original three-light window with flat head and concave-moulded mullions still survives on the south elevation, lighting the buttery. On the same front is to be seen the second of the original windows, once serving the hall and now partially obscured by the later chimney-breast and lighting the sixteenth-century stair. The window is of two lights with square head, having a moulded label with dropped ends terminating in rectangular stops. The former mullion and the tracery of the head have been replaced by a heavier central mullion, and the lower part of the opening has been blocked to allow for the rise of the stair. Internally the embrasure is square-headed, with splayed jambs.

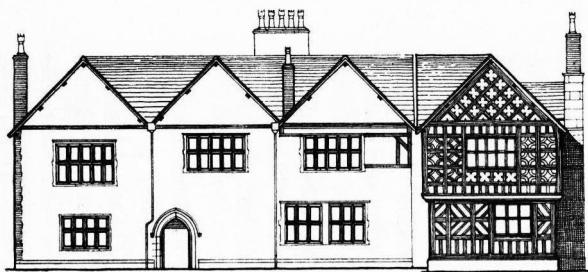
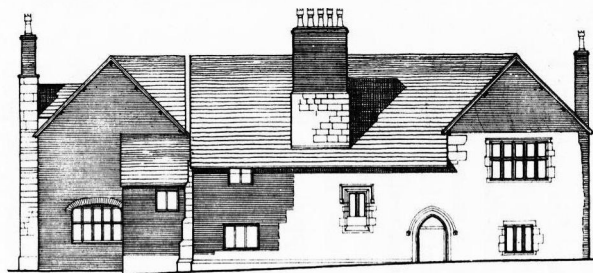
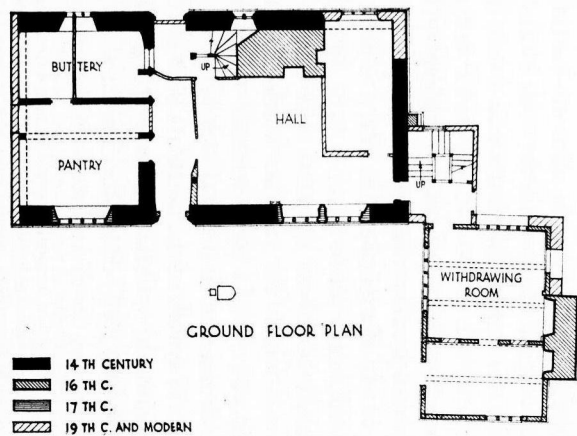
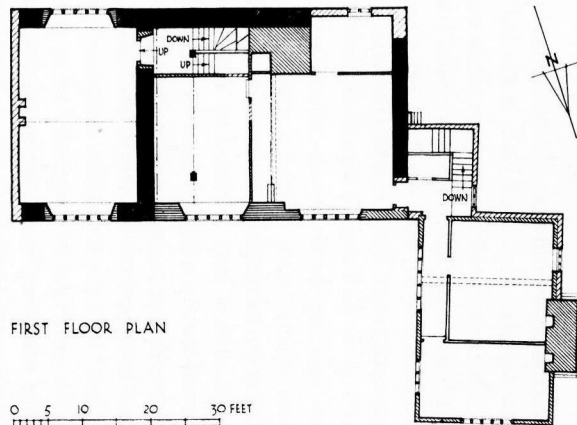
FIG. 7. Chorley Hall, Cheshire.

NORTH ELEVATION

SOUTH ELEVATION

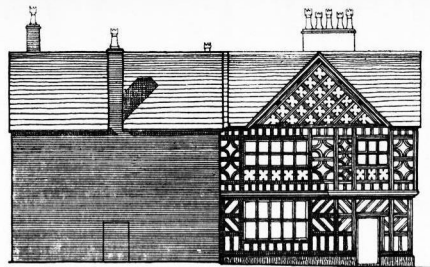
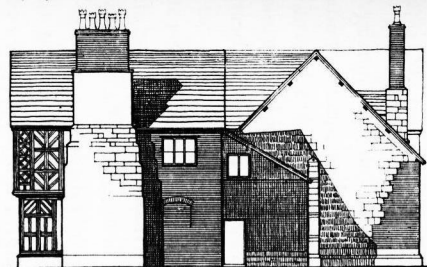
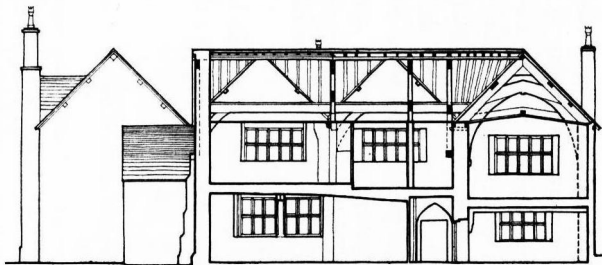
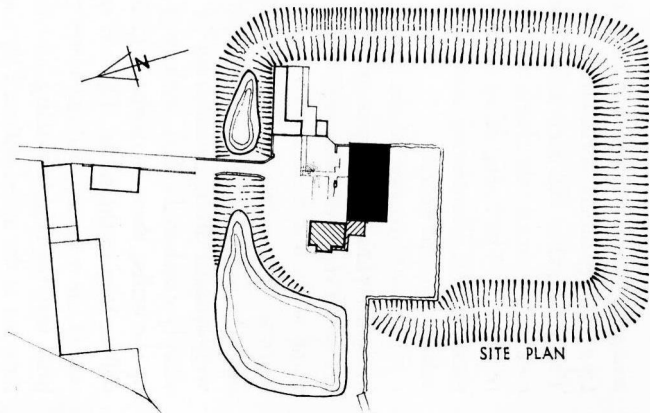
FIG. 8. Chorley Hall Cheshire.

EAST ELEVATION

SECTION THROUGH HALL
LOOKING EAST

WEST ELEVATION

SECTION LOOKING NORTH

SITE PLAN

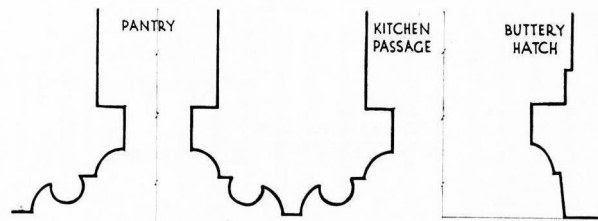
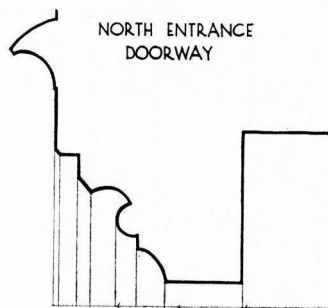
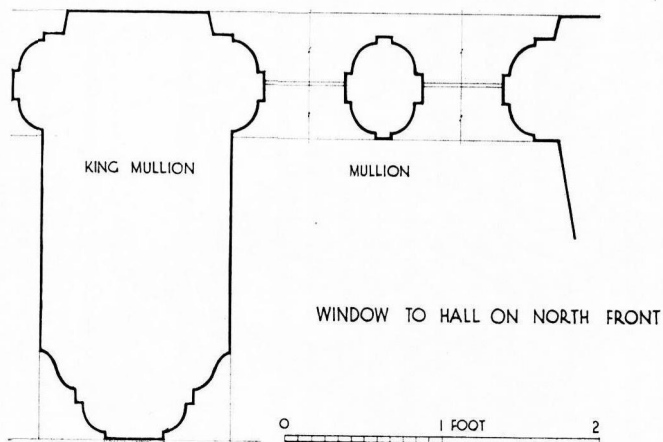
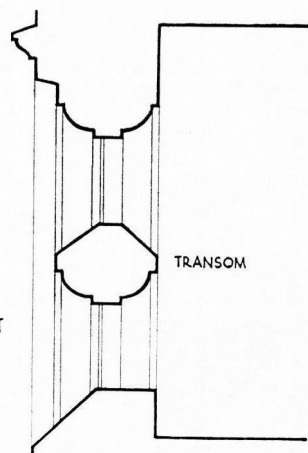
OPENINGS TO SERVICE ROOMS FROM
SCREENS PASSAGE

WINDOW IN SOUTH WALL OF
BUTTERY

WITHDRAWING ROOM
SOUTH FRONT

GROUND FLOOR
NORTH FRONT

WINDOW MULLIONS IN
TIMBER-FRAMED BLOCK

FIG. 10. Chorley Hall. Detail of mouldings.

of that date a significant distinction has been preserved. The oak mullions of the first floor windows are of ogee section, thus representing the original sixteenth-century build, while those of the windows on the ground floor, including the one surviving intact, have the ovolo section, and thus record seventeenth century improvements or repairs.

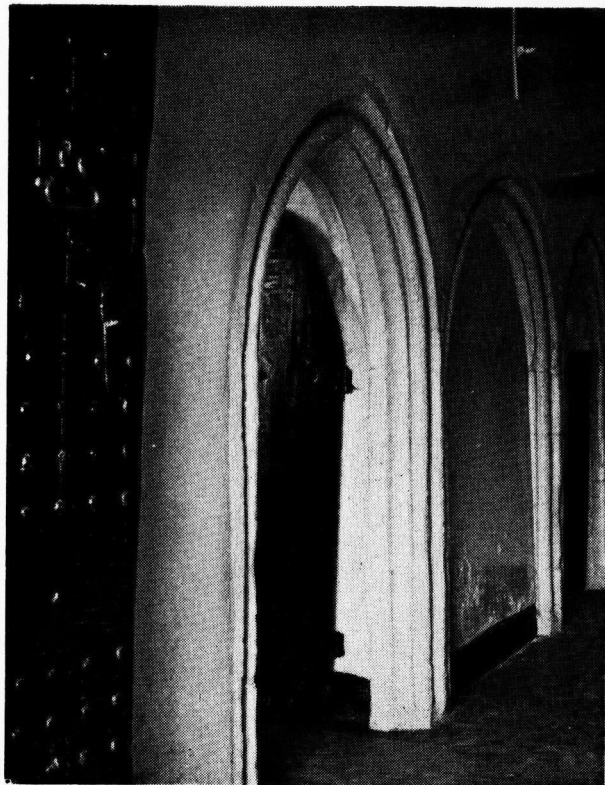
FIG. 11. Service room doorways from entrance passage.

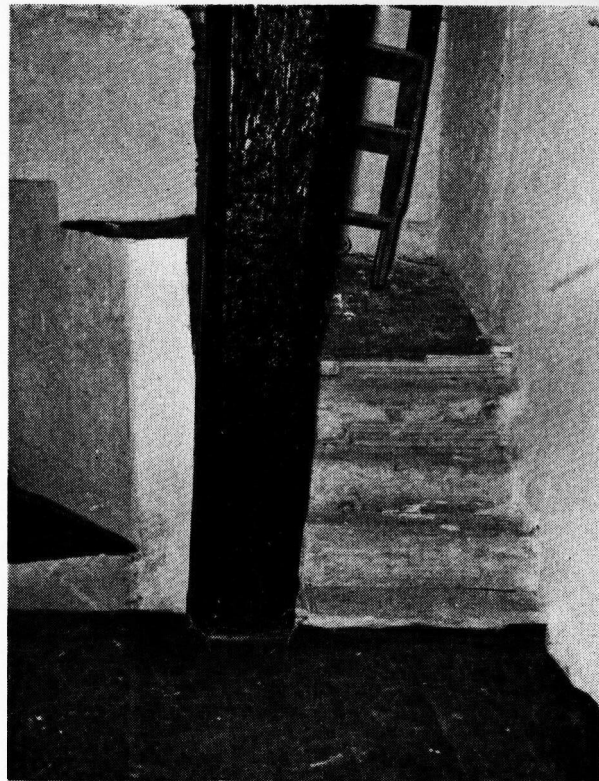
FIG. 12. The landing of the sixteenth-century stair showing spere post.

The spere truss is very similar in form, with the addition of the massive spere posts, averaging 13 inches by 10 inches, and widening at the junction with the blades; the posts here receive the arched braces, that on the south side having been cut away when the sixteenth-century stair was formed. There is nothing to show that there were any timber transverse members between the spere posts and the walls, but one assumes that these spaces were infilled to form solid spurs or "speres" to reduce draughts from the entrances. In later halls of the region, including Rufford, such speres were supplemented by a massive removable screen, standing centrally between them but leaving passage room on either side.

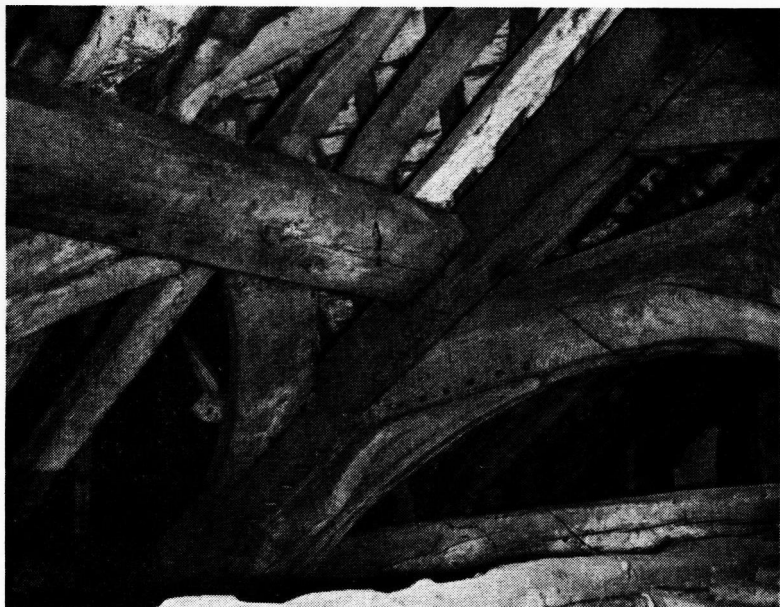
FIG. 13. The central truss, showing later cambered beam supporting ceiling.

Internally, the two building blocks were extensively improved. Large ovolo-mullioned windows were introduced in place of the earlier ogee type in the withdrawing room of the timber block, together with oak panelling and a carved overmantel.¹² In their present form the stone fireplaces in this wing seem to date only from 1915. In the earlier block, the original solar was provided with a cambered ceiling, below the collar of the truss, supported from a cambered beam

which spans the chamber almost on the line of the truss, and which in turn supports a spine beam. Joists of light section span from this spine beam and are housed into the original inner wall-plate. The stair was improved by the addition of a wooden balustrade to the upper landing, with widely-spaced turned balusters, mentioned earlier, whilst new framed doors were made for almost every internal position. The present stone bridge over the moat too, probably dates from this period, as well as the range of timber-framed farm buildings outside the moated enclosure on the north.

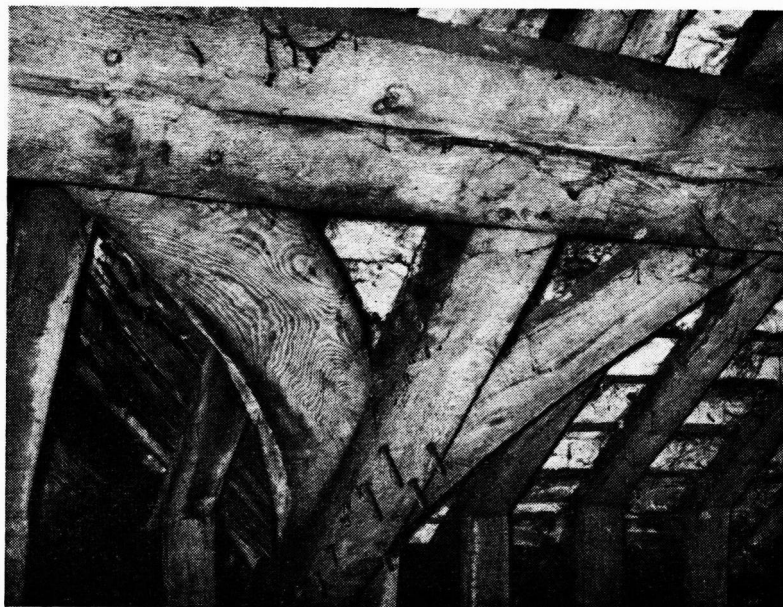
FIG. 14. The subsidiary principal rafter.
DETAILS OF WEST SIDE OF SOLAR ROOF, CHORLEY HALL.

been largely renewed at the time of the rebuilding in brick of the end wall. The north gable, the central truss and the whole of the west side of the roof remain largely unchanged, and this side of the structure, rising from the heavy stone wall between hall and solar, provides the most important evidence of the original methods of construction for the entire roof. The central truss is similar to the central truss of the hall, with cambered collar and arched braces, of which only one survives entirely, springing from a corbel built into the west wall, the form of which is obscured by subsequent plastering. There is a simple rounded boss at the centre of the soffit of the collar. The apex of the blades is formed similarly to those of the hall trusses, with square-set ridge, replaced later by a diagonally-set beam, and again there was a single purlin each side, with curved wind-braces. As in the case over the hall, a subsidiary principal rafter from eaves to purlin subdivides the bay on each side of the truss, and receives the feet of the wind-braces.

Against the west wall of the solar it is possible to determine the original seating of the blades, of the secondary principal rafters and of the common rafters, in relation to the wall-plate, indicating the construction of the entire roof. Two wall-plates are provided on the wall top, each approximately 9 inches by 6 inches, placed on either face of the wall. The plates are tied together at the gables by the tie-beams, which are notched over them, and at the feet of the central truss blades and of the two subsidiary principal rafters. In the latter case, a timber member measuring 10 inches by 5 inches lies across the plates, possibly notched over them, and the principal rafter is tenoned to this member. (Fig. 9). The blade of the truss appears to rise from a heavier cross member, measuring 13 inches by 4 inches, placed in the wall immediately under the wall-plate, and projecting through the wall on the side of the hall. Common rafters appear originally to have rested on the outer wall-plate, and it is likely that small sprocket pieces on their backs carried the projection of the eaves on the outer walls. From the inner wall-plate, vertical members, $2\frac{1}{2}$ inches thick by approximately 6 inches wide, rise to the soffit of the rafters, into which they are roughly housed.

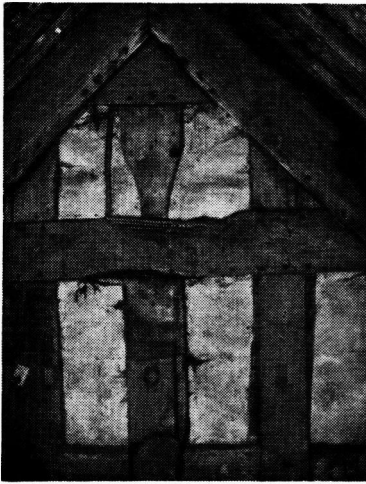
FIG. 15. Original North gable of solar.

The solar over the service rooms is a fine apartment now measuring 17 feet⁴ by 24 feet 9 inches internally, spanned by a central truss. Both of the solar gables originally were timber-framed, that on the north front surviving intact, although concealed externally by later plaster, but the south gable has been replaced by early nineteenth-century brickwork. The timbering of the north gable comprises heavy, close-spaced vertical studs with a squat king-stud rising from a collar. The existing windows to the solar date from the seventeenth century, and the existing doorway, at the head of the stair, was presumably introduced at the same time as the sixteenth-century stair. There is no evidence of an original stair within the solar block, and no position suggests itself, for it is improbable that a stair would have been contrived in either of the service rooms. It is possible that the original access to the solar was by an external stairway, perhaps on the north front, as the centrally-placed buttery window surviving on the south elevation renders the placing of a stair here less likely. The first floor construction is unusual, with heavy joists, 6 inches wide, spanning the cross walls, and solidly infilled between the joists with a form of cement, probably gypsum, over which the random-width oak boards are nailed. The present fireplace is of a piece with the rebuilt brick east wall, and there is no indication of an original hearth.

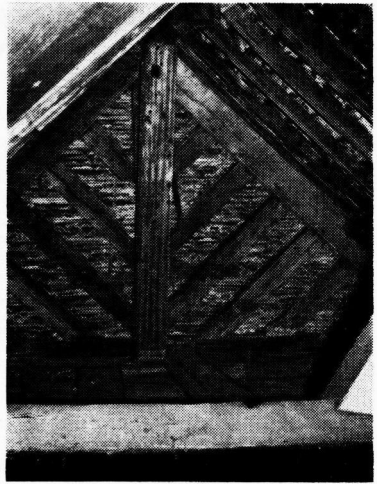
FIG. 16. Sixteenth-century gable on North Front.

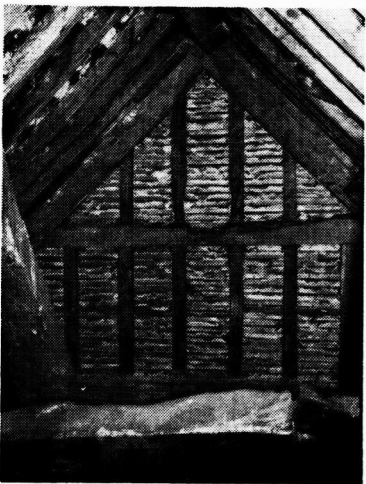
FIG. 17. Seventeenth-century gable on North Front.

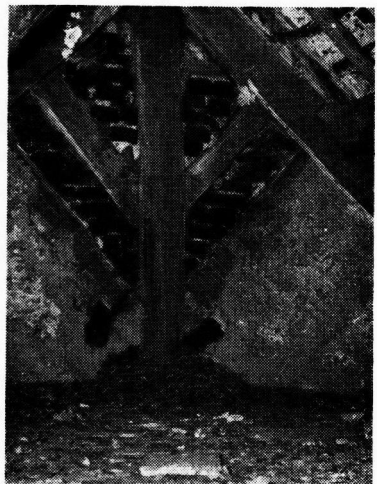
FIG. 18. South gable of timber-framed block.

The framing of the new gable at the west end of the north front corresponds closely to that of the south gable of the half-timbered block, and it is clear that these two stages of building occurred within a short space of time after *c.* 1560. The new block provided greatly improved accommodation on both of its two floors, the principal ground floor apartment being a withdrawing room with two chambers above, fireplaces being provided in all four apartments.¹⁰ The block was originally free-standing, clear of the north-west angle of the hall, and not quite at right angles to the older structure, being jettied on all four faces. The timber framing stands on a sandstone plinth, and the gables on the entrance front are richly decorated with diaper patterning of a form found in several other halls of the region.¹¹ A massive ashlar stone stack projects from the west wall, and corresponds in character to the hall stack. This building was extensively restored in 1915, when much of the original timbering was replaced, but apparently on the original pattern, as indicated by earlier photographs. It is almost certain that the doorway on the east wall, opening from the entrance courtyard, is in its original position, and the stair, now removed, may originally have risen in the corner either to the right or left of this entrance. The ground floor window on the north front, renewed and enlarged in 1915, is off-centre, possibly to allow for this stair. On the south front there is a second doorway to the timber block, and near it, a doorway giving access to the west end of the old hall; but despite the logic (in the modern view) of such a communication between the two buildings, it does not seem likely that either doorway was made at this time. If the new block had been intended as a deliberate extension of the old house, it would not have been difficult to make it so. There is a unity about each of the two blocks as they stood at this period which makes them appear as separate, if related, concepts.

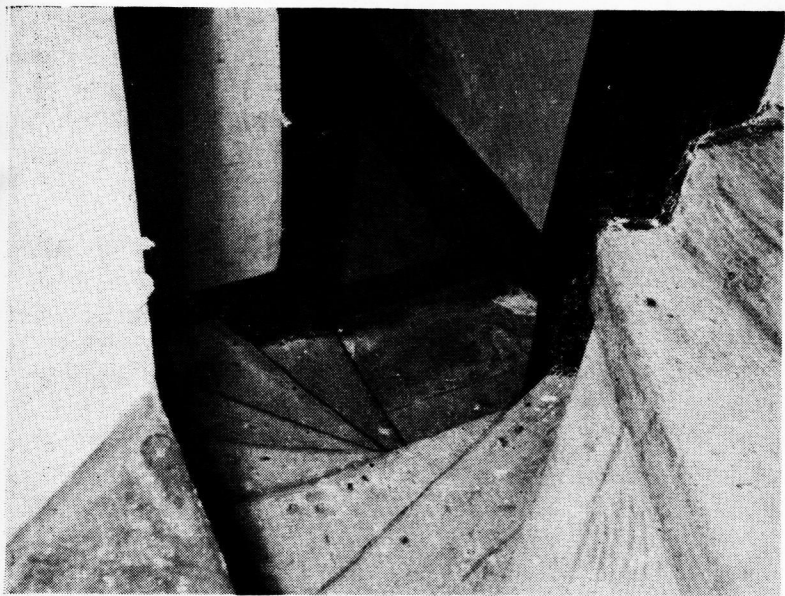
FIG. 19. The sixteenth-century stair.

The stair is of particular interest. It has baulk-timber steps of triangular section, supported on heavy bearers, the winders being constructed with $2\frac{1}{2}$ inch treads and risers, pegged together. Light for the stair is secured from the fourteenth-century window described earlier, this lying partly behind the chimney stack, of which the rear corner has been cut away to allow the window to function adequately. The stair returns upon itself around the southern spere-truss post, at an upper half landing, from which a doorway was cut at this time into the solar,⁹ so obviating the need for retaining the presumed external stair. The short upper flight of the stairs, still of solid baulks, leads to a doorway, now blocked, near the chimney breast, entering the lower (eastern) of the two main chambers: thus the three chambers would have to be reached in series, one from the other. Alongside the upper stair flight is a panel of finely-profiled wooden balusters; these seem to represent an early seventeenth century improvement, belonging to the next stage of alterations.

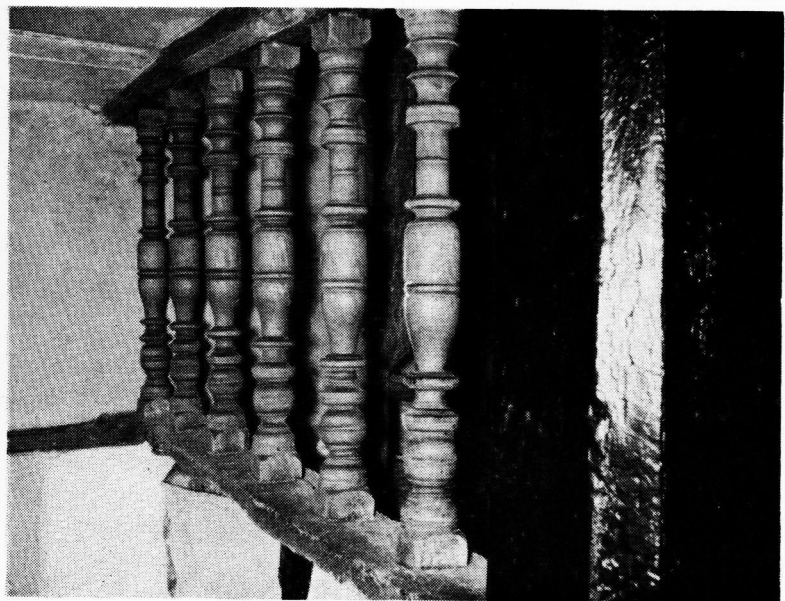
FIG. 20. Balustrade to upper landing.
STAIR DETAILS, CHORLEY HALL.

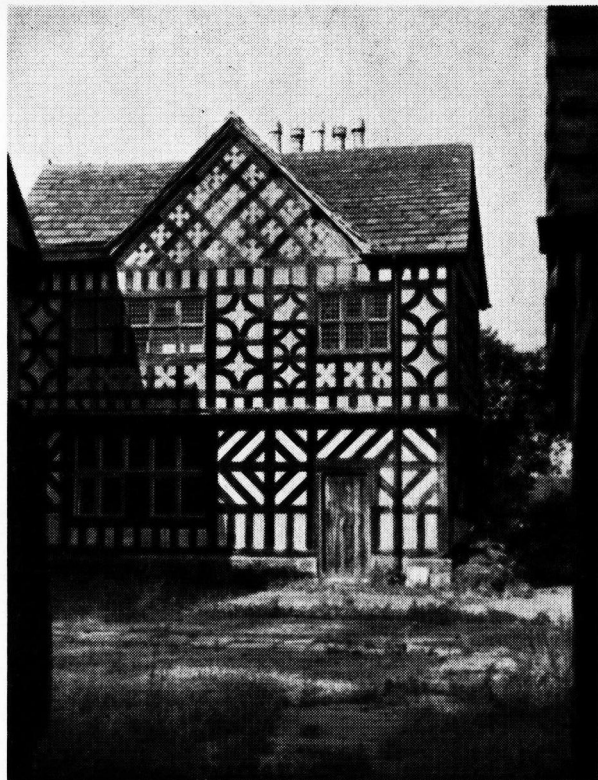
FIG. 21. The half-timbered block from the East.
