MANOR HOUSE FARM, DONINGTON-LE-HEATH, LEICESTERSHIRE c. 1280

By T. L. Marsden

ROOF STRUCTURE OF THE HALL.

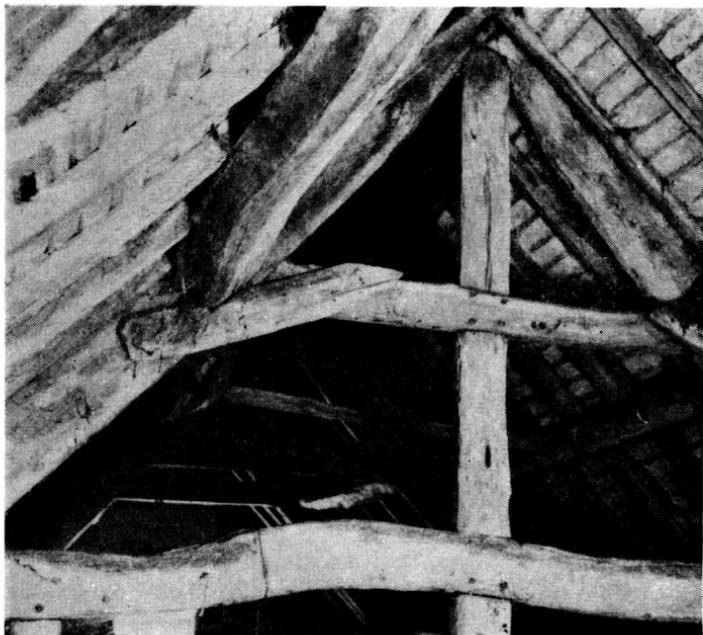
FIG. 1. The upper part of the closed truss over the Hall.

The upper part of the closed truss is intact and merits careful examination; it is shown on the roof plan diagram marked "A". For structural reasons, the two open trusses in the roof have tie beams (balk-ties) of much more substantial proportions than the closed truss. Cut into the ties of the closed truss (on upper surfaces between the studs) there is a continuous groove $\frac{1}{2}$ in. deep and $\frac{1}{2}$ in. wide which formerly received the lower ends of the splints (these supported the infilling of the panels). The splints were fixed at their upper ends into auger holes which measure approximately $\frac{7}{8}$ in. diameter and are bored out about $1\frac{1}{2}$ ins. in depth. Each truss has a "face" side (sawn) and in the case of the closed truss "A" this is directed to the Hall (east of the house). Truss "B" also faces east but in truss "C", the face is on the west side.

Moving to the hall side of the closed truss, the sawn faces of all timbers are in the same plane, except for the uppermost stud which connects with the apex formed by the inclined principal rafters. This upper post is set back approximately $\frac{3}{4}$ in. from the face of the principal rafters at their apex. Carpenters' marks can be seen on the main tie beams. In closed truss "A" (reading from left to right from the south side), the first stud is marked with two chisel cuts (II), the second stud three chisel marks (III), the third stud four chisel marks (II). Where the lower tie meets the centre stud there is a T cut; no other forms of numerals were seen. The mortise-and-tenon joints higher up the truss do not appear to have any carpenters' marks. In all trusses the fixing of the purlins is important; they are reduced in cross-section area where they pass through the holes in the principal rafters. The penetration beyond the point of support is usually about $2\frac{1}{2}$ ins.; some purlins are "D" shaped (half log). The existing ridge is modern (probably fixed with the modern roof tiles) and there is no evidence for an original ridge piece. The pairs of purlins on each side of the trusses are staggered where they meet the principal rafters, separate support slots being provided for each purlin.

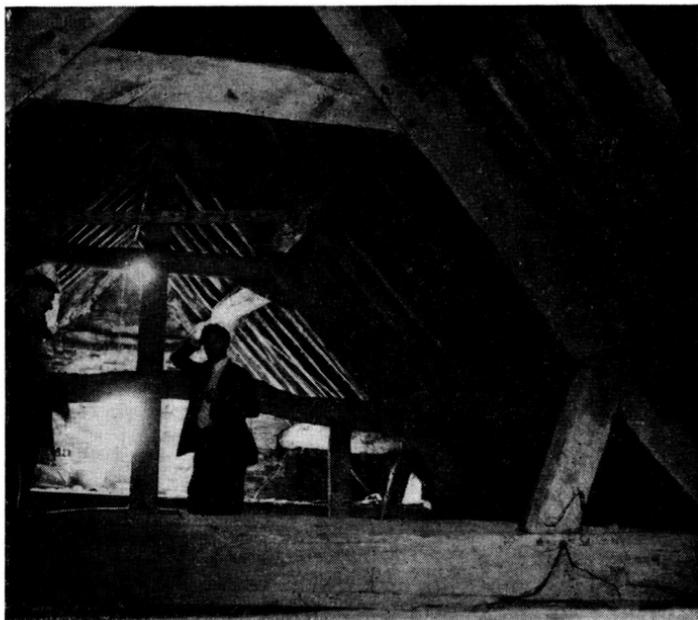
FIG. 2. Open truss in the foreground, showing massive baulk-tie.

Let us now examine the open trusses (marked "B" and "C"). One is immediately impressed by the massive dimensions of the baulk-ties which span only 16 ft. 6 ins. In truss "B" the oak tie is $10\frac{1}{2}$ ins. wide and $13\frac{1}{2}$ ins. deep at the centre of the span, by contrast

the members which connect with it are like blades. For example, the principal rafter on the south side of the truss measures 13 ins. x 4 ins. at the point where it meets the baulk-tie and the inclined strut is 11 ins. x $3\frac{1}{2}$ ins. Carpenters' marks are clearly visible on the face side of this truss. They appear to number from the north side—first connection with strut and baulk-tie on the north side has two chisel marks (II) and on the south side the inclined strut has three marks (III). The principal rafter connection with the baulk tie has four chisel marks $\begin{pmatrix} \text{II} \\ \text{II} \end{pmatrix}$, two pairs of vertical cuts. Truss "B" is unusual in that the baulk-tie has a number of slots on its upper surface which appear to have been made to receive studs. There is no evidence however, of mortises on the upper tie to receive these members. The mortises on the baulk are approximately $4\frac{1}{2}$ ins. long and nearly 2 ins. deep and it is possible that they were the support points of some decorative feature which formerly stood in the centre of the hall on top of the baulk-tie.

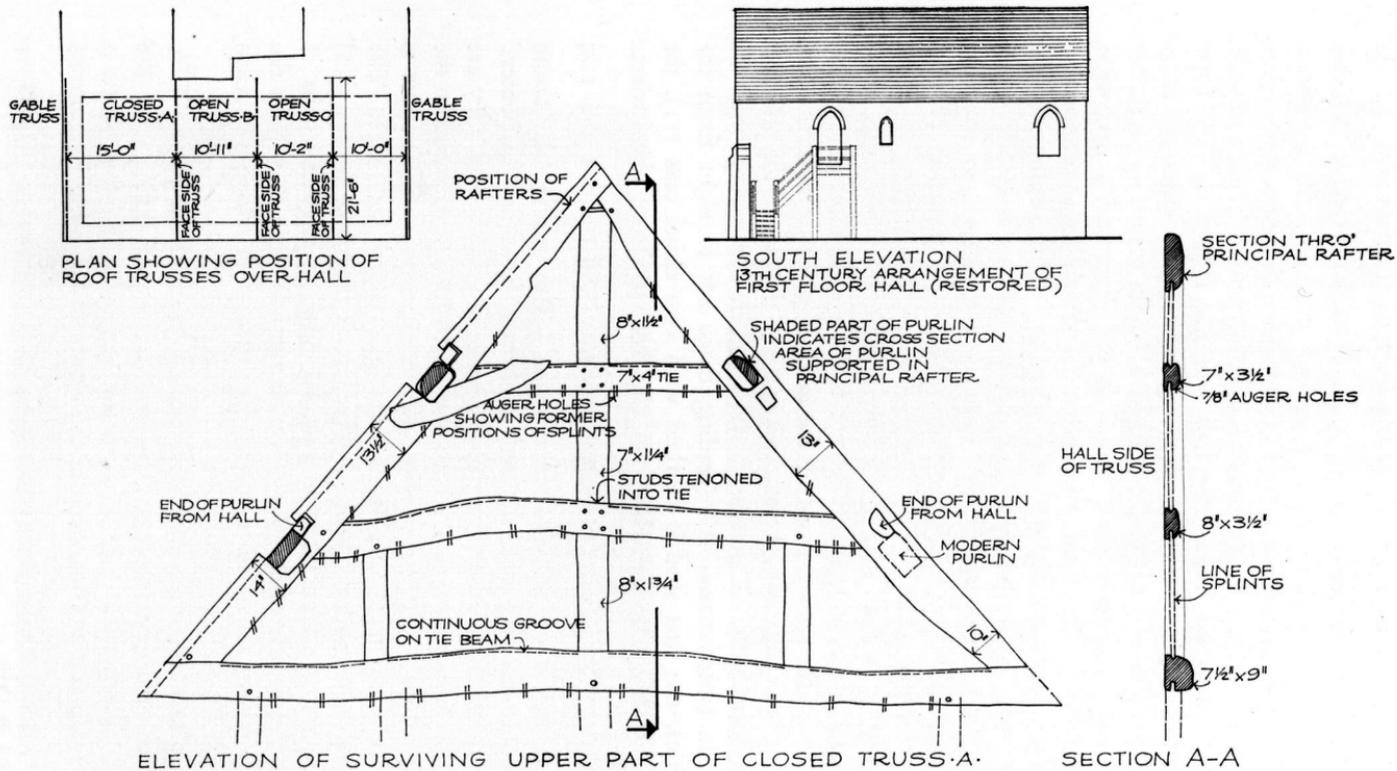
Fig. 3.

DONINGTON-LE-HEATH · LEICESTERSHIRE · MANOR HOUSE FARM · c 1280 ·

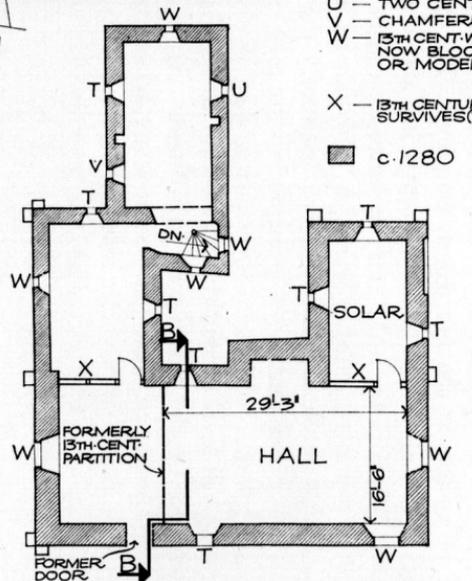
FIG. 4.

WINDOWS
 T — TREFOIL HEADS
 U — TWO CENTRED
 V — CHAMFERED LIGHTS
 W — 15TH CENT. WINDOW POSITION
 NOW BLOCKED IN
 OR MODERNISED

X — 15TH CENTURY PARTITION
 SURVIVES (TIMBER-FRAMED)

■ c.1280

FIRST FLOOR PLAN

c. 1280. The original build with first floor hall approached from an external stair on the south front. An illustration shown in the *Gentleman's Magazine* of 1818, fig. 7, shows the holes in the external wall where the former stair was supported. The extent of the first floor plan in the thirteenth century is shown in fig. 4. Note the thirteenth-century timber framed partitions which separate the apartments of the north wings from the main hall block.

Before concluding this brief description of Manor House Farm, one cannot omit a further reference to the two thirteenth century timber-framed partitions on the north side of the hall at first floor level, (marked X in fig. 4). The better example which shows the method

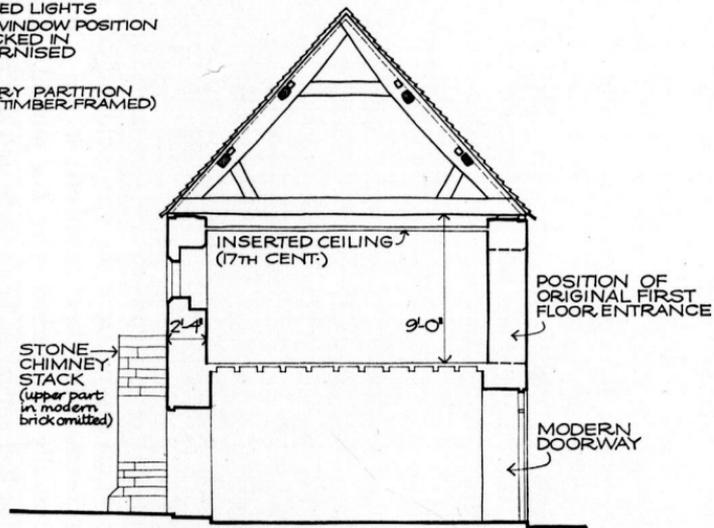
CROSS SECTION B-B
 SHOWING OPEN TRUSS · B ·

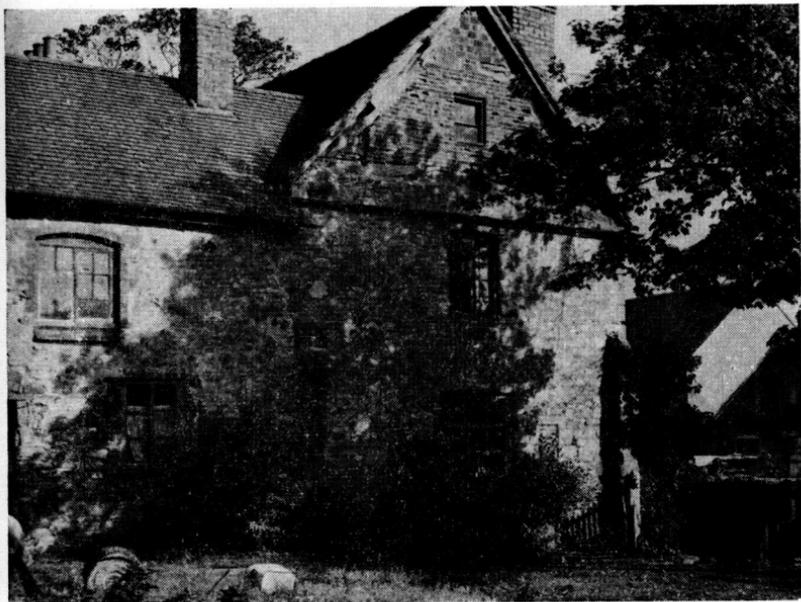
FIG. 5. South-west end of the Hall, showing bow-shaped principal rafters.

Joints in all trusses appear to be mortise-and-tenon held by wooden pegs measuring approximately $\frac{3}{4}$ in. in diameter. A significant feature of many timbers of the roof trusses is their shape in cross section. The principal rafter on the south side of truss "A", for example, has a well-cut sawn face to the hall side and curves in "D" form on the reverse side of the truss; its opposite timber—principal rafter on the north side—has been cut from a larger scantling of timber and is rectangular in section, being 12 ins. deep and 4 ins. wide. Principal rafters in the closed truss and in the gables show a pronounced bow-shaped form on the underside (fig. 1). This swelling of the principal may be deliberately designed to give extra depth where the butt purlins penetrate their supporting member. In the roof of Ragdale Old Hall,¹ Leicestershire, there was a similar type of shaped principal rafter.

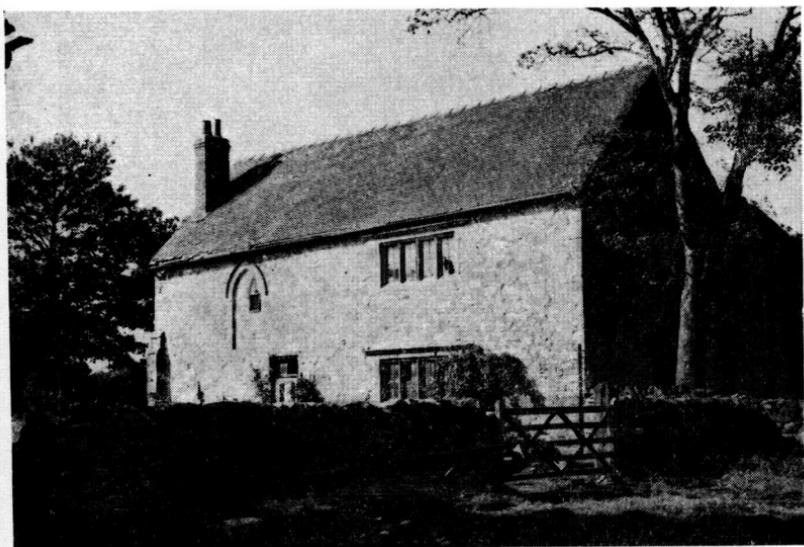
FIG. 6. South-east view of Manor Farm. (Photograph taken in 1962.)
MANOR HOUSE FARM, DONINGTON-LE-HEATH.

Minor changes seem to have occurred about the third quarter of the nineteenth century. The upper part of the great chimney stack has new brickwork in place of stone. It is postulated that the original chimney stalks were stone—similar to Stokesay Castle. The roof covering was probably replaced about this time.

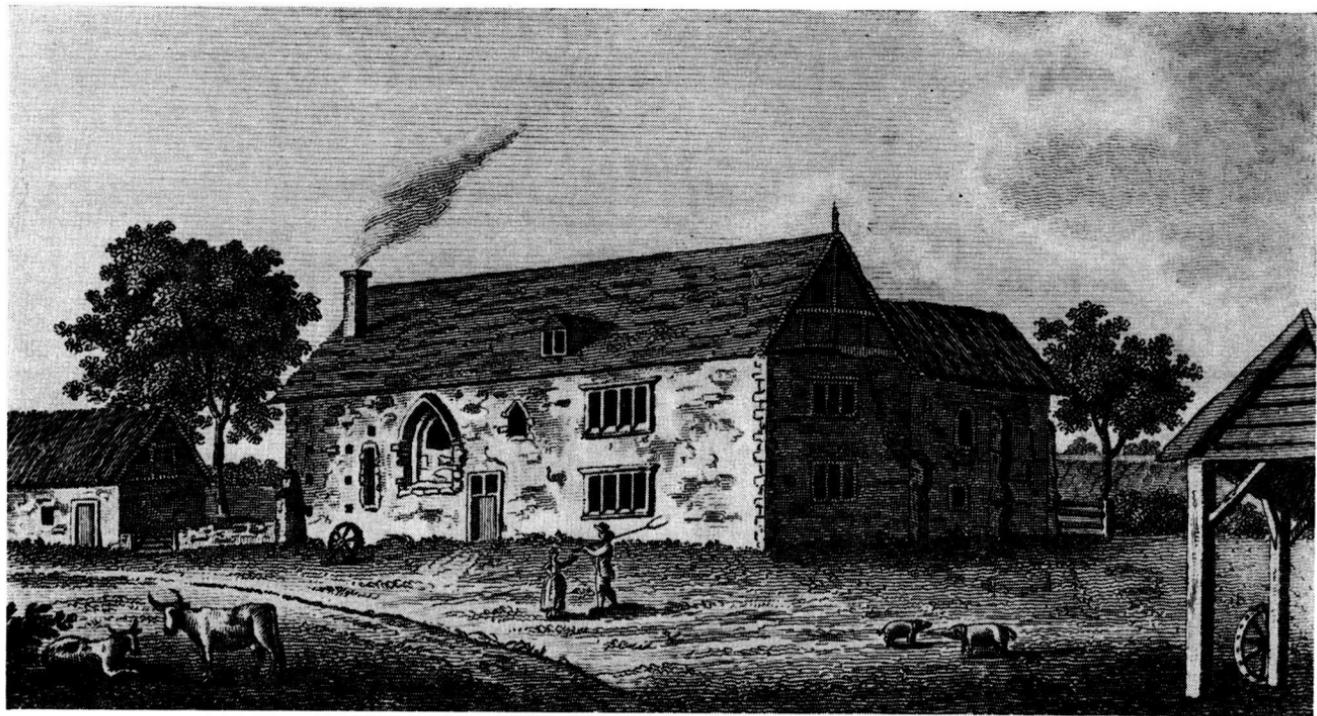
FIG. 7. South-east view of Manor Farm at Donington-le-Heath, shown in Vol. 2 of the *Gentleman's Magazine*, 1818.
