WELLS CATHEDRAL: Architecture and Conservation

By John H. Harvey and L.S. Colchester

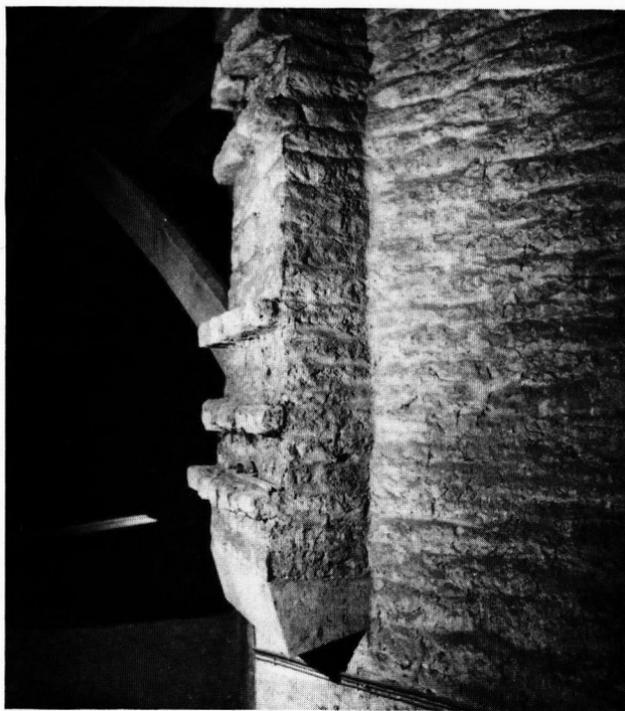
Probably intended as supports for flying buttresses: Toothings on the corners of the Lady Chapel under the retroquire roof.

the intended retrochoir by arches carried on two free-standing piers with mouldings and slender shafts. Pending erection of the retrochoir it was necessary to support these piers, and the architect's intention was to build temporary stone flying-buttresses. Between the vaults and the roof, above each pier, is a projecting block of toothed masonry for abutment. Since there is no old mortar in the toothing, it seems likely that the flyers were never built. Probably raking timber shores, of the sort still usual until the present century, were applied.

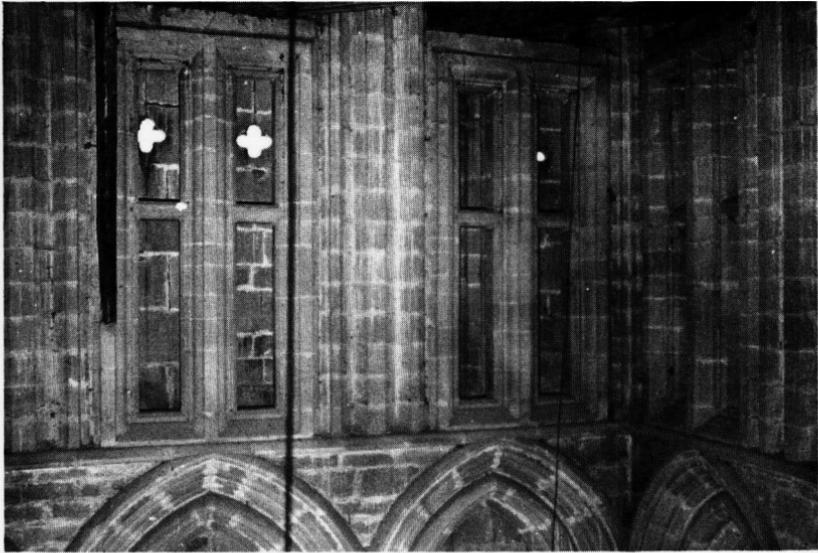
Square grids, dating from about 1356, in the central tower. They were inserted to stabilise the structure.

The second phase consisted in stabilising the tower itself so as to make it resistant to the heavy winds. The thin outer skin is supported on a strong inner framework of masonry. Halfway up this, square stone 'grids', with mouldings similar to those of the scissor-arches, were added. The Abbot of Glastonbury had granted to the Dean and Chapter 50 loads of freestone from his quarry at Doultling 'for the repair of the tower' in May 1356; and an earlier grant of 20 loads in December 1354 may have been for the same work. This would appear to be designed by William Joy, master mason from 1329, although, as he had been succeeded at Exeter by 1352, it is likely that he was dead when the 'grids' were inserted. The genius responsible for scissor-arches, built-in flyers and tower 'grids' was entirely successful, for there has been no movement since.
