# The Monument in the City of London: Repair and Discoveries

*The Monument to the Great Fire of London, constructed between 1671 and 1677, is located near Pudding Lane in the City of London where the Great Fire started in 1666. A contract to conserve and enhance the Monument was undertaken between 2007 and 2009 at a cost of £4,500,000, funded by the legal custodians, the City of London Corporation. This paper discusses why such a sum should be spent on the Monument and the philosophical questions raised during the conservation design process. An account of the preparation works prior to the contract is given together with the attitude taken to repair work and new interventions. The new design initiatives are described together with discoveries made during the works.*

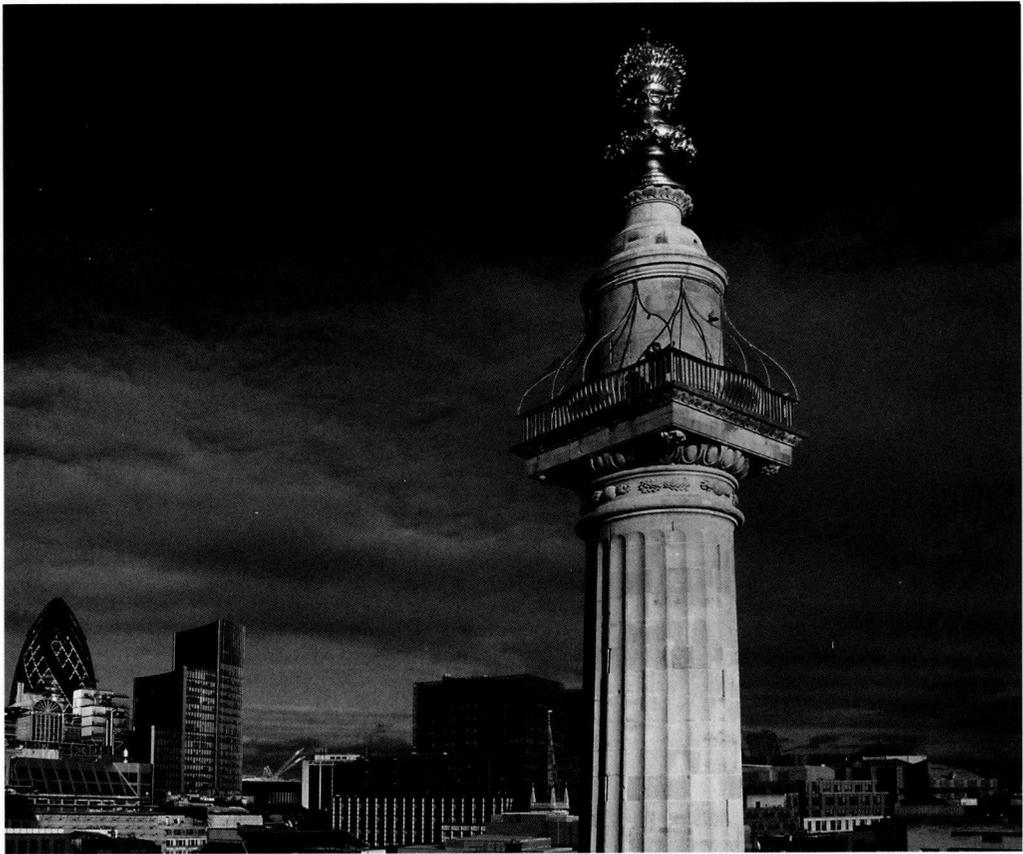
Fig. 1

View of the top of the Monument against the City skyline, following completion of the repair contract.

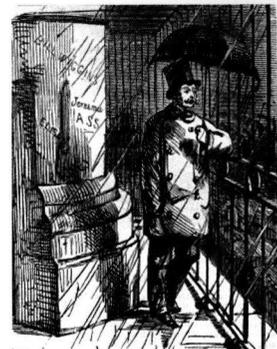
Fig. 16  
Historic sketch illustrating a former cage over the viewing platform at the Monument.  
Punch, *January-June 1850*,  
cartoon no. 64

Early images of the Monument show an iron balustrade around the perimeter of the viewing gallery to reassure and restrain the visitors. Archives record six people having committed suicide by throwing themselves from the gallery between 1788 and 1842; in the latter year the building was temporarily shut and, to prevent further precipitations, the gallery was enclosed in an iron cage (Fig. 16).

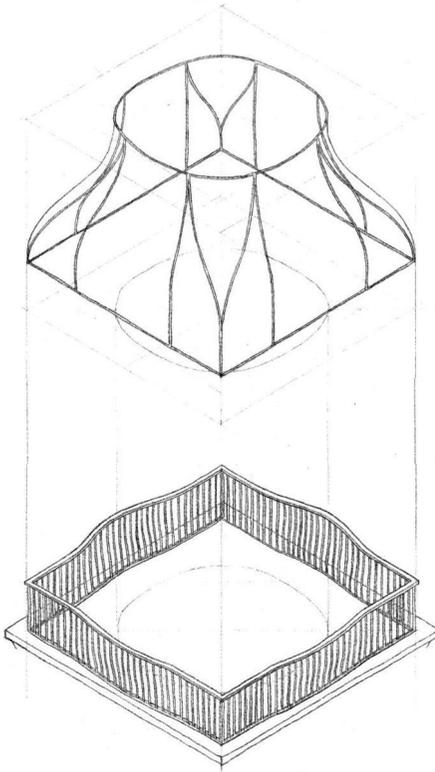
Fig. 17

The Monument: Initial hand-drawn design for the new balustrade and cage for the viewing platform.

The balustrade and cage were replaced in the 1950s with a basic steel bar enclosure, and the opportunity was presented to replace both in the 2007-2009 contract. Early design drawings and Roman precedents have informed the new balustrade design, of widely spaced square balusters, each appearing to be lead caulked into the stone platform. Only alternate balusters are actually structurally embedded to avoid inducing a crack along the edge of the black limestone. The intention for the cage above the heavy and reassuring balustrade was to create a lightweight birdcage hanging from the stone dome beneath the flaming orb (Fig. 17). The curved profiles of the slim structural members are cloaked

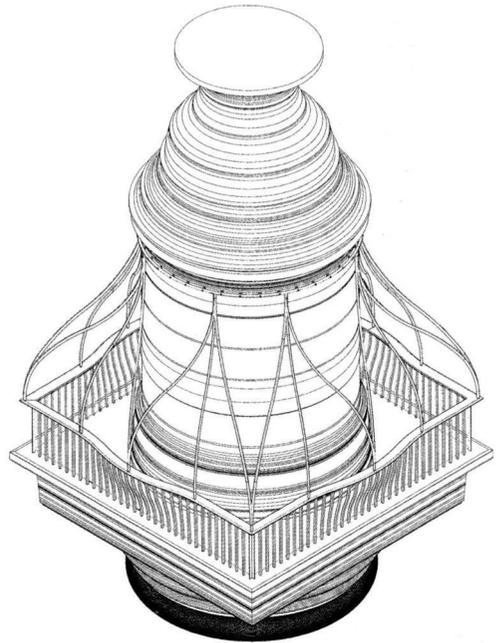
Fig. 18

Computer model of the top of the Monument and the new balustrade and cage, for fabrication purposes.

in fine stainless steel cable mesh, its diamond pattern distorting as it stretches over the bulbous lower frame and contracting at the slim neck beneath the dome. The curved form of the cage avoids reflecting blocks of light, whilst the mesh is almost invisible from afar and less obtrusive to the high level viewer than the former prison-like bars. The throwing of potentially lethal large objects, such as drink cans, has been prevented. To replace the former inelegant freestanding telescopes, new telescopes have been designed, integrated with the stainless steel handrail which is widened at the corners to receive them. The stainless steel tubes of the cage contain electric cables to the telescopes, lighting and discreet CCTV cameras surveying the viewing platform (Figs 18, 19).

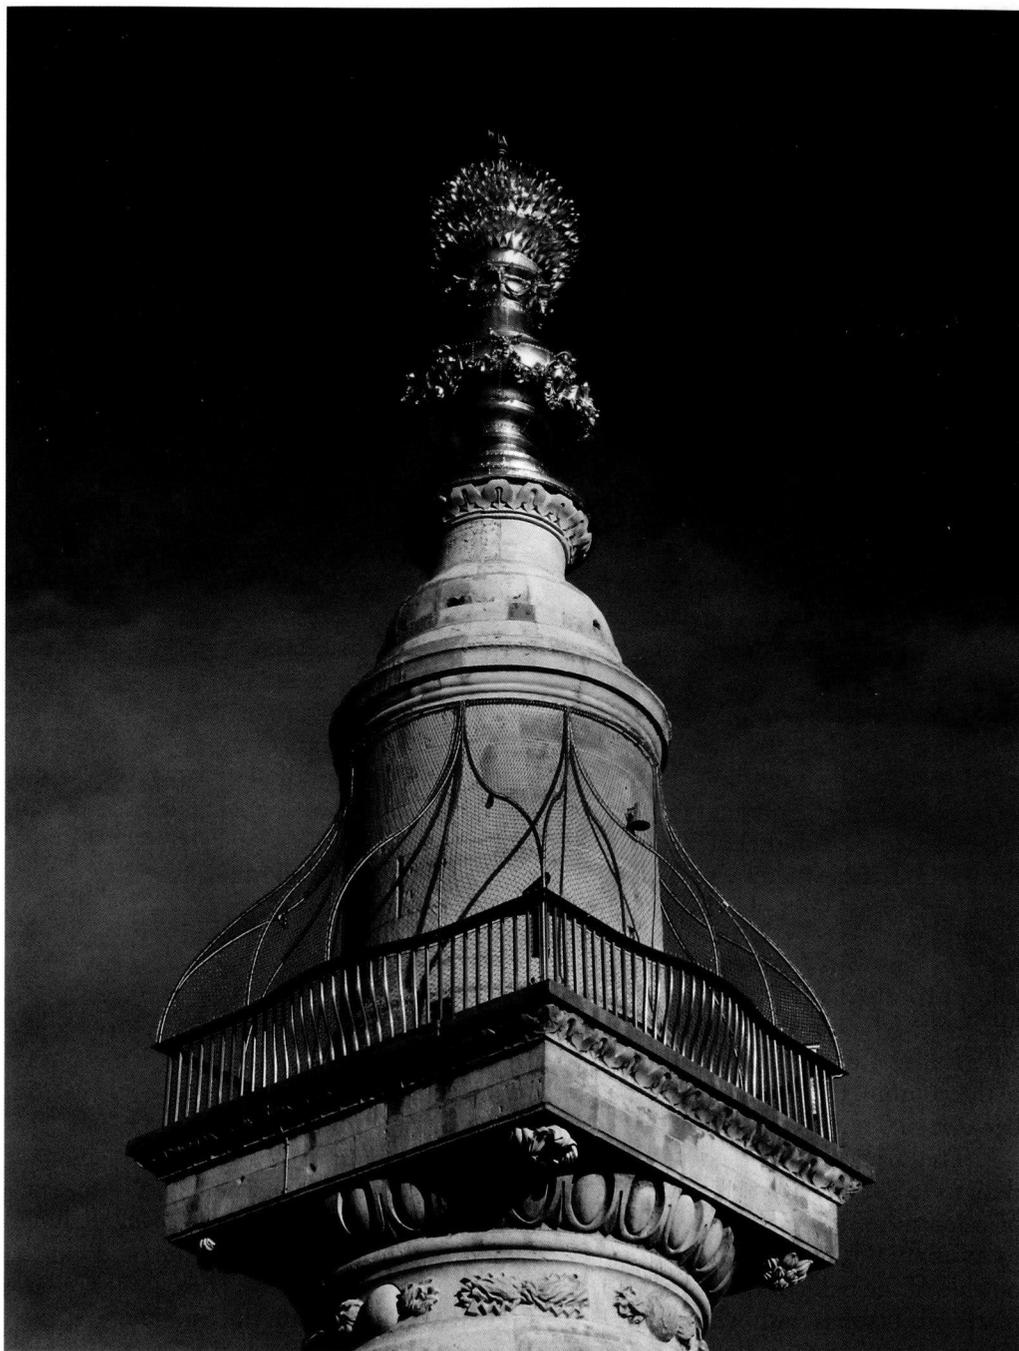
Fig. 19

The Monument: The new balustrade to the viewing platform with the lightweight cage above, made of curved stainless steel tubes and expanding mesh.
