PLAS-UCHA, LLANGAR, CORWEN

By Peter Smith and Ffrangcon Lloyd

SUMMARY

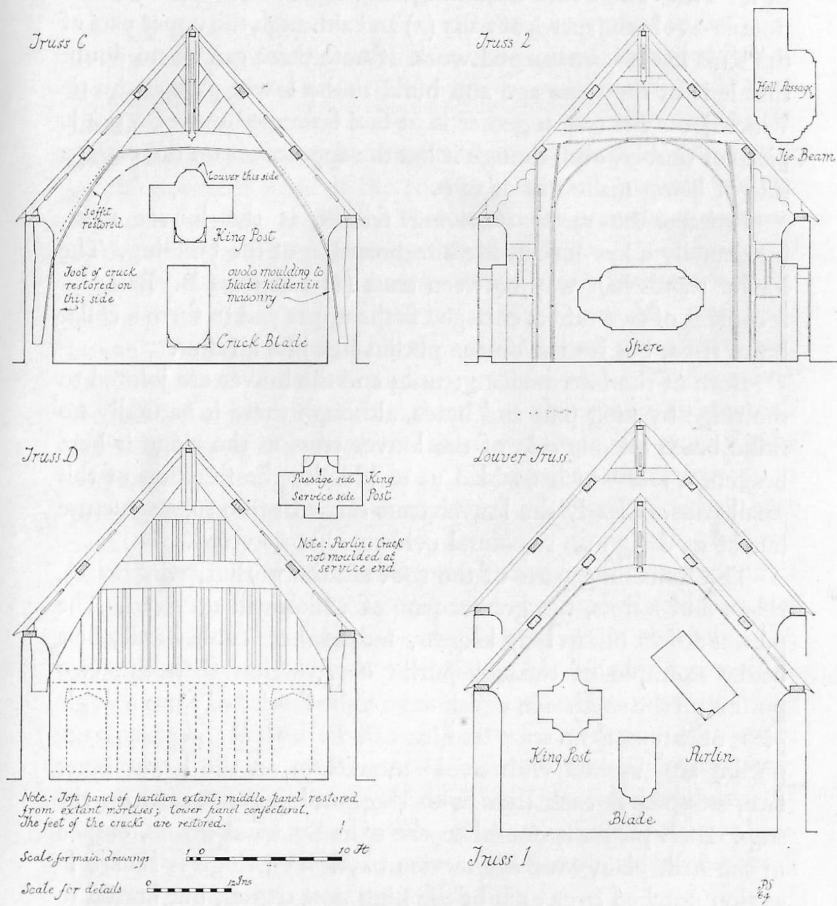
FIG. 2. Plas-Ucha

There remain in the hall the two intermediate trusses, the simple collar truss (1) and the elaborate spere (2). The collar truss has the ovolo moulded soffit which we have already surmised in truss C. The ovolo moulding also decorated the soffit and a double-ovolo the speres of truss (2) and although the upper part of the truss has no ornamental work of note there can be no doubt that it is of the same age and build as the lower part as the tie which joins the two together is in fact fashioned out of a single piece of timber, even though it has the appearance on the passage side of being made out of two.
