## Zacs, Oxford:

### The Restoration of 26, 27 Cornmarket Street and 26 Ship Street

F.W.B. CHARLES

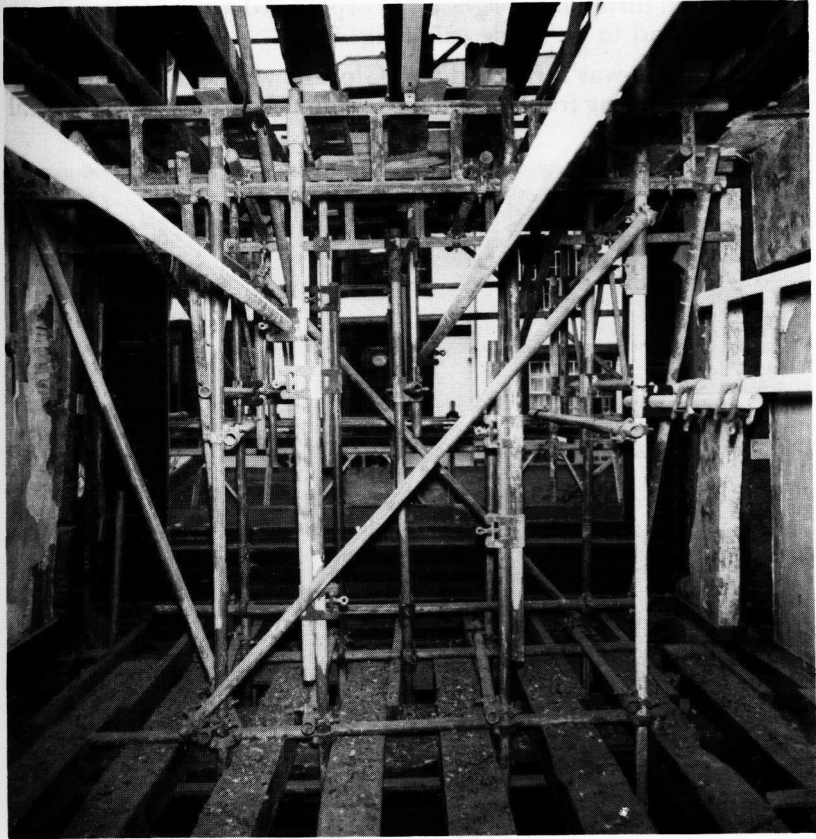
Fig. 8  
Pre-contract scaffolding in 27 Cornmarket Street  
*Photo: B.J. Harris Photographers, Oxford*

Work started on 15 November 1985. The state of the structure meant complete dismantling of the wall-frames, floors and roofs of the Cornmarket shops and every part of the gallery, and radical *in situ* repairs of the Ship Street building.
