The Dovecotes of Rutland

JOHN and PAMELA McCANN

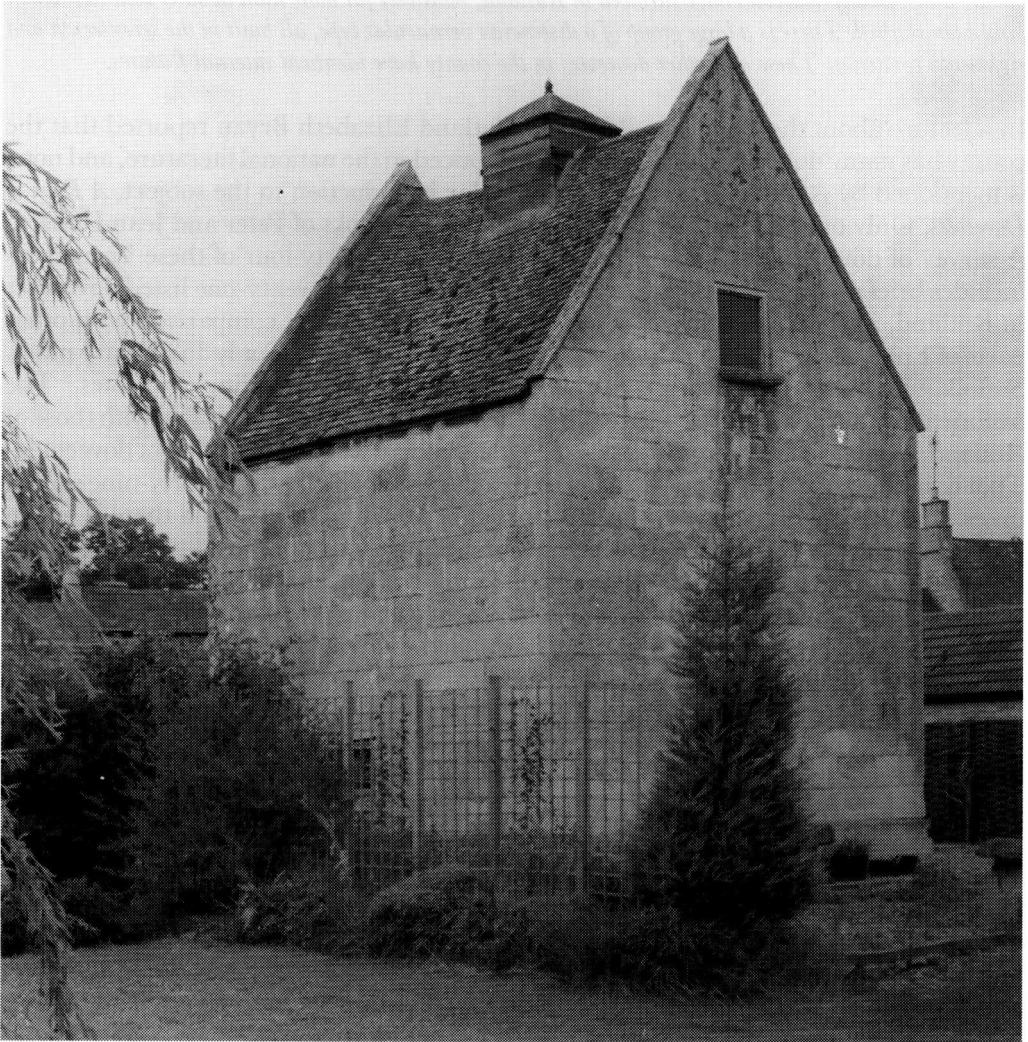
Fig. 1

The dovecote at Manor Farm Barn, Ketton, wholly of limestone ashlar externally

Within this group of buildings there are differences of quality. Most are built of coursed and squared rubble with quoins of ashlar. Two are built wholly of limestone ashlar externally (at Manor Farm Barn and Water's Edge, Ketton, Figs 1 and 2). Some have no ashlar at all. Rutland is fortunate in having easily-extracted stone of high quality throughout the county. The eastern part is of oolitic limestone, which weathers to a creamy grey. The western part is of marlstone, whose iron content produces various colours ranging from old gold to deep brown. All the dovecotes are built of one or other

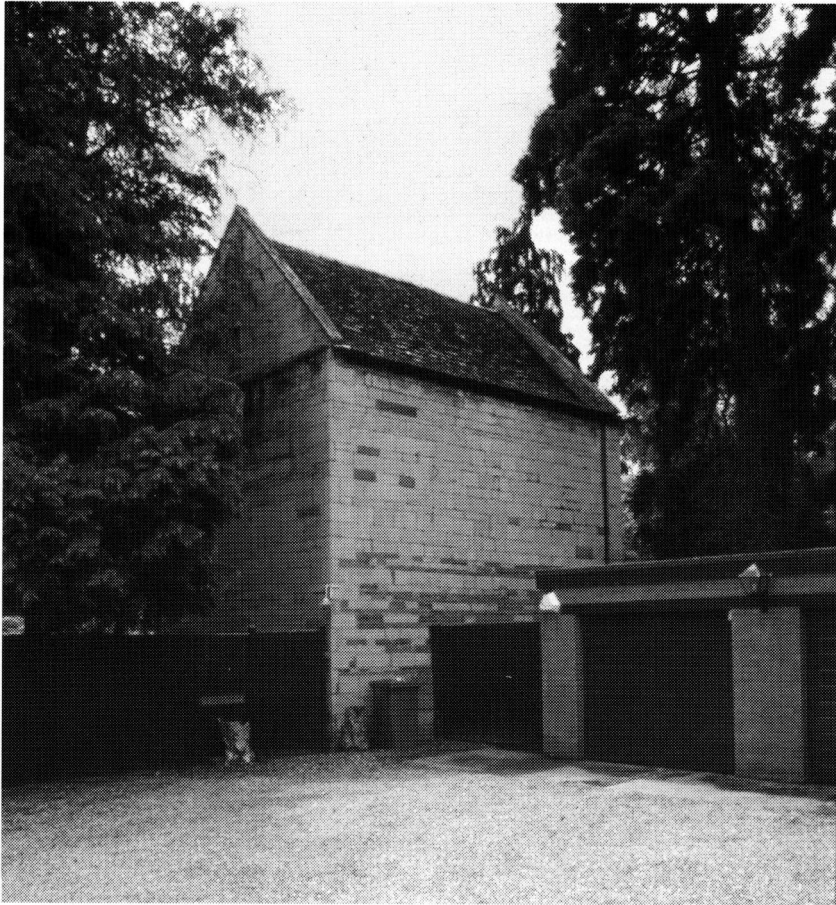
Fig. 2
The dovecote at
Water's Edge,
Ketton, is wholly
of ashlar. Note
the perching
ledge across the
gable

Most of the dovecotes do not have any ledges externally, but at Tixover, Water's Edge and The Grange, Ketton, there is a ledge across the base of each gable (Figs 6, 2 and 14). There is a perching ledge a little below eaves level all round the rectangular dovecote at Belmesthorpe, and round a cylindrical dovecote at Exton Road, Empingham (Figs 7 and 8). Pigeons like to perch and sun themselves, particularly in the early morning and evening; in windy conditions they seek a place out of the wind.¹³ Perching ledges were always provided in Scotland, where strong winds from all directions are the norm, and at exposed sites near the coast in England. The parapets on the gables provided shelter from strong wind for pigeons perching on the roof. High parapets are very common in Scotland.¹⁴

Water's Edge, Ketton, is now closely hemmed in by huge *Wellingtonias* (Fig. 2), a species which was not introduced to England until the early nineteenth century, and the one at The Grange, Ketton, is also flanked by tall trees (Fig. 14). A working dovecote could not have functioned so close to trees, for they concealed the approach of sparrowhawks. The trees have grown since the buildings ceased to be used for their original purpose.

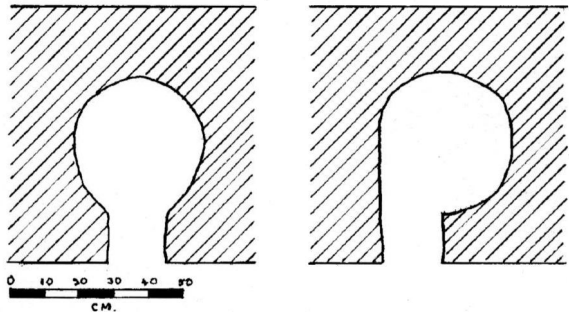
Fig. 3
Plans of nest-holes of symmetrical and asymmetrical bulb shape

The nest-holes are sunk in the depth of the walls, which vary in thickness from 61 to 81 cm. Most are of the same plan type, an asymmetrical bulb-shape. Elsewhere in the country there is no such uniformity.⁸

Generations of English pigeon-keepers found that pigeons like to make their nests in a rounded cavity approached from a narrower entrance-passage (Fig. 3). Setting the cavity to one side of the entrance-passage made the interior darker and cosier than if it were symmetrical. At Yule House, Oakham, and Belmesthorpe bricks are used to form more geometrical versions of the same, better described as L-shaped (Fig. 4). (At the latter the nest-holes are of brick only up to eaves level; above that in the gables they are of stone.) In all but one dovecote the nest-holes are arranged in chequer pattern. (For some unknown reason the nest-holes of most Scottish dovecotes are quite different, simple rectangular recesses arranged in grid pattern, like the 'pigeon-holes' of an office desk.⁹ Whoever first borrowed the term to describe office equipment must have been a Scot.)

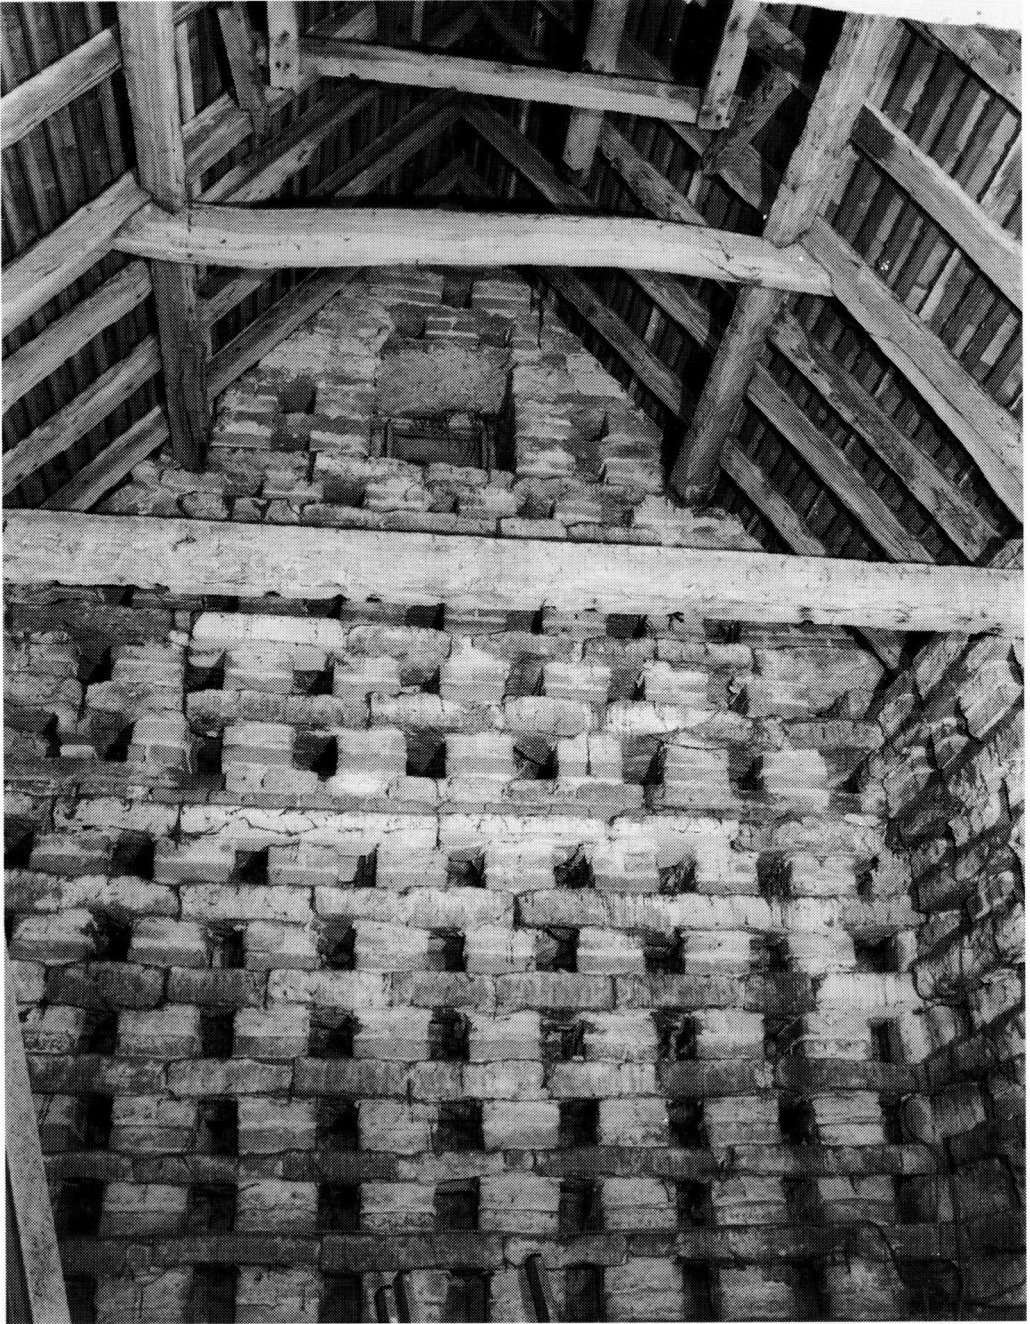
Fig. 4

Inside the dovecote of Yule House, Oakham. Exceptionally, the nest-holes were formed with bricks, the floors and alighting ledges with stone. The exterior is wholly of stone

Every dovecote in Rutland has an alighting ledge to each tier of nest-holes (Figs 4 and 5), except one at Home Farm, Egleton, which has a separate alighting step to each nest-hole. Elsewhere in England these alighting ledges are by no means standard. The earliest firmly dated dovecote in England, at Garway in Herefordshire, has an alighting ledge to every second tier.¹⁰ Some have a ledge to every third or fourth tier, some do not have them at all. Whether they were ever really necessary or useful has not been established, but it is clear that in Rutland every owner and builder of a dovecote was convinced that

All the roof constructions are of the same type, with short bays, one purlin in each pitch, and no ridge-piece (Fig. 4). Common rafters are of horizontal or square section. Where the louver has gone, original rafters in the middle terminate below the apex to outline the aperture where it stood.

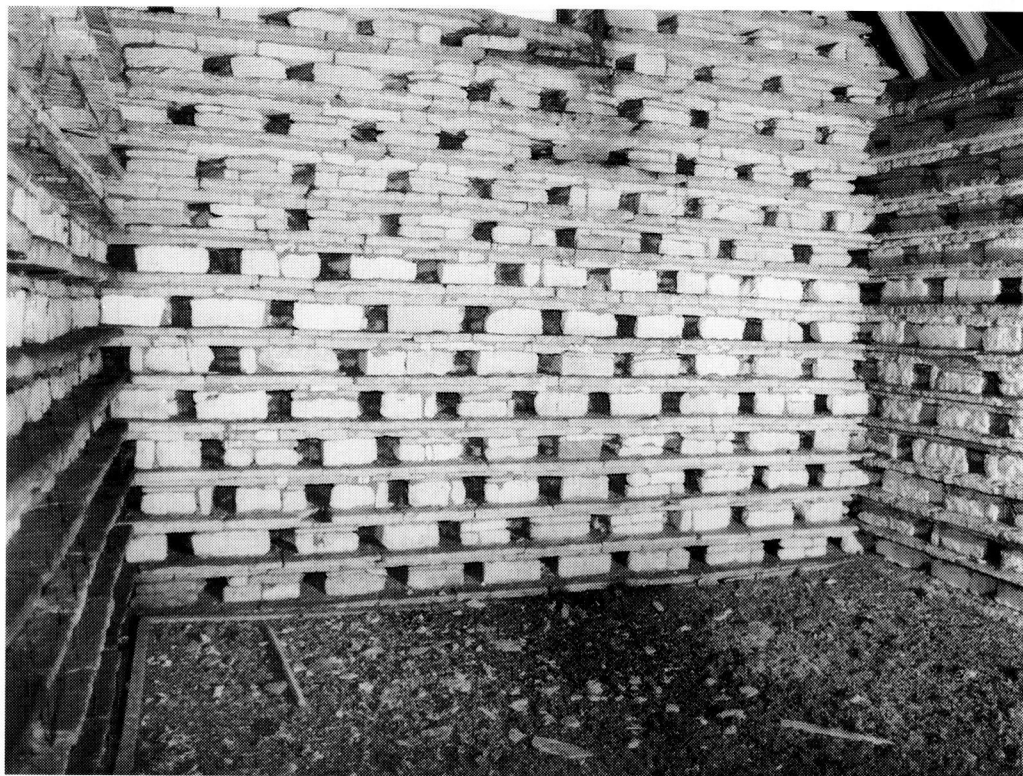
Fig. 5

Inside the dovecote at Manor Farm, Tixover, above the inserted floor

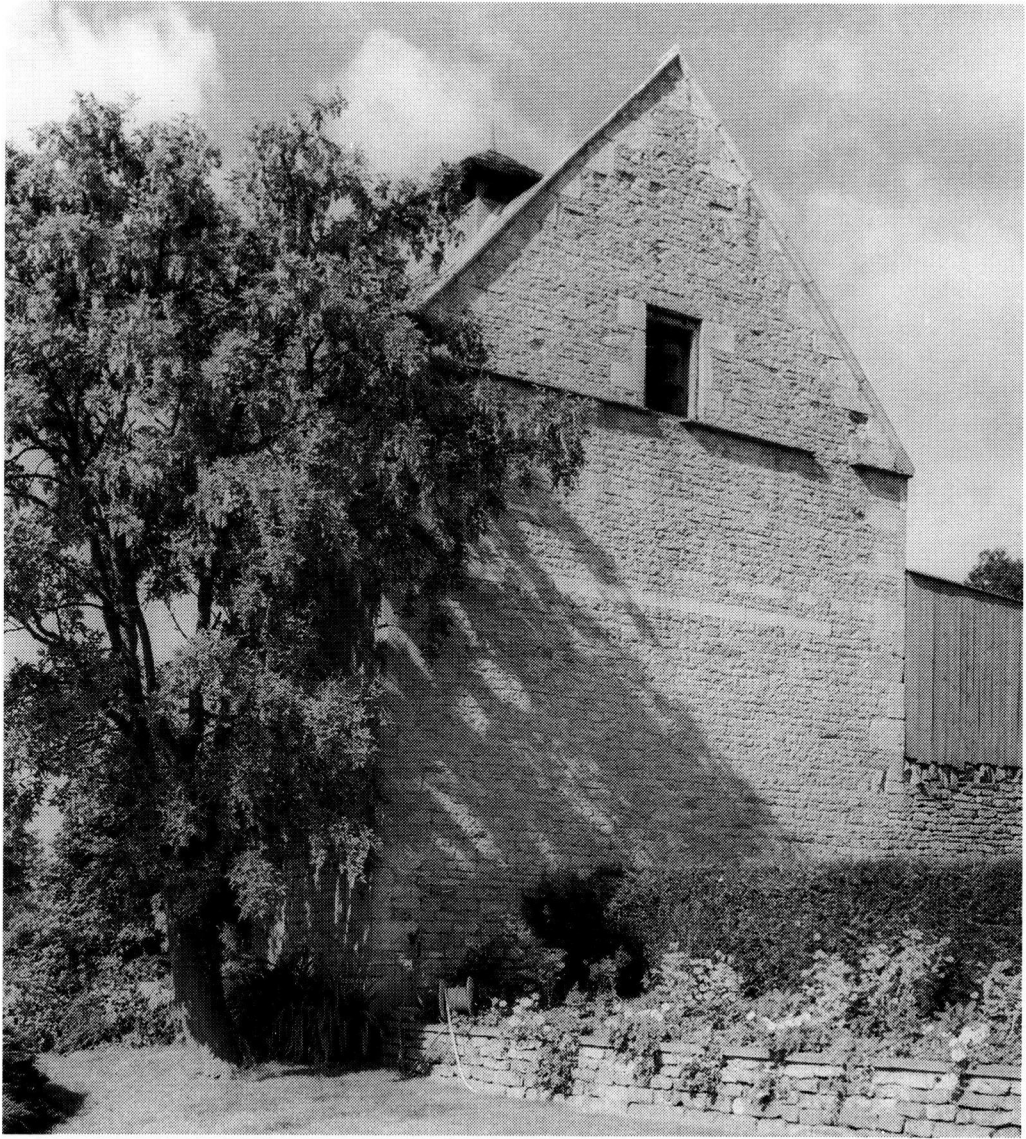
Fig. 6

The dovecote of Manor Farm, Tixover. Note the perching ledge across the base of the gable

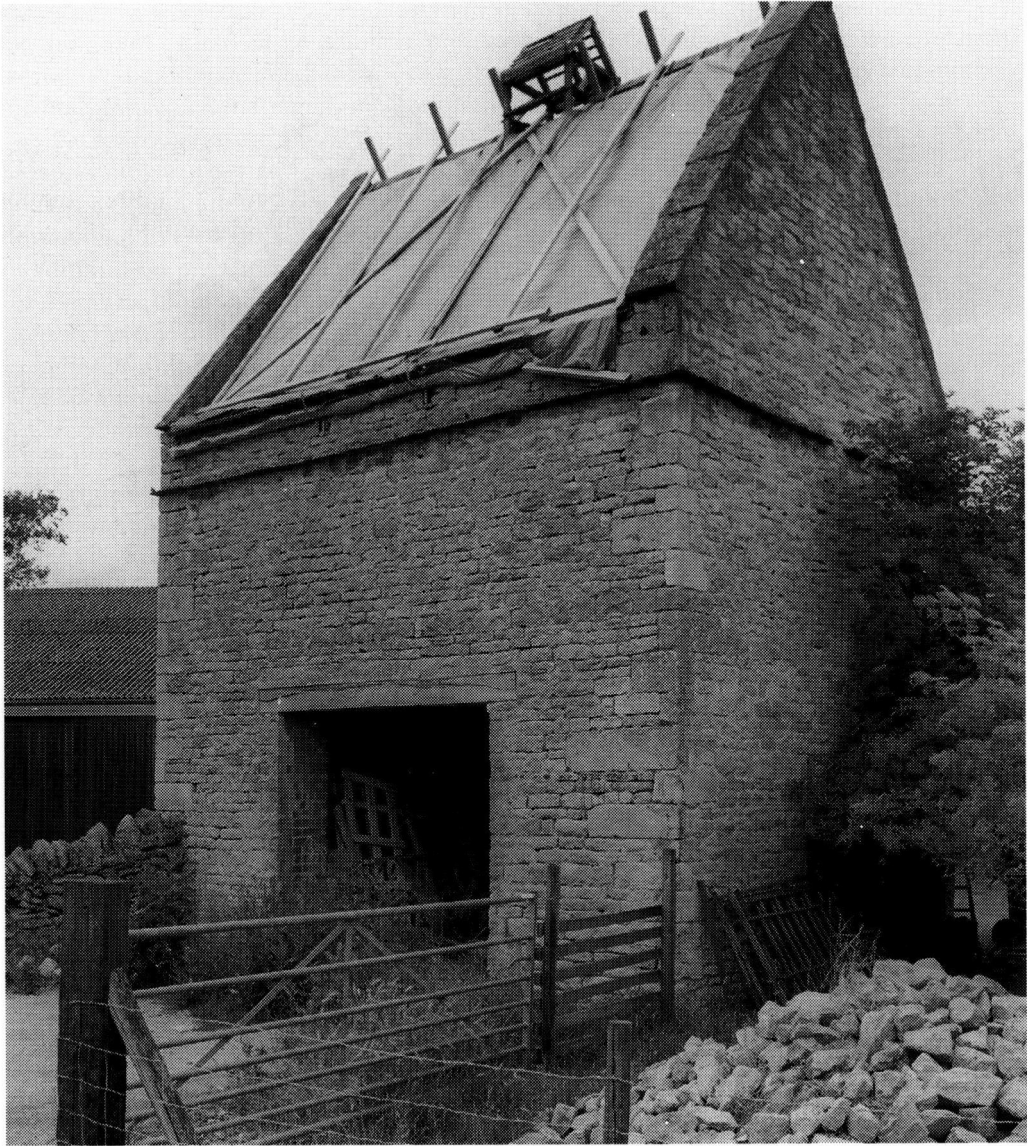
Fig. 7

The dovecote at Belmesthorpe, Ryhall. Note the perching ledge all round. The original low doorway is on the other side, blocked. A larger opening was formed when the building was converted for use as a cart-house

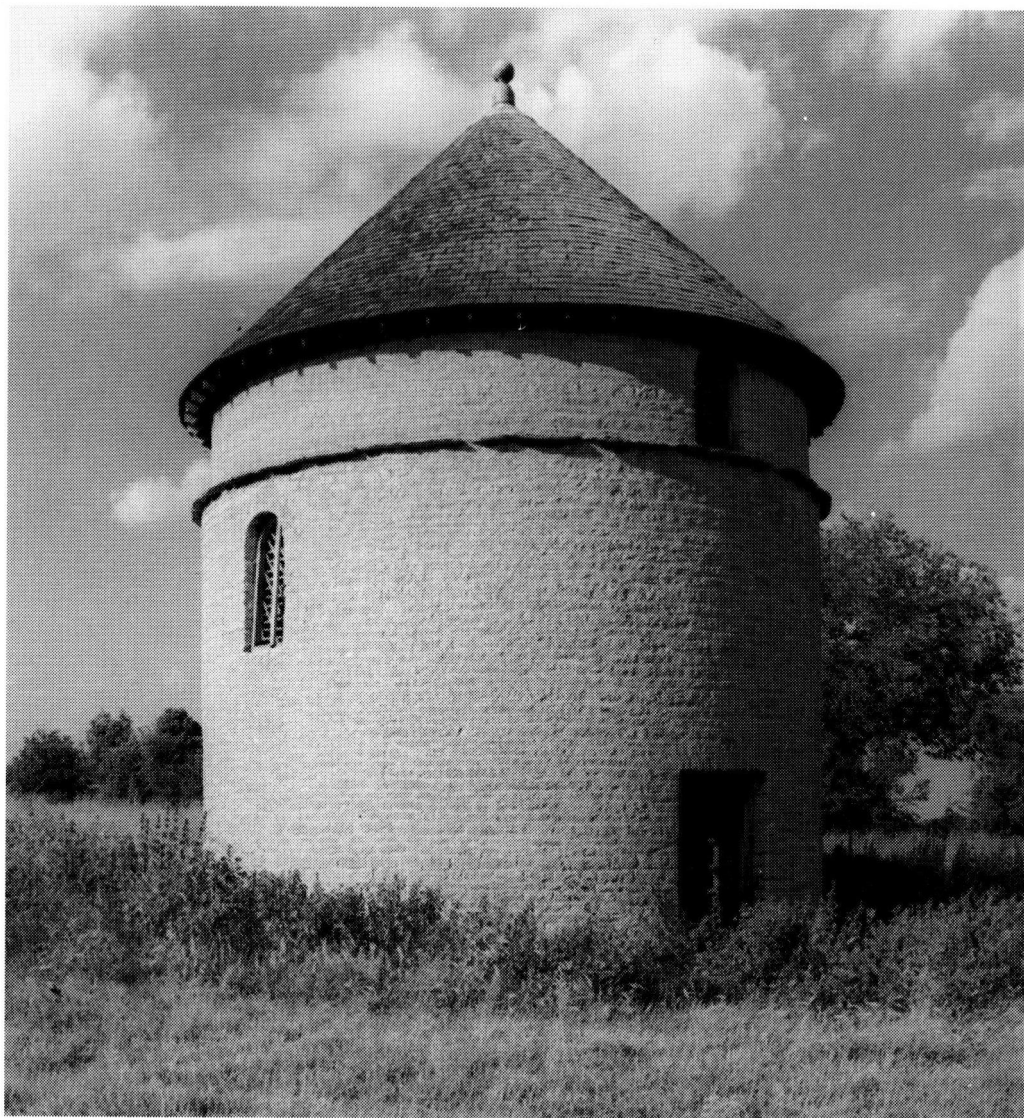
Fig. 8

The dovecote at Exton Road, Empingham stands isolated in a paddock, remote from any house. Note the perching ledge all round. The modern roof is of American shingles

It is not always possible to reconstruct the original context, for in some cases the associated house has gone. The dovecote at Exton Road, Empingham (Fig. 8) stands remote from any house of comparable age, as does that at Pilton A (Fig. 15). The dovecote at Belmesthorpe (Fig. 7) stands just outside a large farm complex, but there is no farmhouse there now. The dovecote of Water's Edge, Ketton, (Fig. 2) is now in the garden of a modern bungalow, but formerly it served The Priory, a prebendal manor

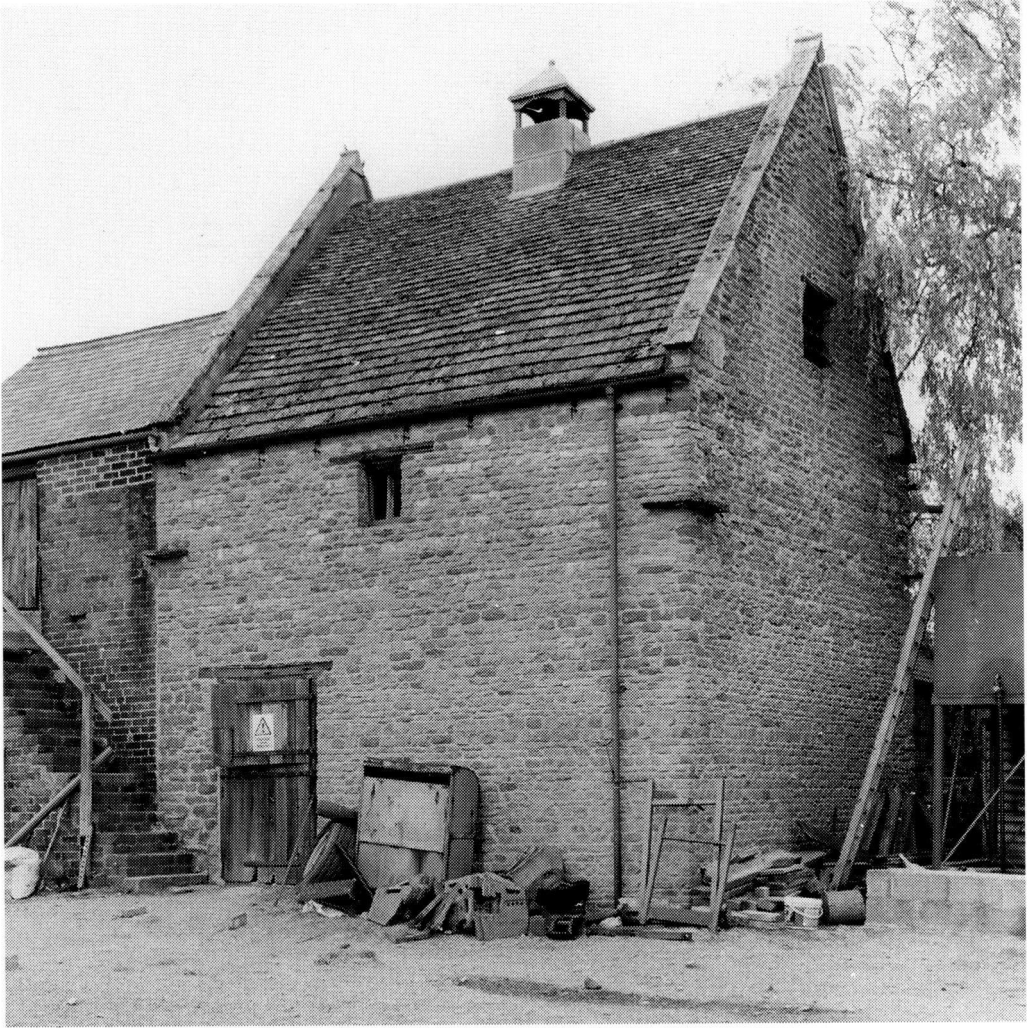
Fig. 9

The dovecote of Home Farm, Egleton, has been converted to a stable by enlarging the doorway and inserting a window above. The projecting stone slabs are original, and were intended to prevent polecats and martens from climbing the corners to enter at the caves

The dovecote at Egleton has projecting stone slabs high on each corner (Fig. 9). Their purpose was different. Before the mid-eighteenth century the only quadrupeds which presented a danger to pigeons were polecats, martens and domestic (or feral) cats. Some of these predators could climb the corners of a rectangular dovecote to enter at the eaves; the corner slabs were to prevent that. They are not often found today, which suggests that many have been broken off in the course of repairs, but surviving examples have been found in Gloucestershire, Northamptonshire and Somerset. They are common in France, where the stone marten continued to be a hazard to dovecotes much later.

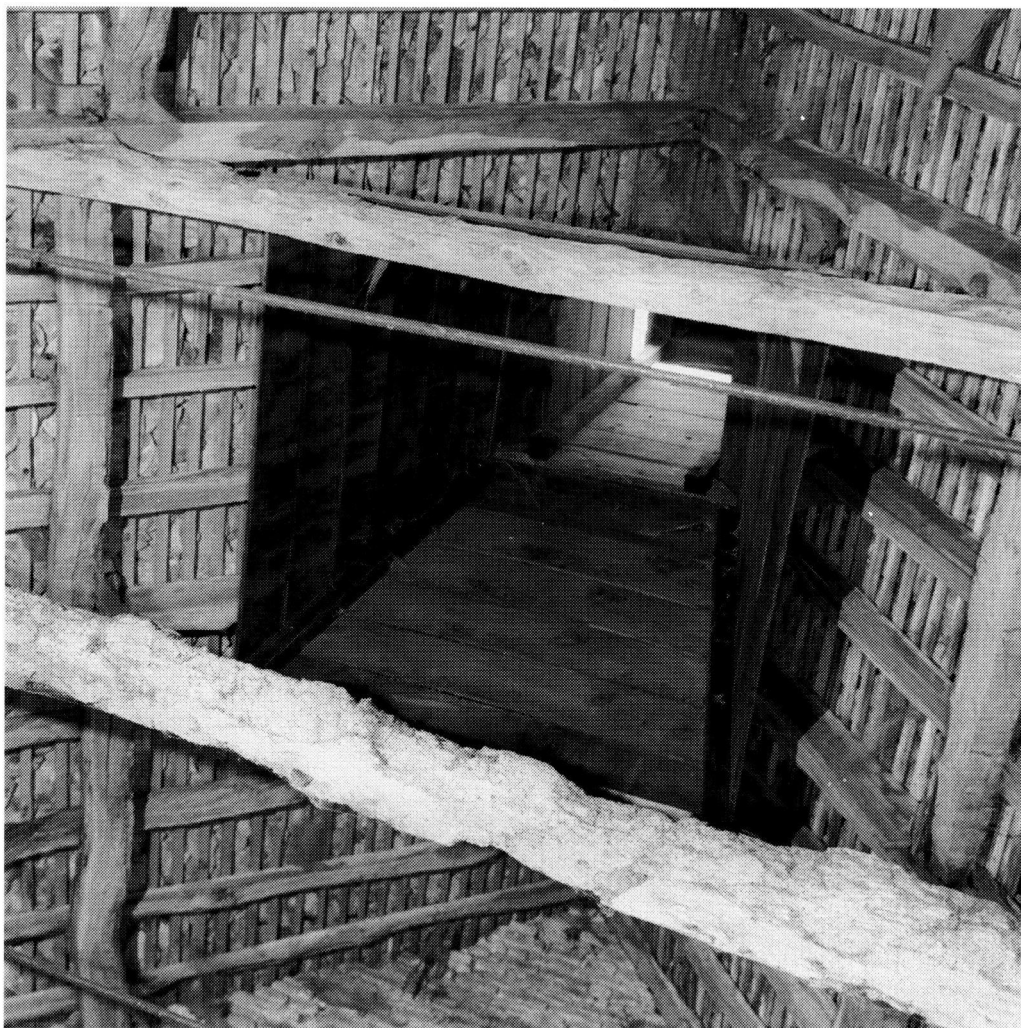
Fig. 10

In the roof of the dovecote at Home Farm, Eggleton, a 'pipe' has been reconstructed, copied from the decayed original. Its purpose was to trap any sparrowhawks which penetrated to the interior

protective device against sparrowhawks, which are small enough to penetrate the louver. These birds cannot fly vertically upwards as pigeons can, so if one succeeded in entering the dovecote it would be trapped there until it was despatched by the pigeon-keeper. Original pipes have been recorded in Essex, Suffolk and Somerset.¹⁵ This dovecote formerly displayed a datestone high on the west gable but it has been lost in the course of repairs; it is reported to have been inscribed with the date 1652.¹⁶

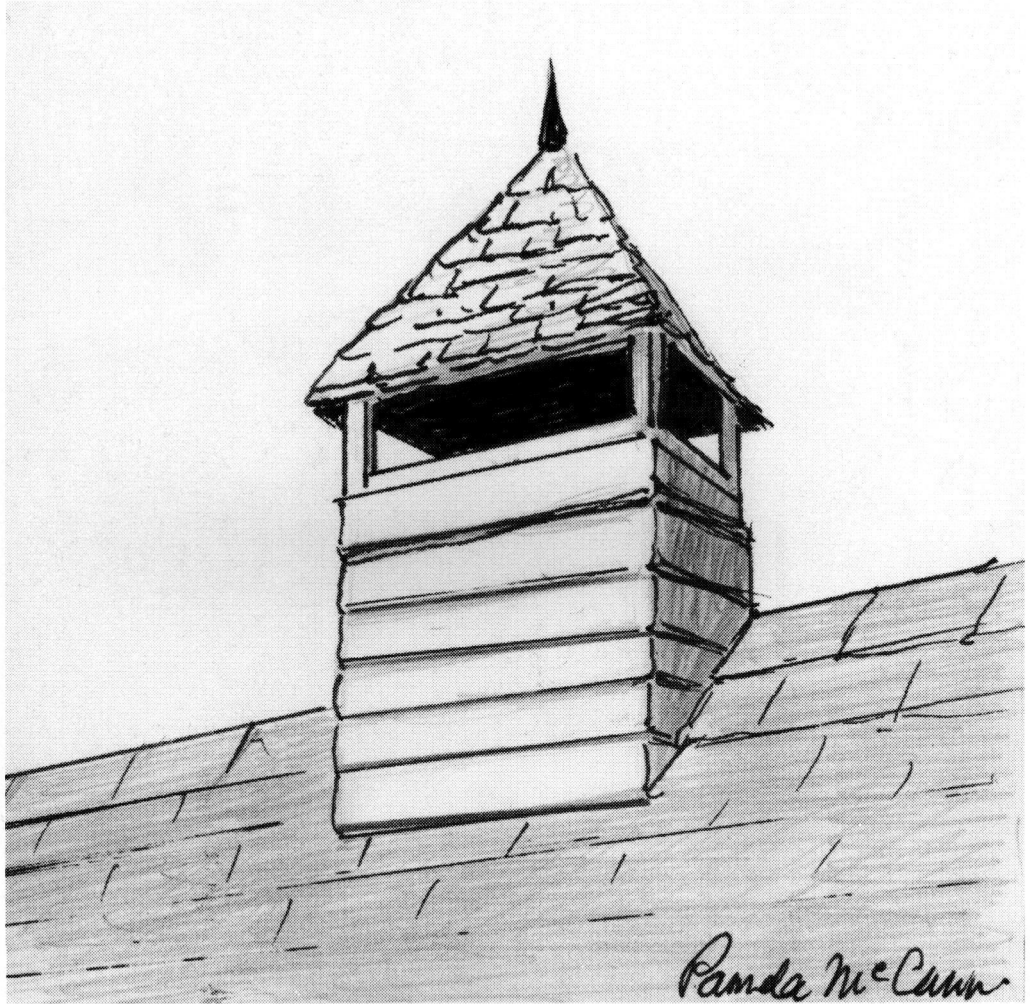
Fig. 11

The original louvers are believed to have been of this type.

Reconstructed by Pamela McCann from old photographs

No original louvers have survived unaltered, but old photographs dating from the first few years of the twentieth century show that they were of the type illustrated in figure 11.¹⁷

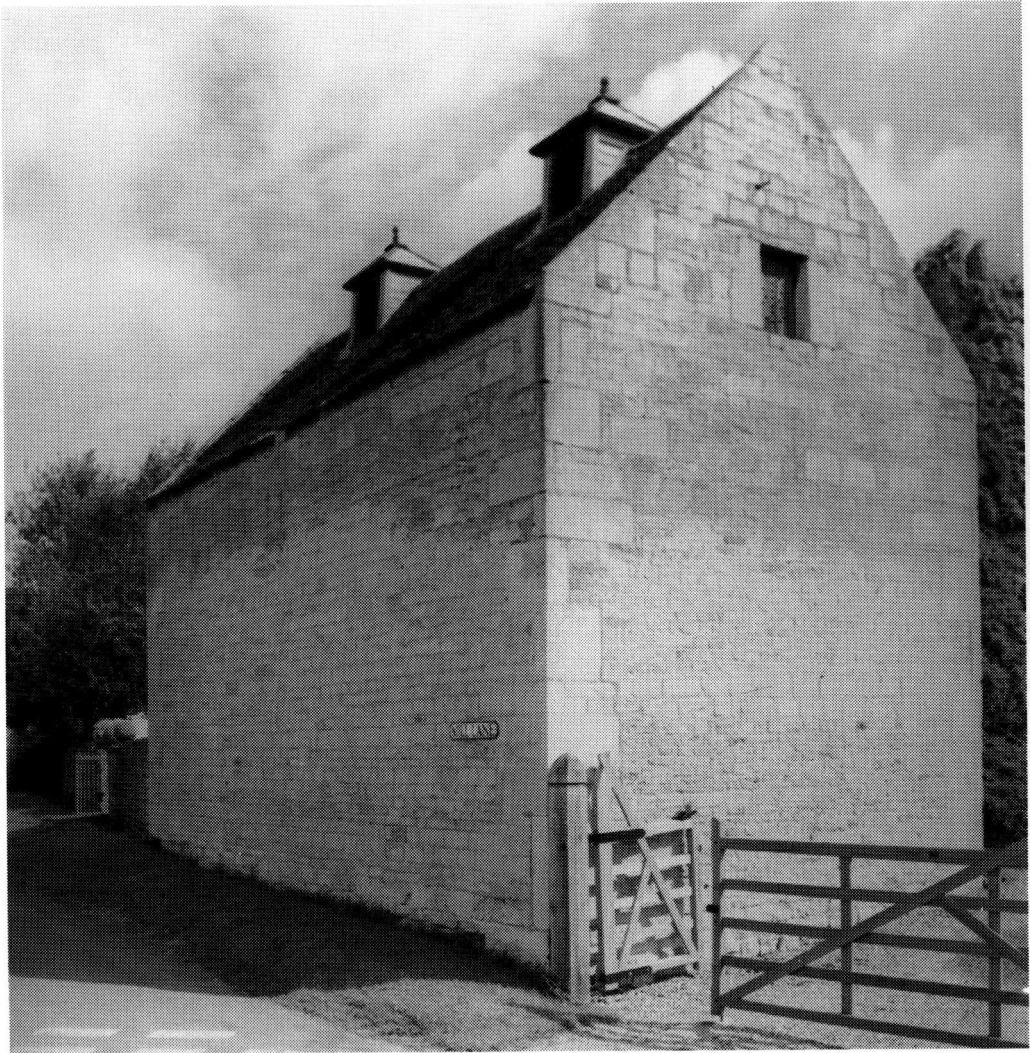
Fig. 12

The double dovecote at Knob Hall, Barrowden. The twin louvers are modern reconstructions

The dovecote immediately adjacent to Knob Hall, Barrowden, is of the same type but is doubled, having two square cells with separate entrances and louvers (Fig. 12). The nest-holes are arranged in grid pattern, but in all other respects it is of the standard type. It has 1,276 nest-holes; most manorial dovecotes have between 300 and 1,000. Knob Hall itself is not large enough to account for a dovecote of this size, but the owner reports that it was formerly the steward's house of a large estate.

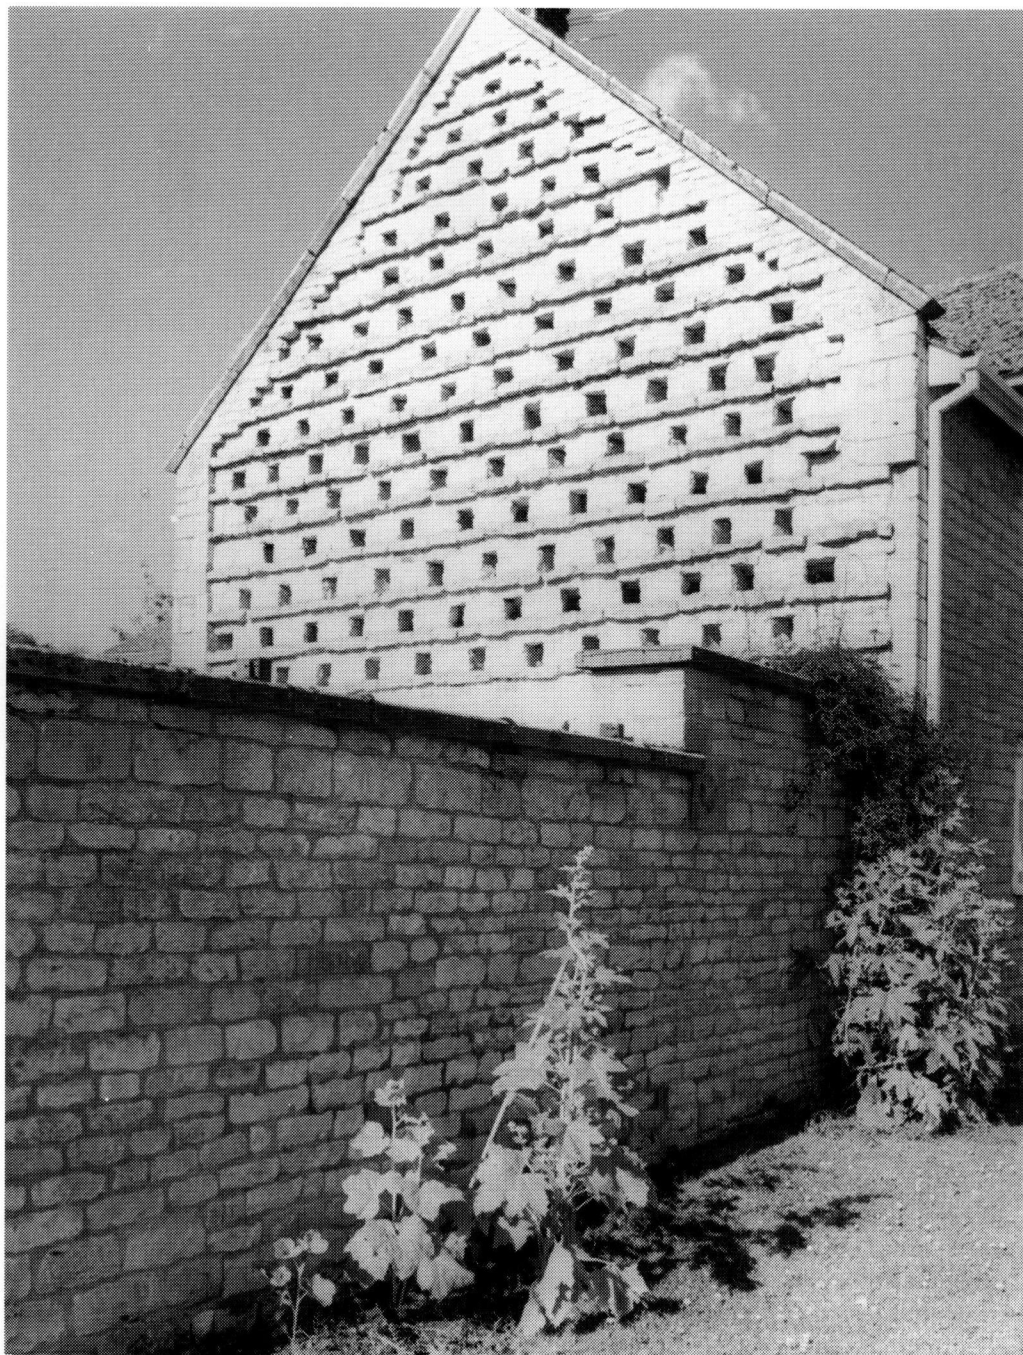
Fig. 13

At Cottesmore one wall survives of a dovecote which was formerly integrated with a corn barn

Some dovecotes of this type exist in incomplete condition. At Cottesmore only one gable wall remains of a dovecote which formerly was integrated with a corn barn (Fig.

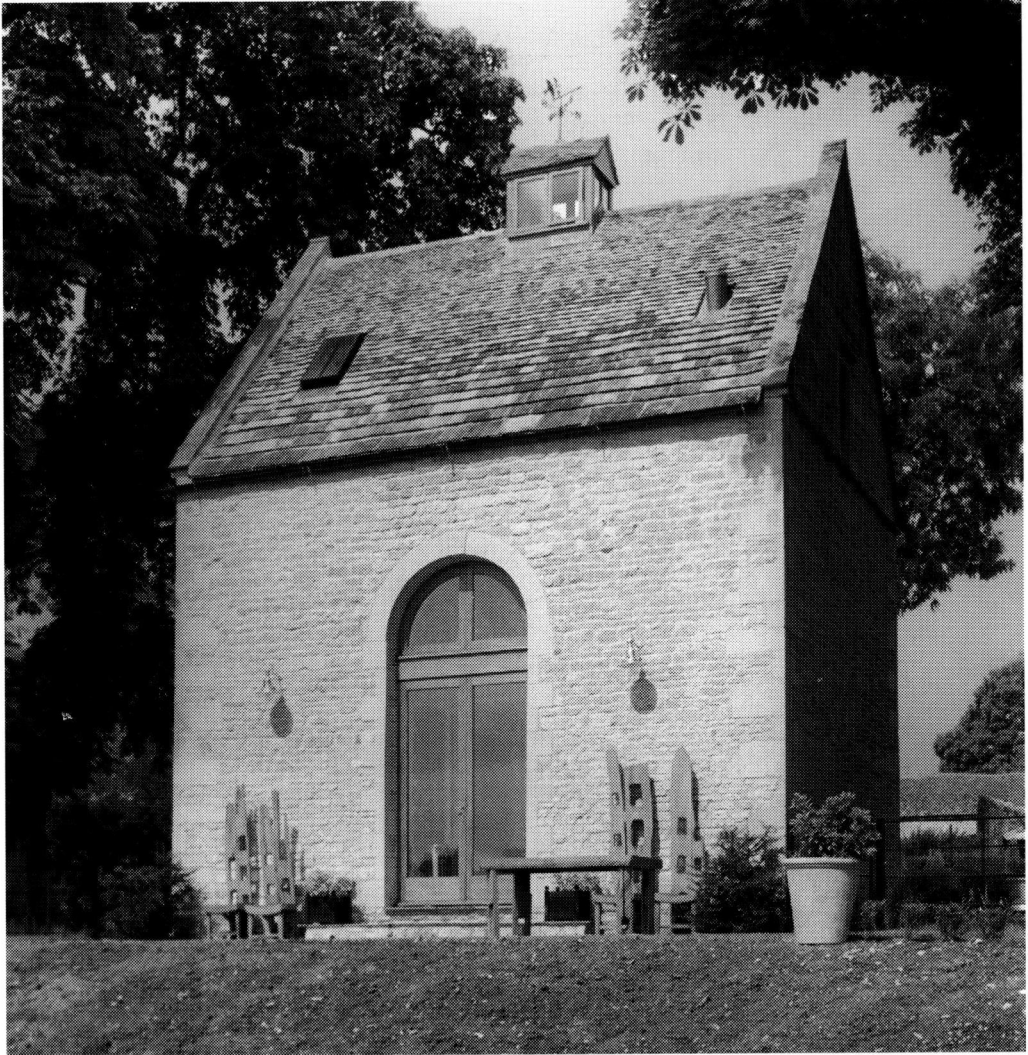
Fig. 14

The dovecote of The Grange, Geeston, Ketton, formerly part of Manor Farm, now converted into a domestic annexe. The large aperture was formed when it was converted for use as a cart-house. Note the perching ledge across the base of the gable

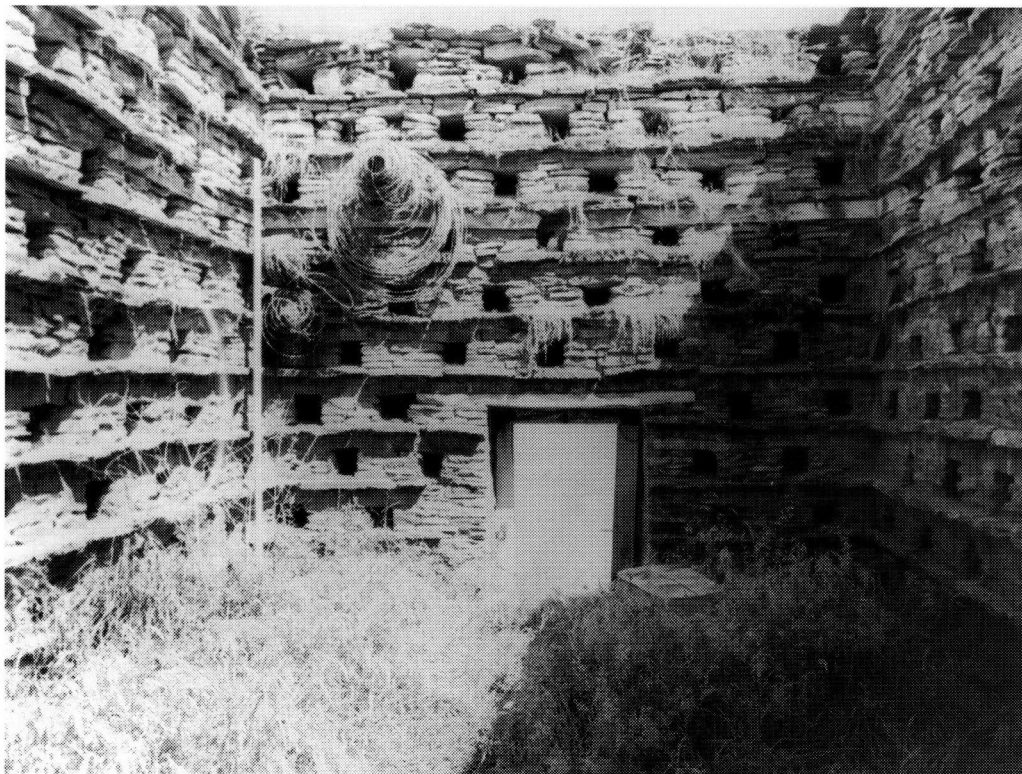
Fig. 15

The derelict dovecote identified as Pilton A retains its original low doorway. Three tiers from the top timbers are built into the stonework to strengthen the corners

A, standing roofless and without gables but otherwise in fair order (Fig. 15). Timbers are built into the seventh tier of nest-holes to strengthen the corners, a feature not observed elsewhere.

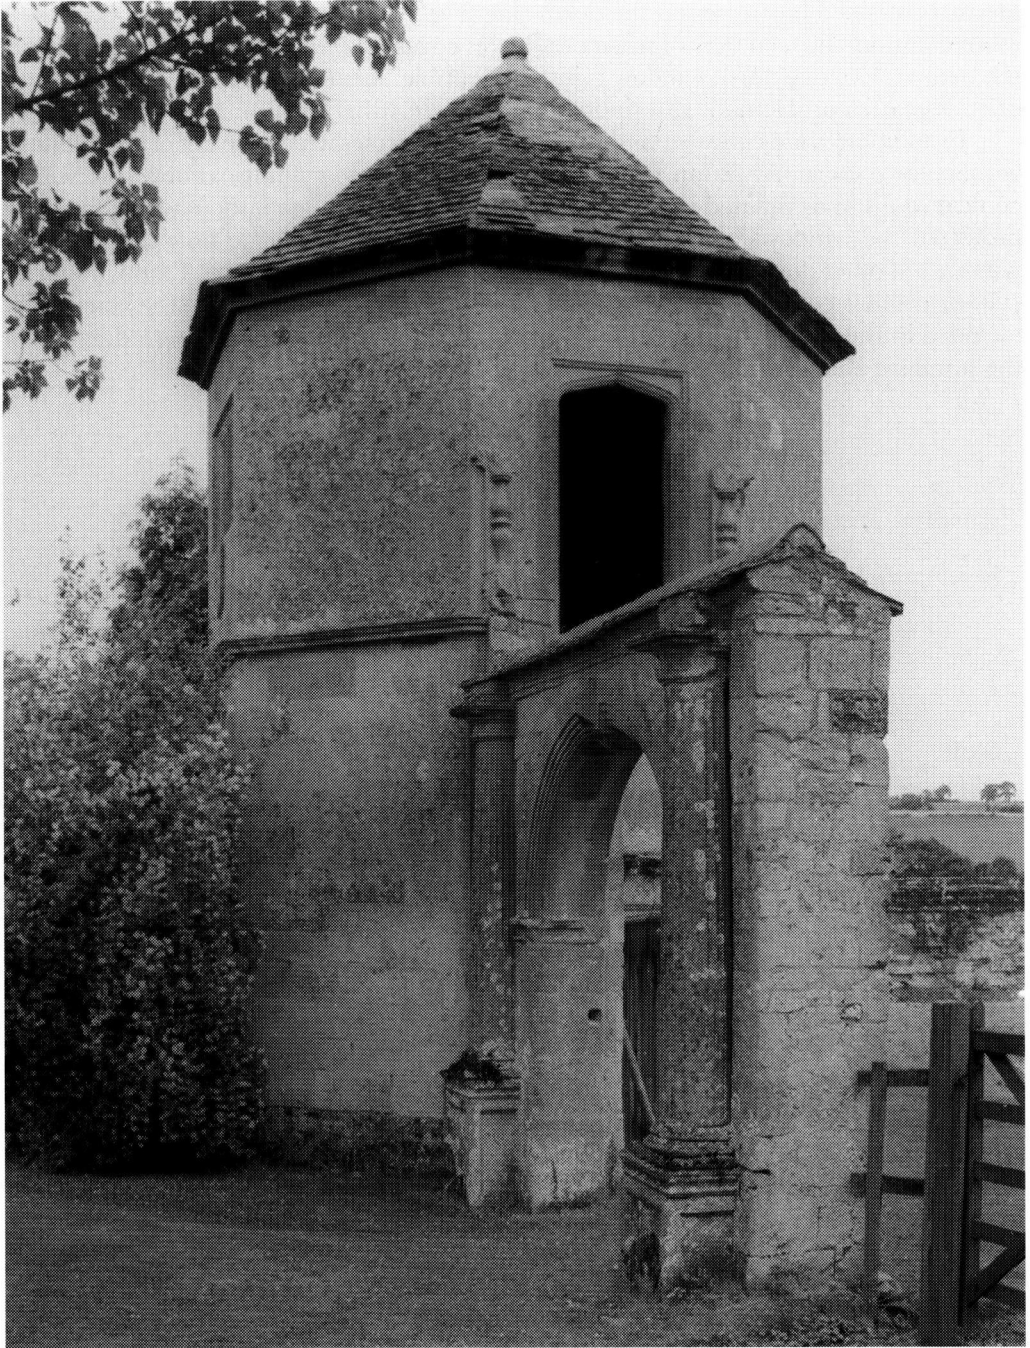
Fig. 16

The late-sixteenth-century gatehouse at Brooke Priory, converted into a dovecote

a gateway flanked by Roman Doric columns, built wholly of limestone ashlar externally. At each floor an ovolo-moulded doorway faces south towards the gateway, the upper one leading to what remains of a balustraded walk over it (Fig.16). An ovolo-moulded two-light window at each level faces east towards the site of the mansion, and a similar three-light window at first-floor level faces west, with below it a raised heraldic shield. On the north side is an original chimney with the moulded base of an octagonal shaft. In this handsome building, evidently designed by an architect and executed to the highest standards, twenty-two tiers of nest-boxes have been constructed of re-used limestone and squared marlstone rubble. They cover the fireplace and formerly covered most lights of the windows. There were about 900 nest-boxes, of which 460 remain against five walls. A moulded string course at mid-height became a perching ledge for the pigeons. The pyramidal roof has been rebuilt, so there is no trace of the louver.

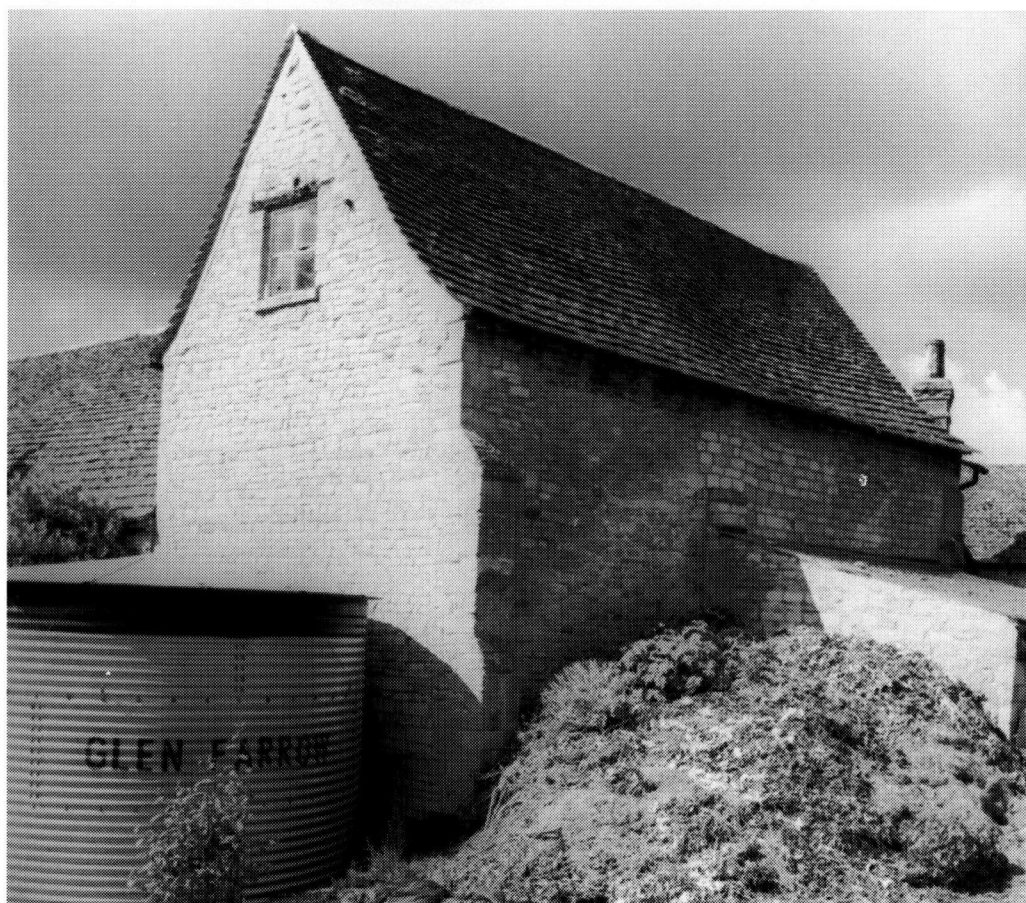
Fig. 17

The medieval chapel of Old Prebendal House, Empingham, converted into a dovecote.
Three stepped buttresses are visible on the north side

are three stepped buttresses on the north side (Fig. 17). The remainder has been much rebuilt. Inside, thirteen tiers of stone nest-boxes cover every medieval feature, although the rear-arch of one north window is just perceptible. A limestone panel over the south door displays a problematic inscription and the date 1619 (Fig. 18).

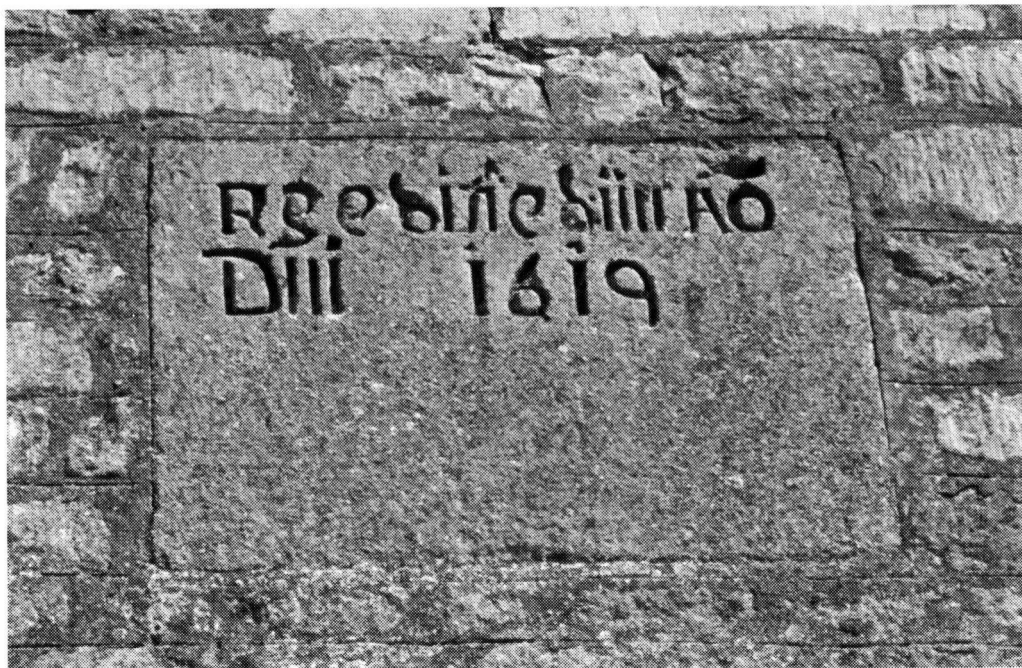
Fig. 18

This inscribed stone is above the modern south doorway of the dovecote at Old Prebendal House, Empingham

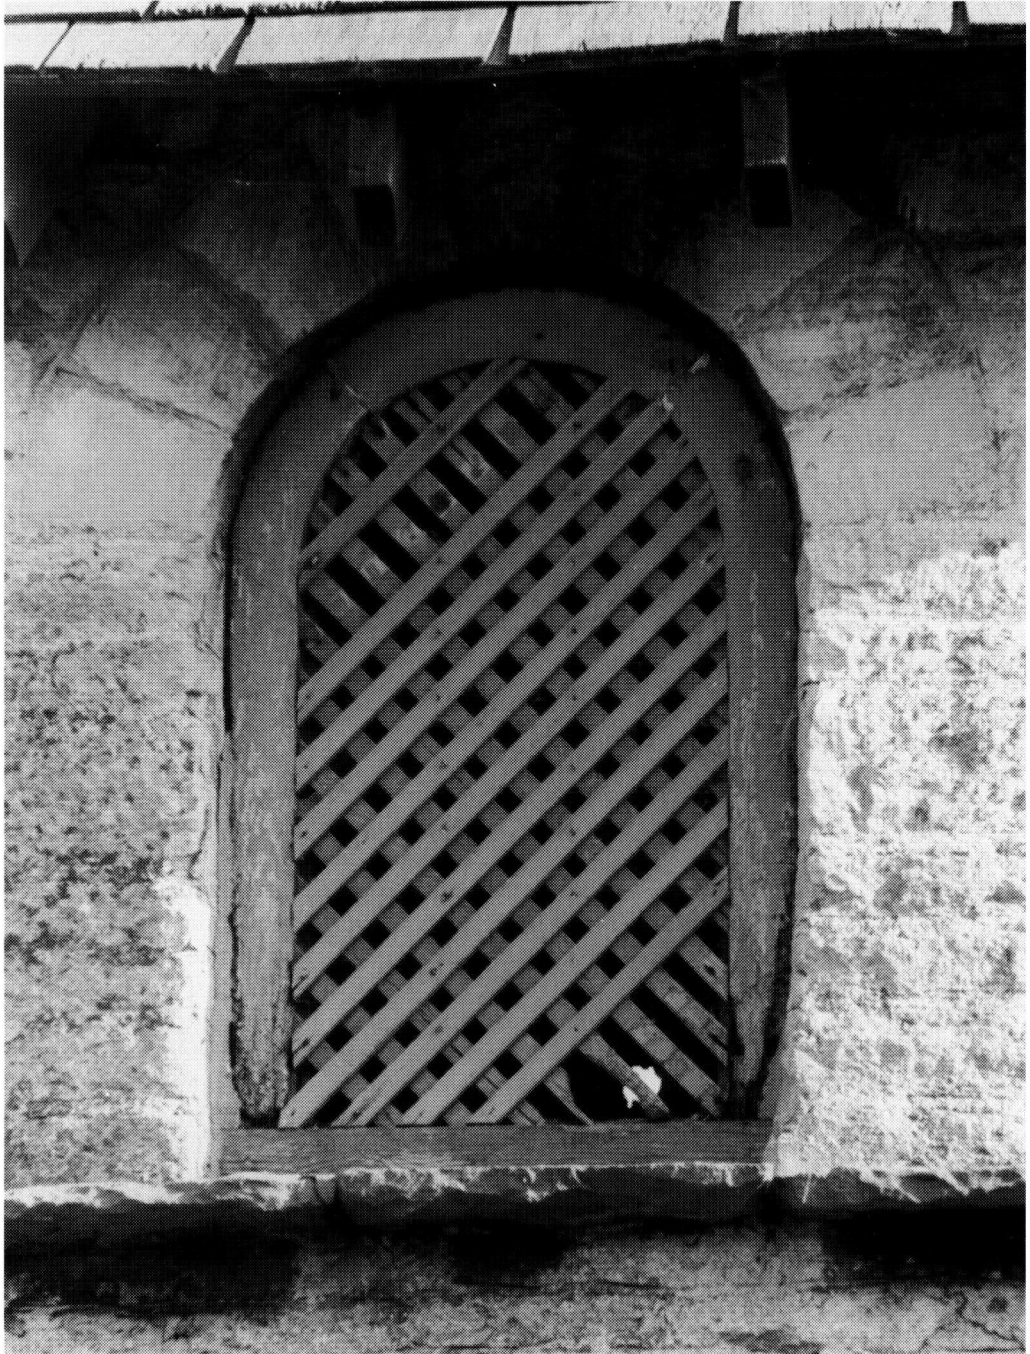
Fig. 19

A surviving lattice at the dovecote at Exton Road, Empingham Its purpose was to keep out birds of prey
