The Dovecotes of Rutland

JOHN and PAMELA McCANN

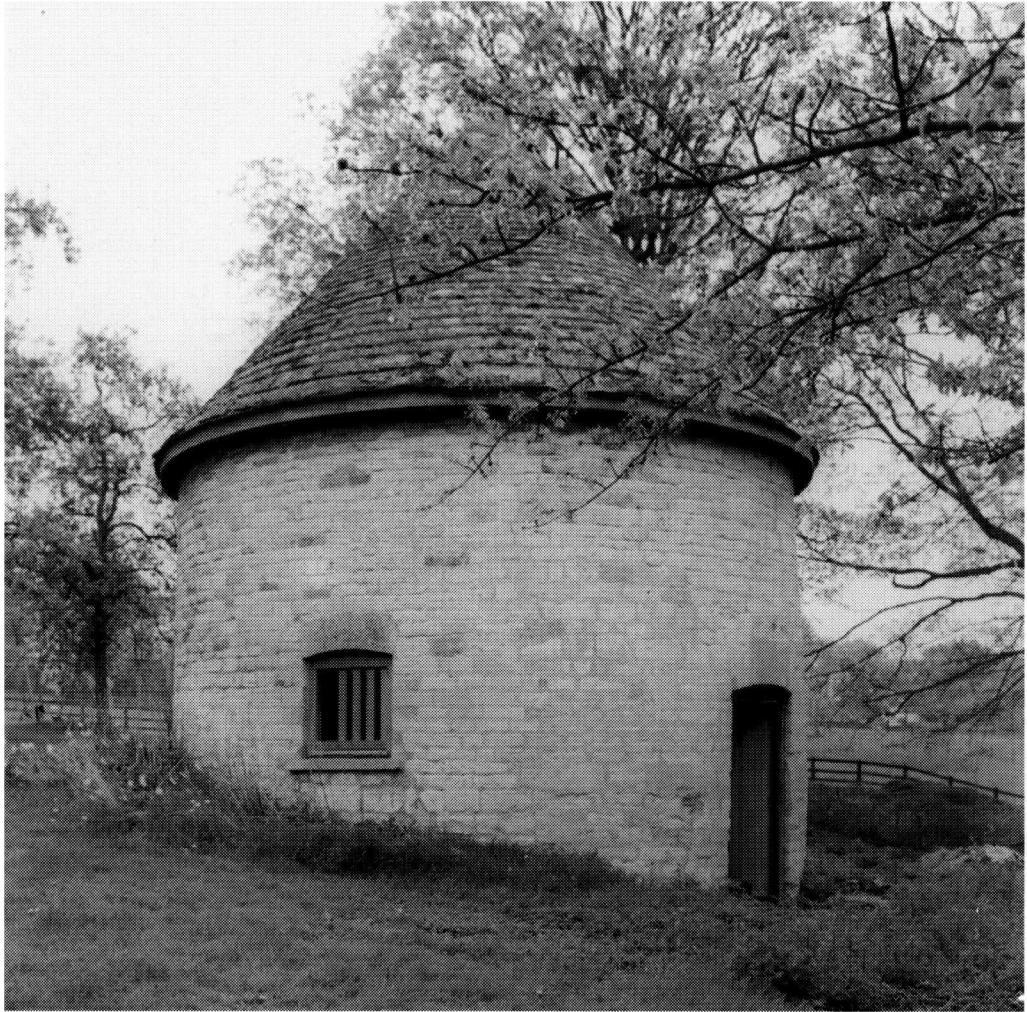
Fig. 20

The dovecote of Barham Court, Exton, converted into a stable.
It may have been substantially taller before the conversion

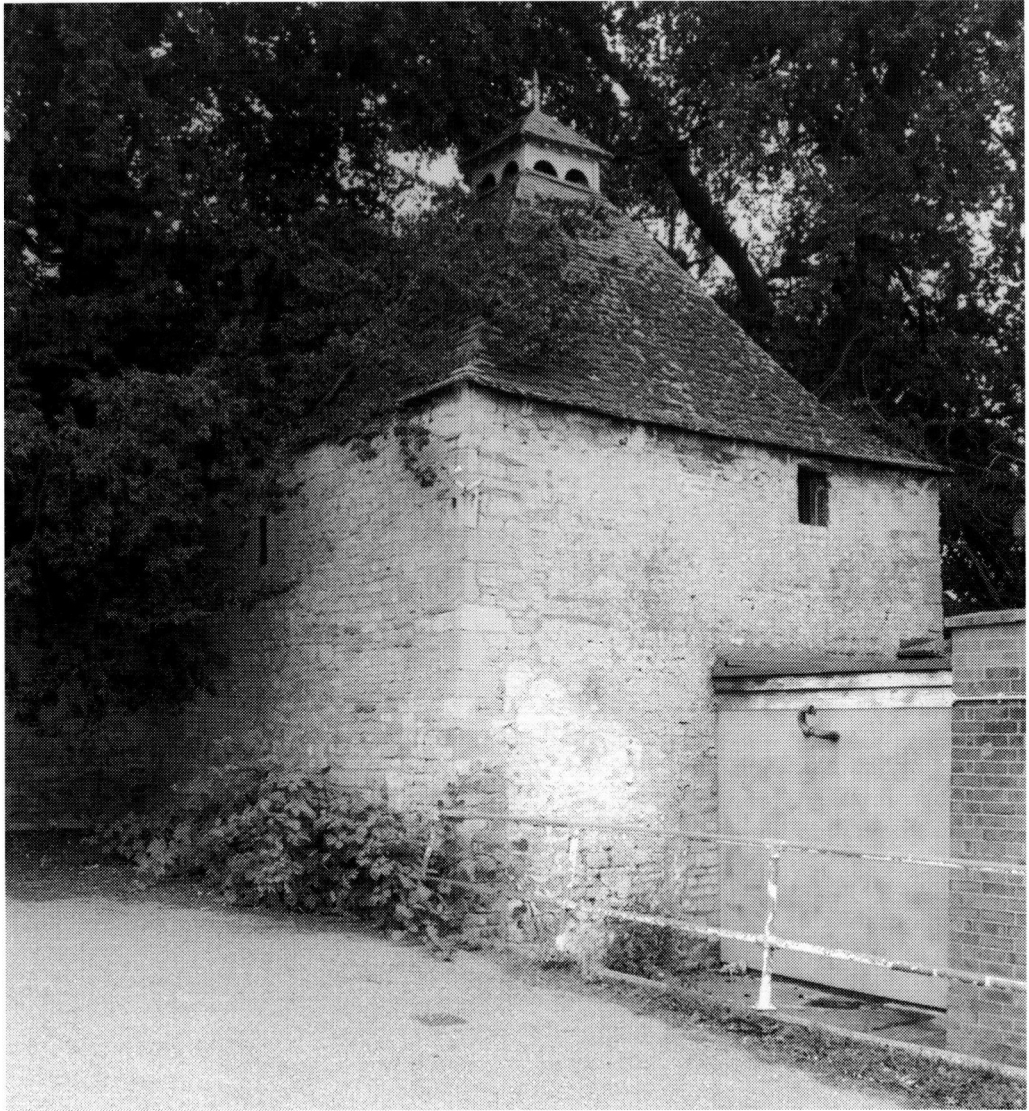
Fig. 21

The dovecote of Ryhall Hall, Ryhall. The louver is a modern reconstruction. No nest-boxes remain

At Ryhall Hall, Ryhall, the dovecote is square with a pyramidal roof, and the walls do not contain nest-holes; evidently nest-boxes were separately constructed of wood or bricks (Fig. 21). The square dovecote of Bassetts Manor, North Luffenham was built originally with two wings containing coach-houses, a symmetrical composition typical of the eighteenth century. A photograph records it in that condition,¹⁹ but in the twentieth century it has been converted to a house (Fig. 22), and all the nest-holes have been covered.

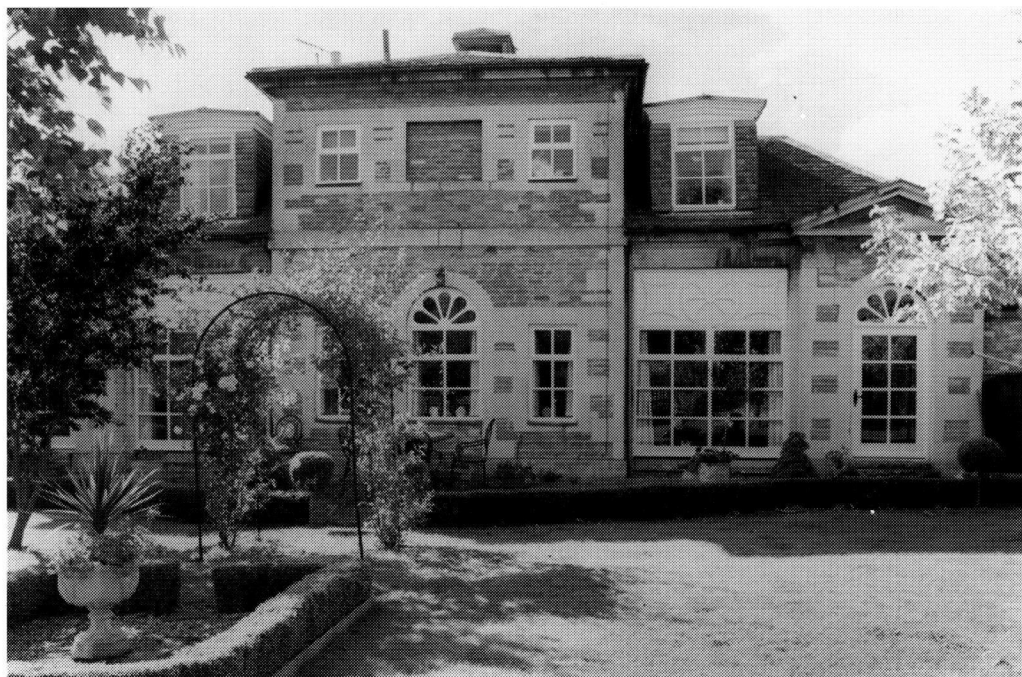
Fig. 22

At North Luffenham the central dovecote was combined originally with a coach-house to each side. It has been converted to a house. The apertures and blind recess closely follow the original design

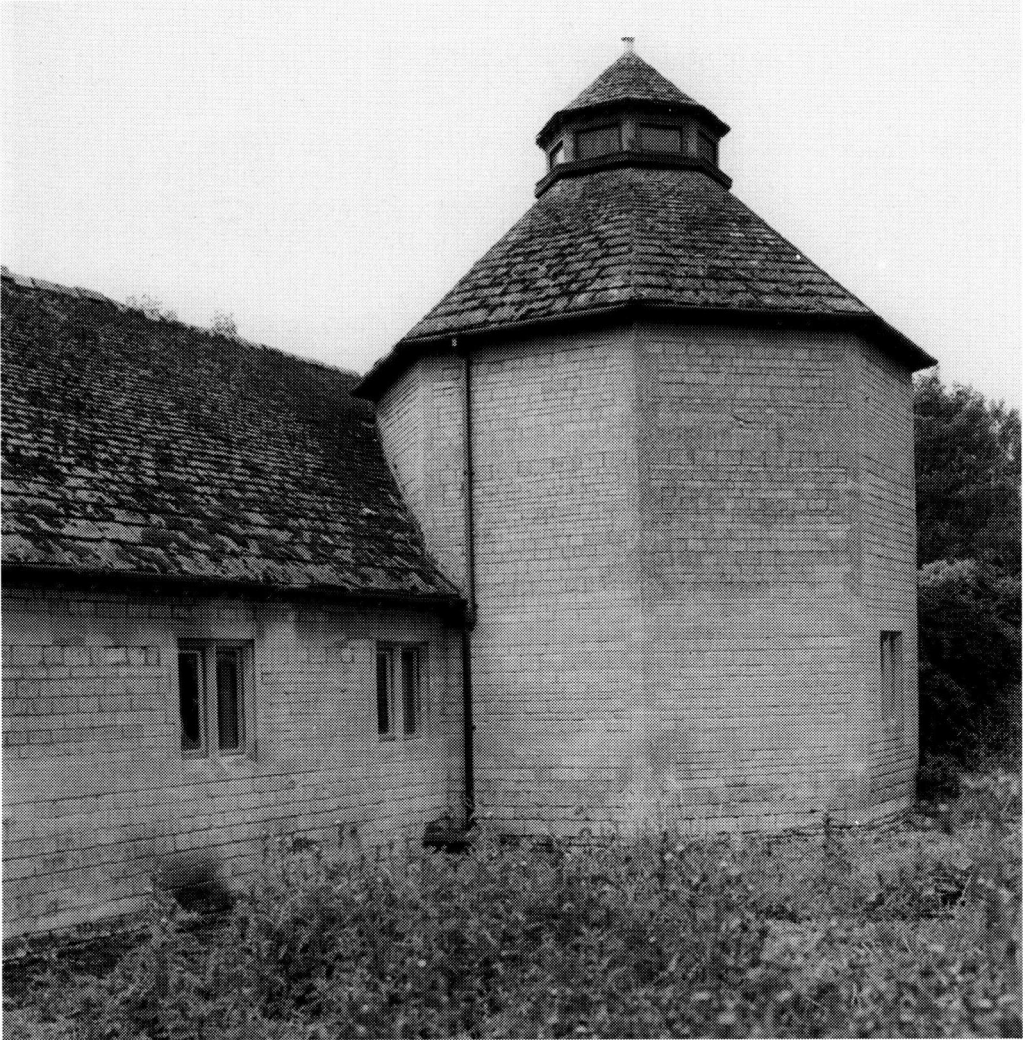
Fig. 23

The nineteenth-century pigeon tower of Clipsham Hall, Clipsham.
Only the upper part contains accommodation for pigeons

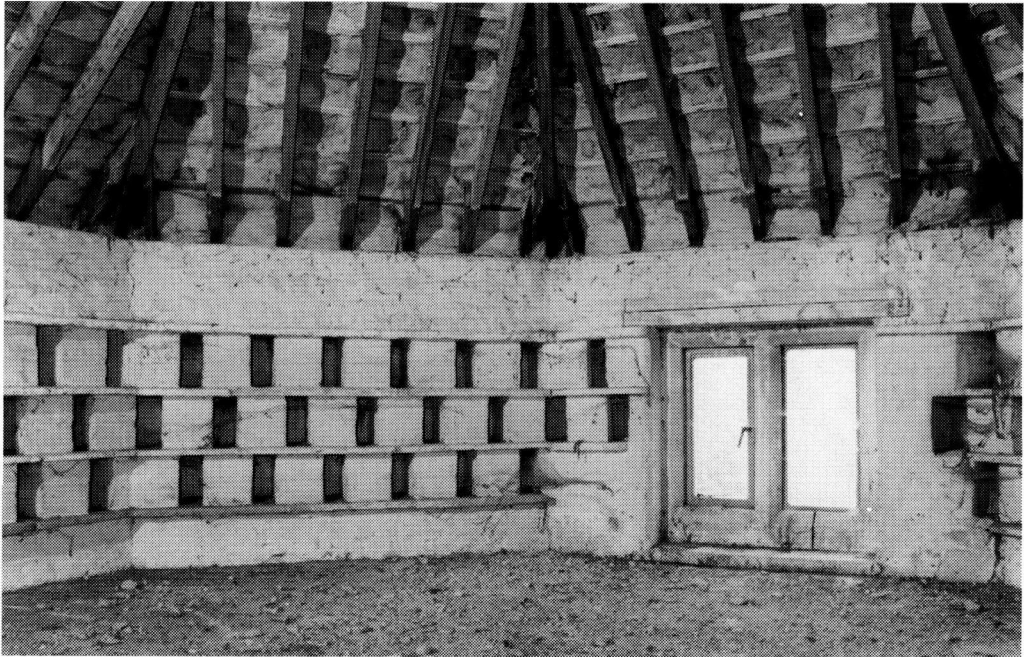
Fig. 24

Inside the octagonal pigeon-loft of Clipsham Hall. The nest-holes are formed with thin slabs of Clipsham limestone, and are substantially larger than those in earlier dovecotes

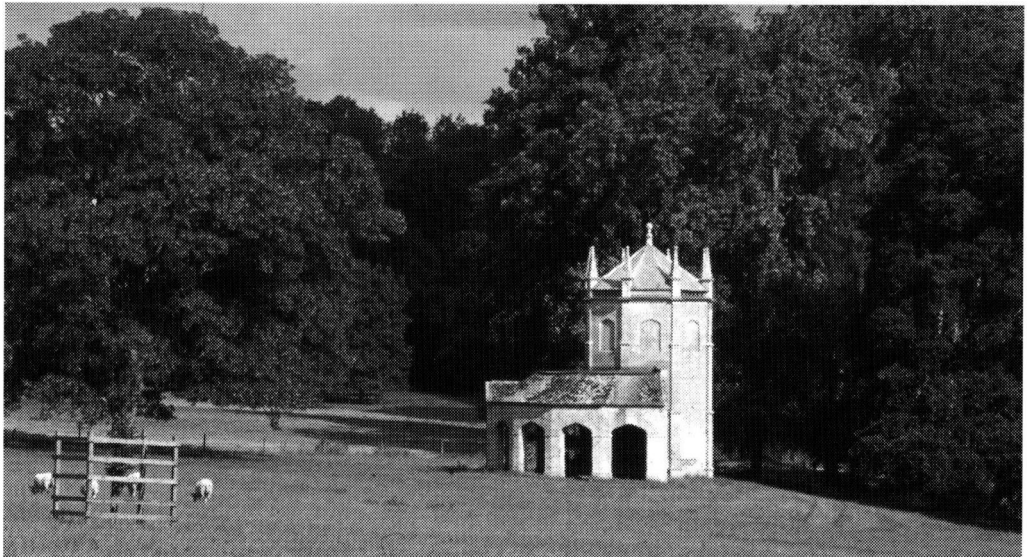
Fig. 25

The dovecote in Exton Park, with a nineteenth-century cattle shelter built against it

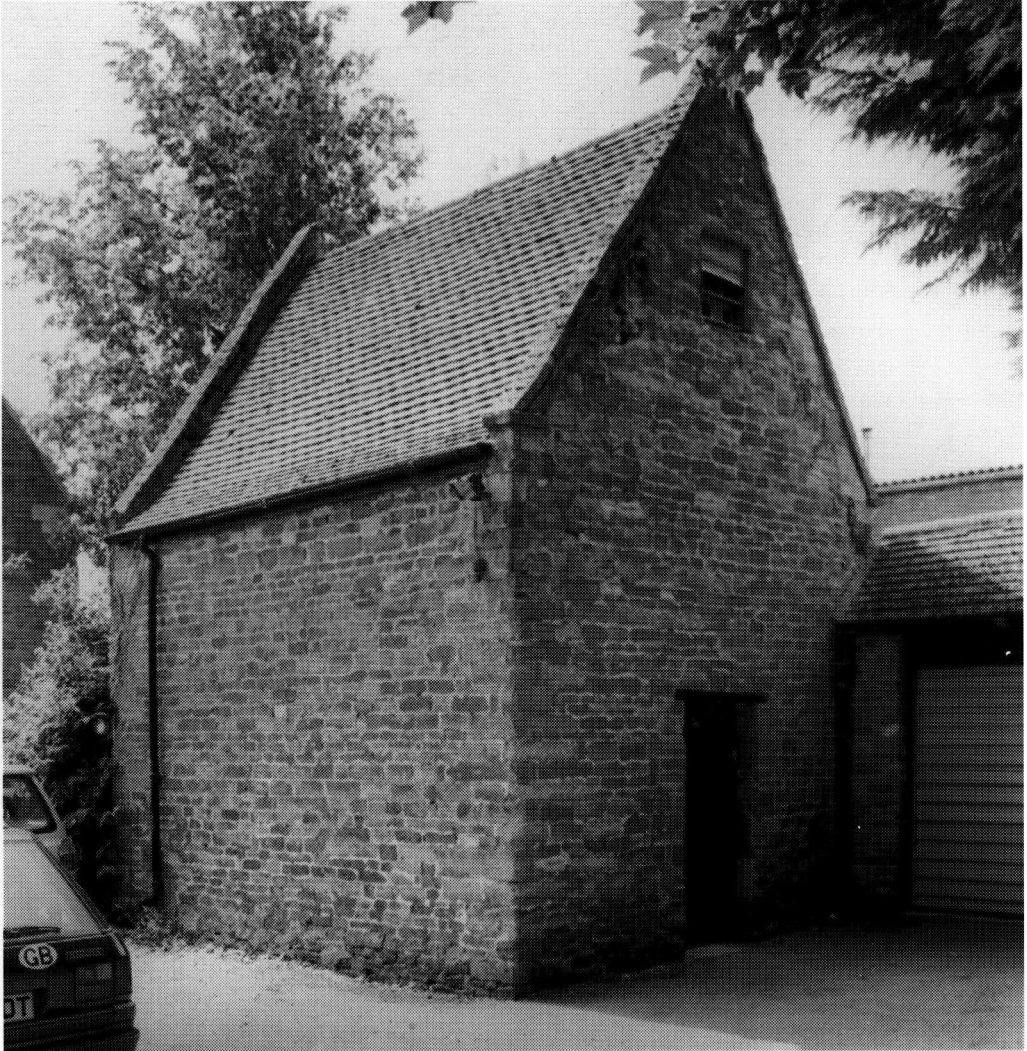
Fig. 26

The dovecote of Yule House, near the middle of Oakham, is roofed with machine-made clay tiles. It has been converted into a workshop with the insertion of a large window on the other side. The interior is shown in figure 4
